## Simpson Street Tunnel Rehabilitation and Lining Stage 1

Rohan D McKinnon <sup>1\*</sup> and Luke Coughlan<sup>2</sup>

<sup>1</sup> Senior Projects Engineer, Warrnambool City Council

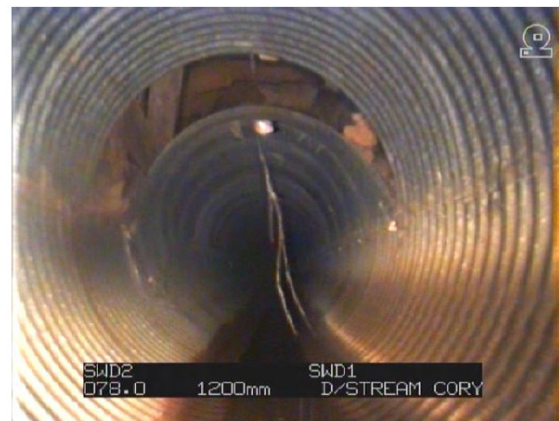
The second reach from MH 3 to MH 4 is also lined with the galvanised steel multi-plate corrugated culverts, again the invert was rusted out and the floor shoring through. There were also two sections of multi-plate dislodged and protruding down into the flow, behind the dislodged section were shoring timber and loose rubble and rocks. (See Figure 3)

Figure 3: Dislodged section of multi-plate. <sup>2</sup>

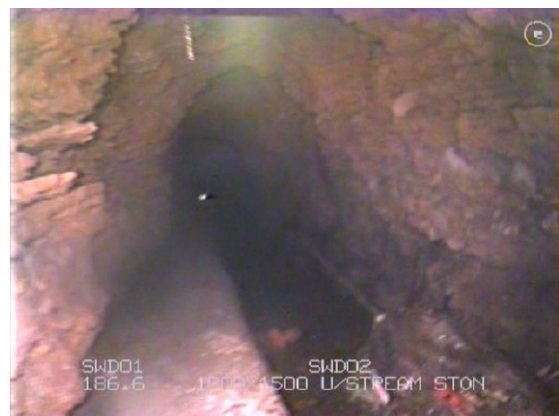
Co-located in the section of tunnel is a 300mm diameter sewer, controlled and operated by Wannon Water. The sewer is encased in concrete and blue-stone 600mm wide and 600mm high encasement. (See Figure 4).

Figure 4: Tunnel between MH 4 and 5 looking upstream with sewer encasement on left <sup>2</sup>

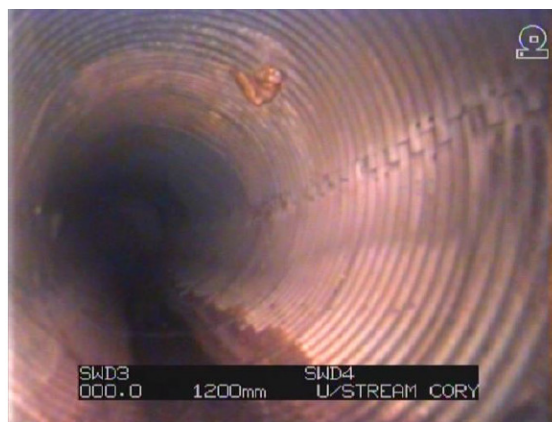
The first reach from MH 2 to MH 3 was lined with 1200 mm dia galvanised steel multi-plate corrugated culverts. The invert of the culvert is rusted out and the flood of the tunnel is showing through. (See Figure 2). There is no information on the soil condition outside the culvert.

Figure 2: Reach 1 galvanised steel multi plate culverts, not rusted floor. <sup>2</sup>

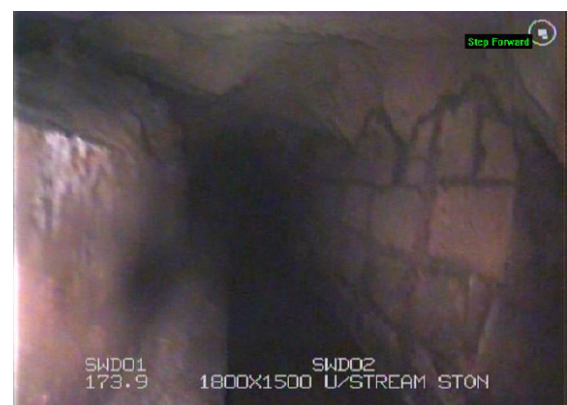
The third reach from MH 4 to MH 5 was lined with 30 metres of galvanised steel multi-plate corrugated culvert. After 30 metres the tunnel is general un-lined natural sandstone ground. There are isolated sections of sandstone block walls and blue stone block walls that had been constructed to control poor section of the tunnel.

Figure 5: MH 4 to MH 5 section of sandstone wall, looking upstream <sup>2</sup>

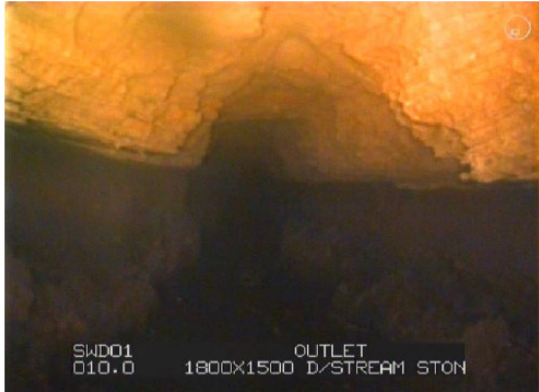
The section of tunnel from MH 5 to outfall is mainly unlined. (See Figure 6). There were two sections of timber shoring and two sections of corrugated culverts of a different design to the upstream sections. The final outfall is a 900mm diameter flush joint concrete pipe.

Figure 6: Downstream of MH 5 showing different stratum <sup>2</sup>

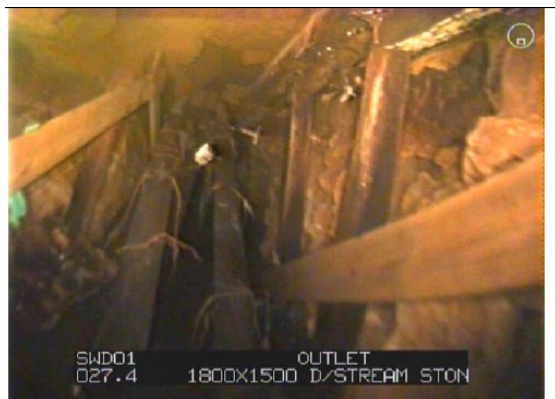
The timber shoring had collapsed and was not supporting the roof, material had eroded from the roof leaving the shoring free standing in the tunnel. (See Figure 7). The collapsed shoring was partially blocking the flow in the tunnel reducing capacity.

Figure 7: Downstream MH 5 collapsed timber shoring

- Increase the frequency of inspections of the tunnel.
- Undertake works to clear rubble and fallen timber.
- Undertake works to improve access to the tunnel by replacing rusted black iron access ladders.
- Repair the dislodged multi-plate culvert sections. (See Figure 9)

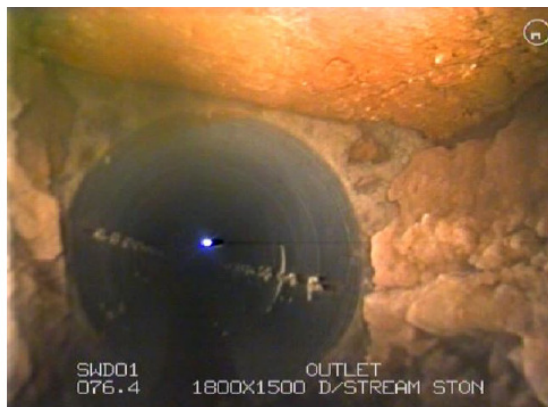
Figure 8: Figure 8 corrugated pipe downstream MH 5

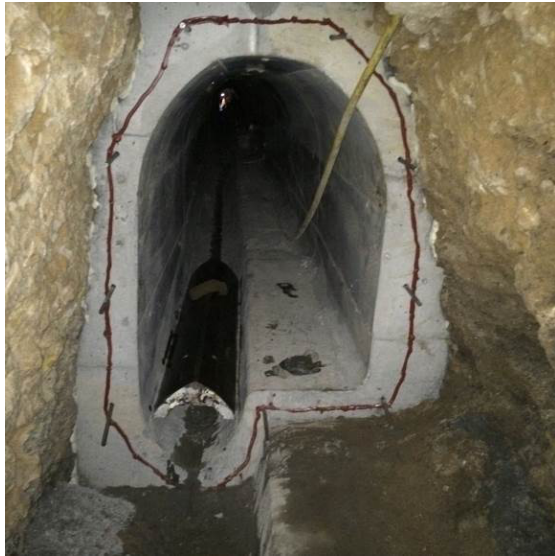
During the Tunneline works a large void over the first 30 metres of multi-plate culvert was discovered downstream of MH 4. (See Figures 16-17). The demolition of the culvert and replacement with liner was included in the works.

Figure 16: Entrance to void over multi-plate culvert

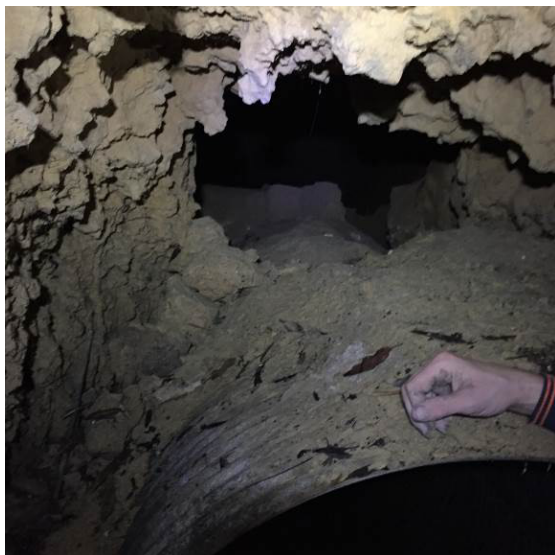
Figure 17: Void over multi-plate Culvert.

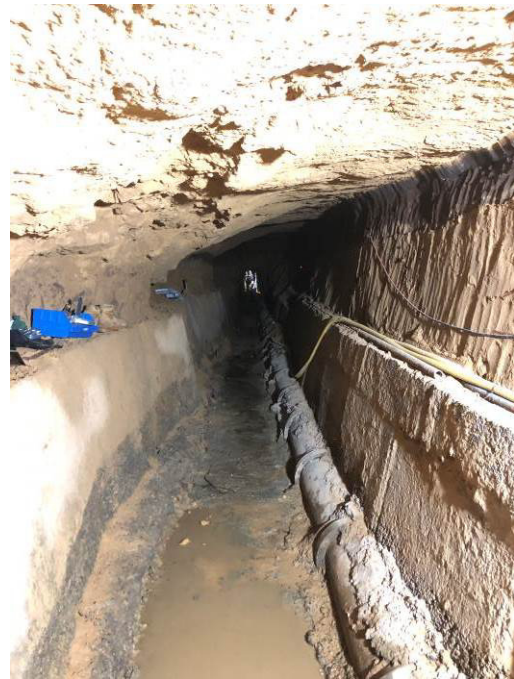
Again the tunnel was excavated to ensure a consistent clearance from the GFPS profile. Figure 21 shows the tunnel following excavation ready to accept the GFRP liner.

Figure 21: Tunnel downstream of MH 4, note sewer exposed
