## Stormwater pipe condition assessments - if only animals could talk

**C Campbell<sup>1</sup>**

<sup>1</sup> Moreton Bay Regional Council, Strathpine, QLD

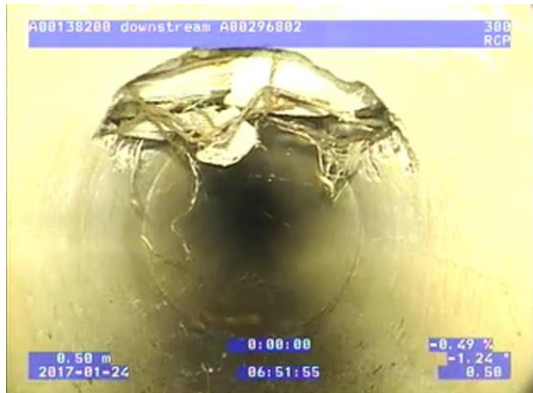
**Issue:** As the service was constructed through the pipe; slightly obstructing the pipe and pushing concrete and reinforcement into the pipe, relining was no longer a viable solution.

**Figure 2:** CCTV photo of intruding service

**Outcome:** Council are still working with Unitywater to get the service relocated and the stormwater pipe replaced.

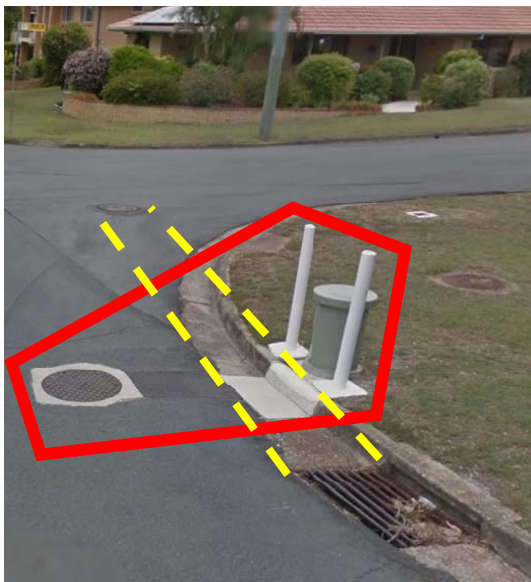
**Figure 3:** Streetview photo of intruding service

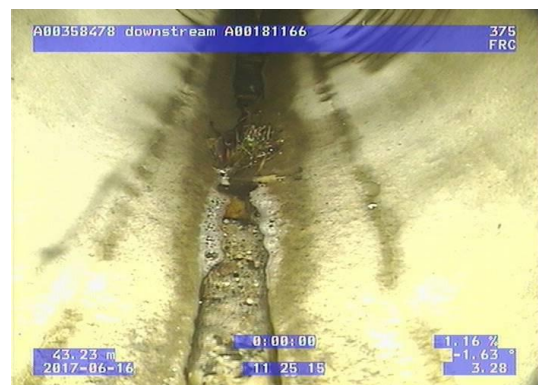
**Issue:** The 500 metres of FRC pipe ranging in size from 300mm to 750mm in diameter was in very poor condition due to invert corrosion, circumferential and longitudinal cracking and fracturing, and complex cracking and fracturing. The rural residential area had no evidence of anything that would cause failures of this nature, and Council did not want to risk replacing the network and having it fail within 20 years. Council engaged GHD to conduct a number of tests to determine the failure mechanism and recommend a replacement pipe material. GHD's investigation determined that acid attack from the inside of the pipe was the most likely cause of the deterioration, however were not able to determine the cause of the acid attack.

**Figure 5:** CCTV photo of damaged network

**Outcome:** In 2019 Council replaced all the affected FRC pipes with HDPE pipes and brought in imported backfill material.

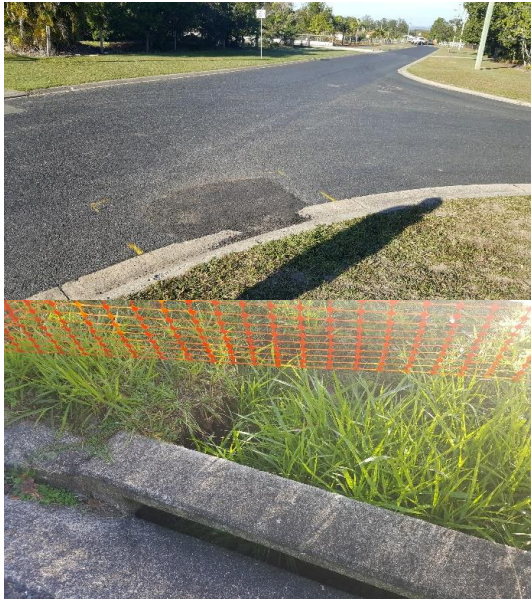
**Figure 6:** Site photos above the damaged network

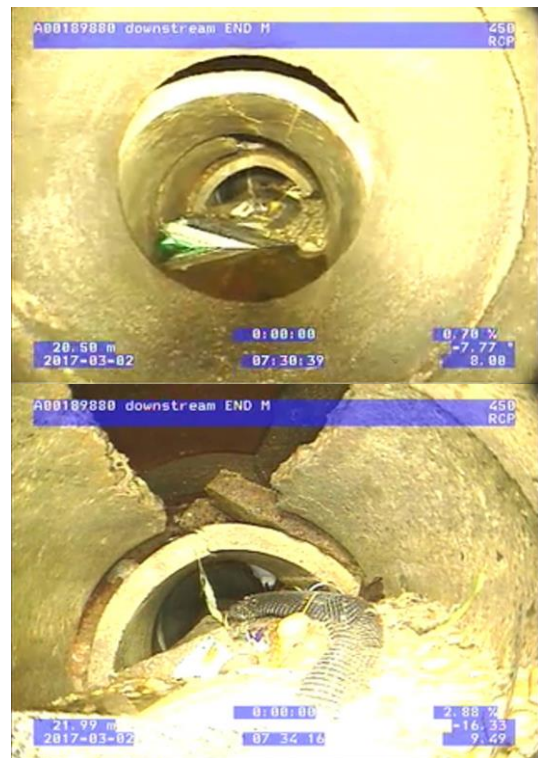
**Issue:** After all the investigation Council could reasonably do, the condition of the remaining 90% of the 450mm pipe was unknown. Another element that complicated any renewal was that the Department of Transport and

**Figure 8:** CCTV photos of collapsed pipe

**Outcome:** Council decided to abandon the 450mm pipe at the upstream manhole. This leaves the unknown network in place for any pipes connecting into it, however does not address the major defect. If the area above this defect does eventually collapse, Council will repair the defect and inspect the rest of the network.

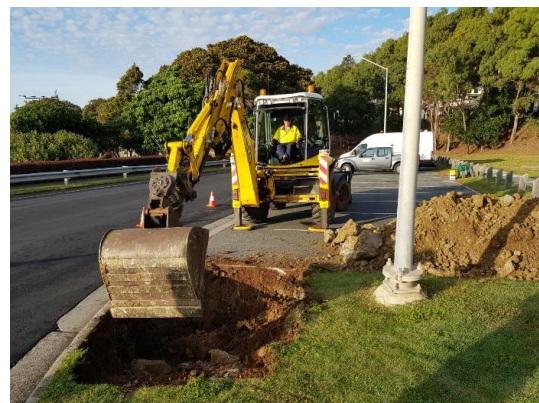
**Figure 9:** Site photo of excavation to try and locate the network

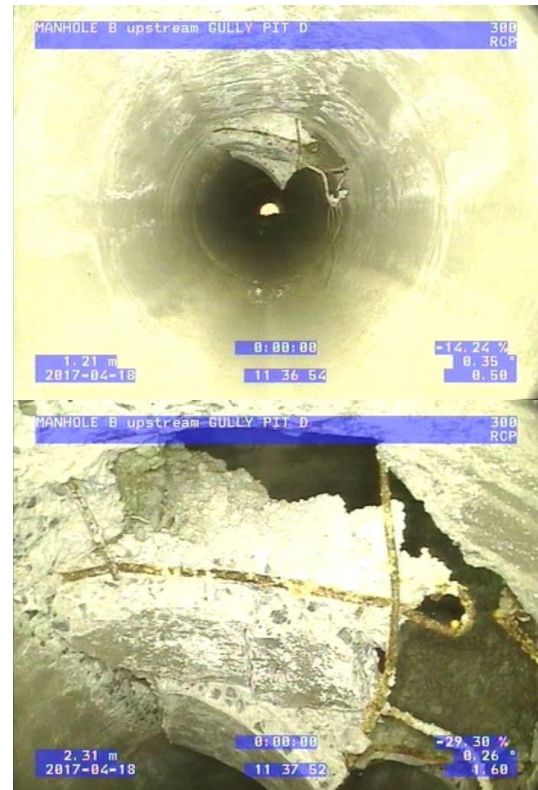
**Issue:** The original CCTV did not inspect the damaged section of pipe, however it did show that the pipe appeared to be intact. The new CCTV, when reviewed very closely, showed a subsoil pipe above the broken and displaced concrete and void. A review of the as-constructed plans showed no assets were constructed near the major defect, except for the kerb and channel. Council would normally replace a section of pipe with this type of defect, however did not want to damage brand new pavement or kerb and channel.

**Figure 11:** CCTV photos of broken pipe

**Outcome:** In 2017 Council engaged Pipe Management Australia to cut back the concrete intruding into the pipe, patch the hole in the pipe, and address the void above the pipe by core-drilling a 100mm hole through the pavement and filling the void with flowable fill.

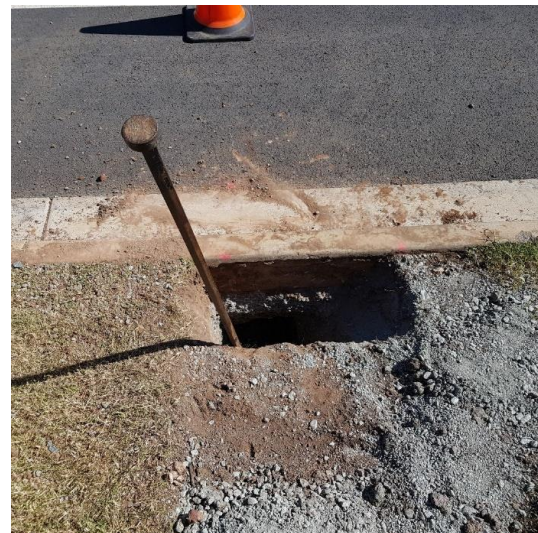
**Figure 12:** Site photos of void above break

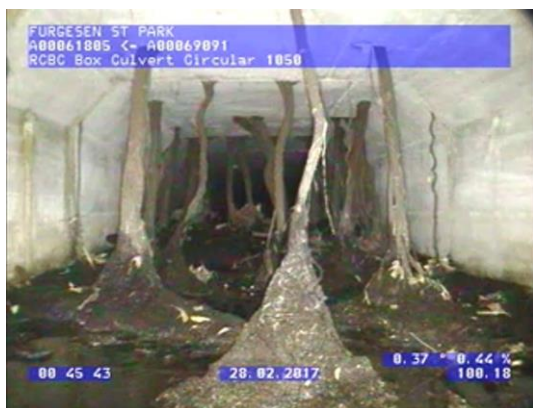
**Issue:** The access points for the culverts were 45m upstream and 100m downstream from the blockage. This posed an issue when it came to confined space, particularly as the culverts, at 900mm high, were not a comfortable height to walk through. Council decided it would be safer, cheaper, and better in the long run to install a manhole where the blockages were. This would allow the blockages to be removed more quickly, safely, and cheaply, and would provide an access point in future. The property owner was supportive of Council removing the tree to install the manholes and unblock the culverts, with the understanding that the tree would not be reinstated in the easement.

**Figure 14:** CCTV photo of root blockage

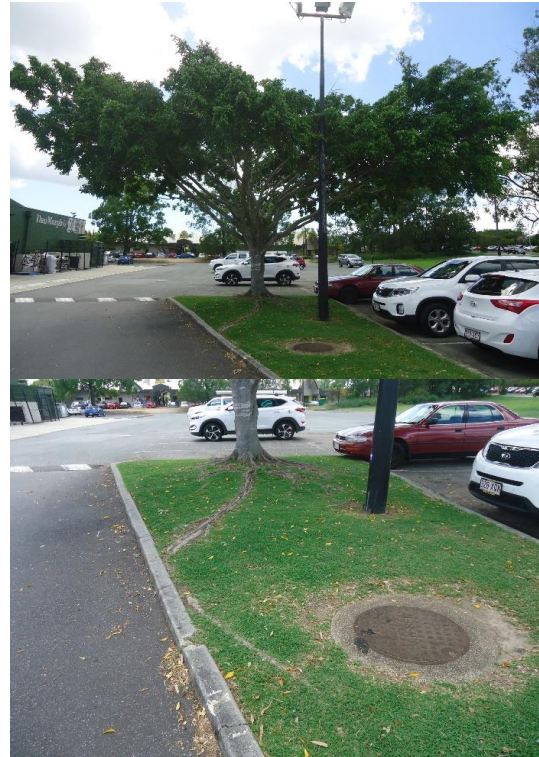
**Figure 15:** Site photos of fig tree and roots
