Aerial Drone-Based Inspections on Critical Infrastructure

Paul Davis¹, Mark Rippon¹, Mike Larkin²
IPWC August 2019

1 – TasWater Asset Performance

Case #1: Visual Inspections of Water Storage Infrastructure

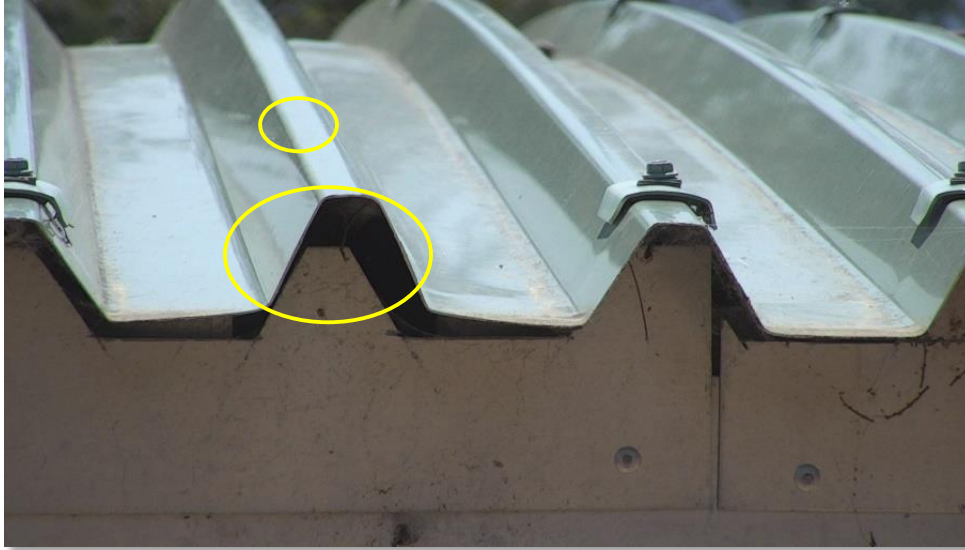
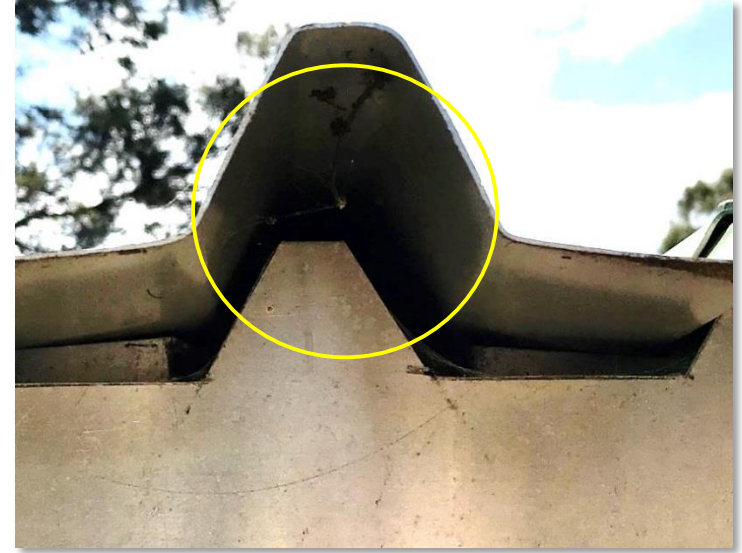
Deficiencies in roofing construction that may allow points of ingress around perimeter of reservoir

Identification and closer examination of defects

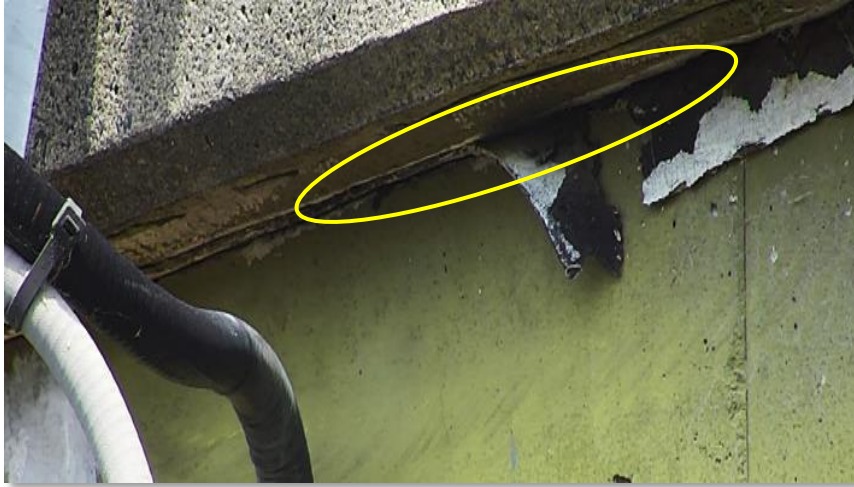
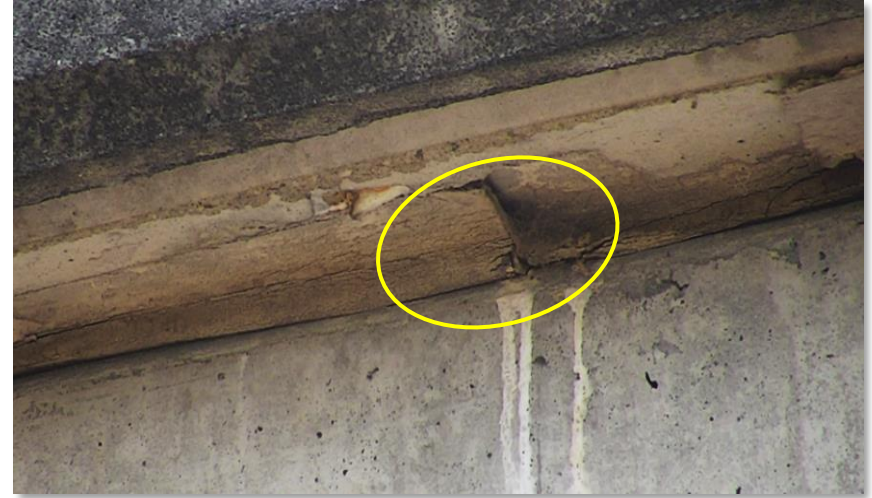
Impaired jointing system between wall and roof presenting potential points of ingress

Difficult to detect by an operator at ground level

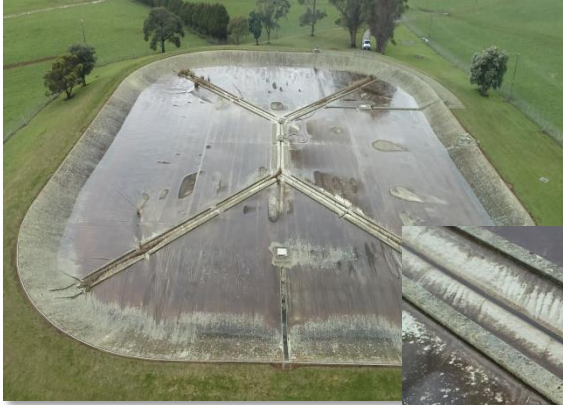
Floating cover- vegetation
build up impacting
drainage of surface water

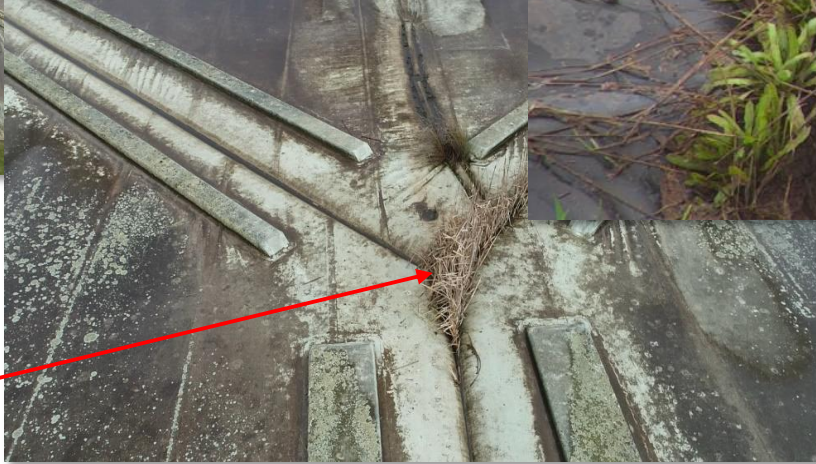
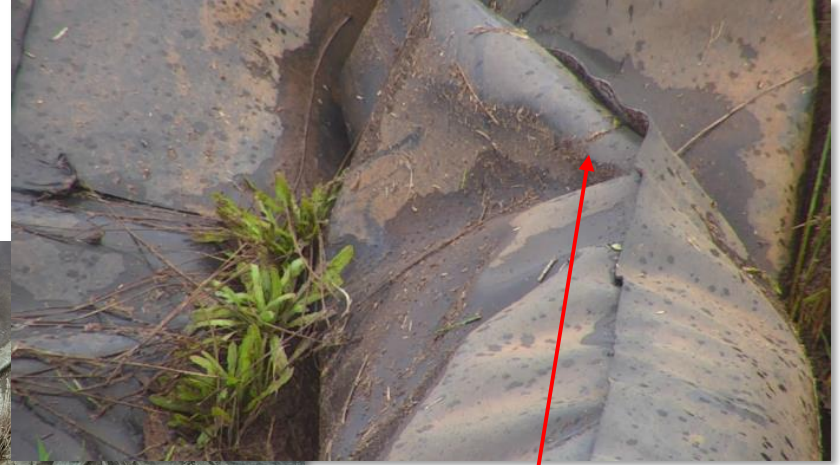
Floating cover-
unsecured seam

Detected without operator traversing the covers

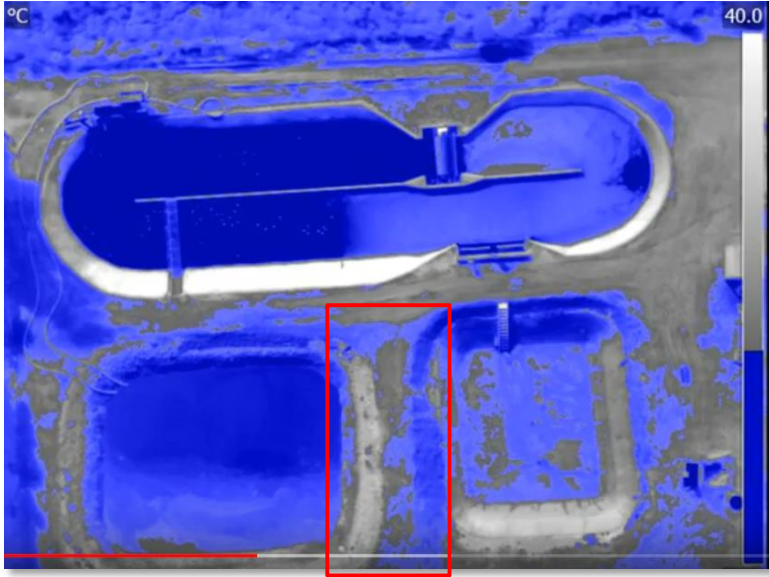
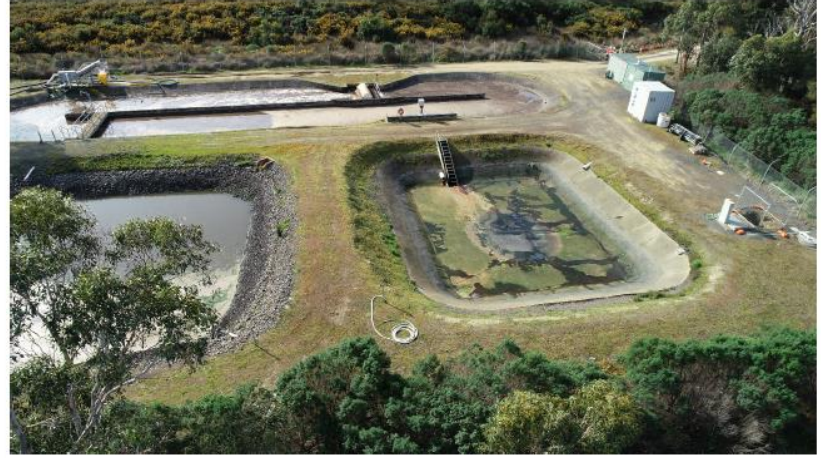
Thermal imaging mapped out leakage pathways from lagoons

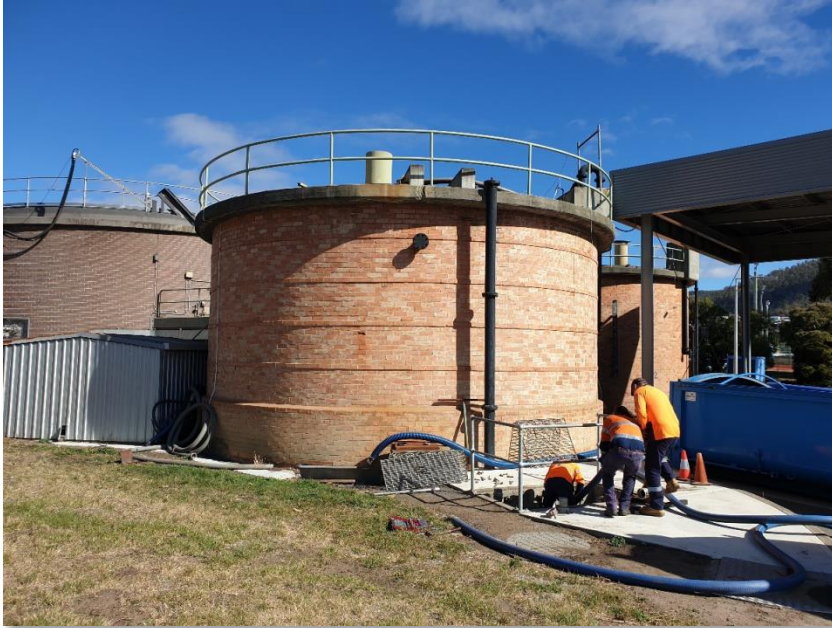
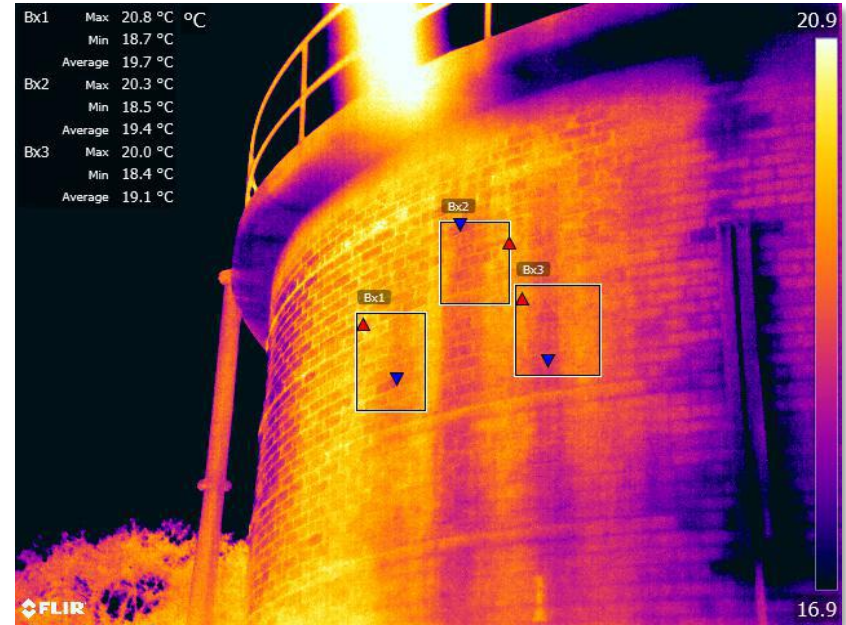
Operational activity to flush the digester with water to remove rags

....provided contrast for thermal imaging survey

Identified cracks with penetration of flushing water

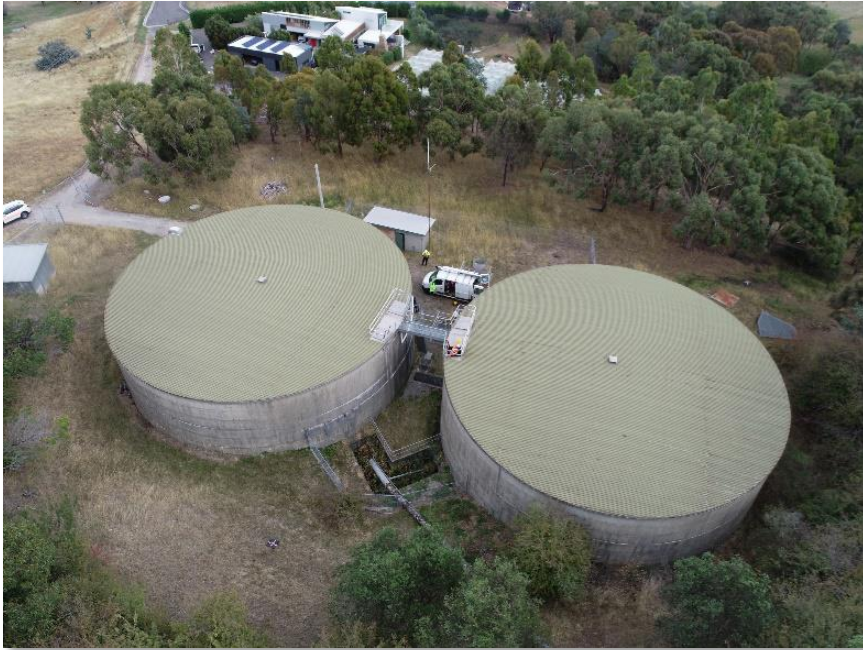
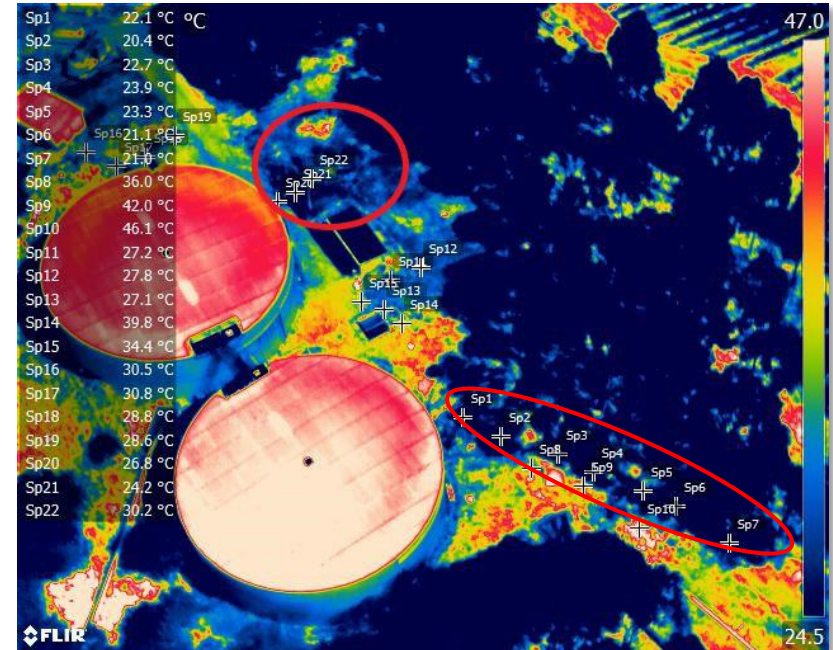
Thermal imaging showed extent of leakage and detected other leakage sources

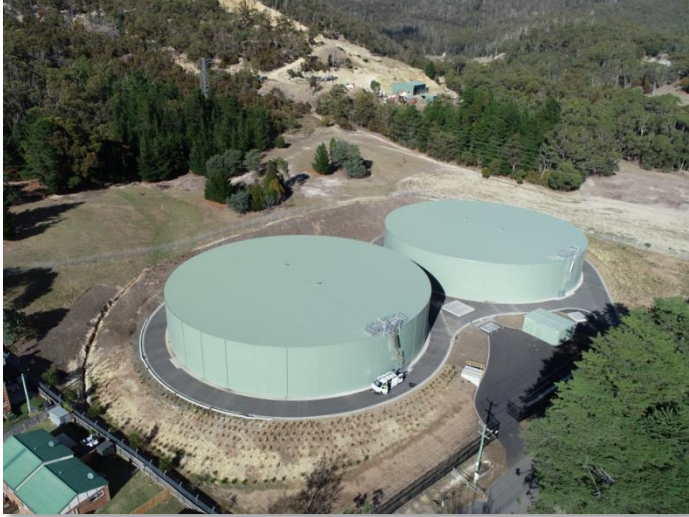
Post-tensioned panel construction reservoir showing signs of leakage

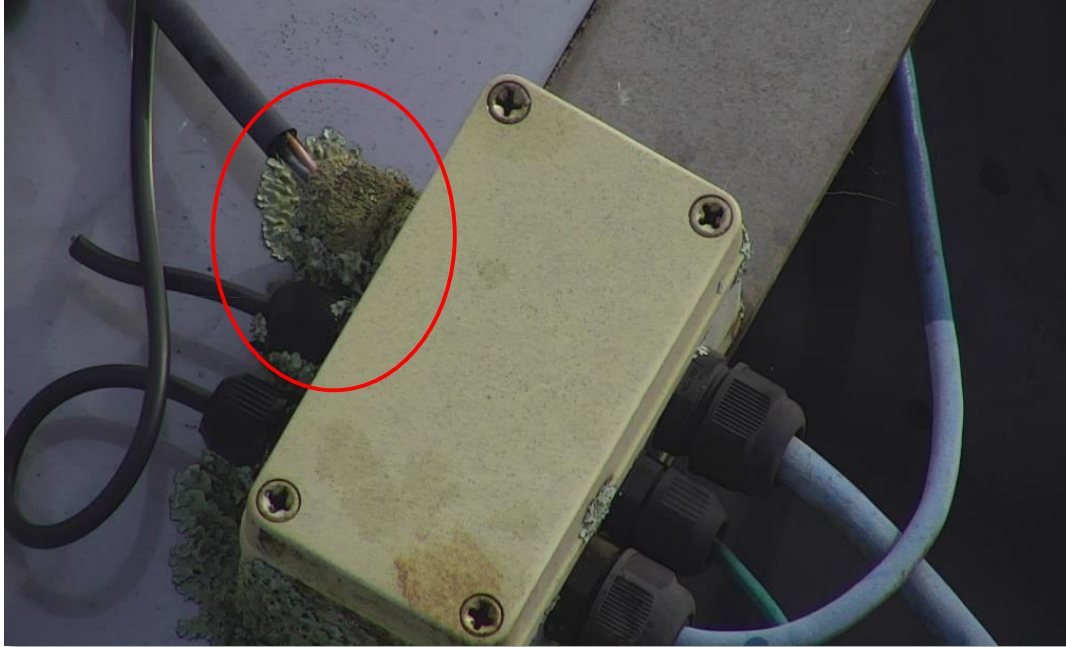
Cable not secured in gland seal
for floating cover pumps

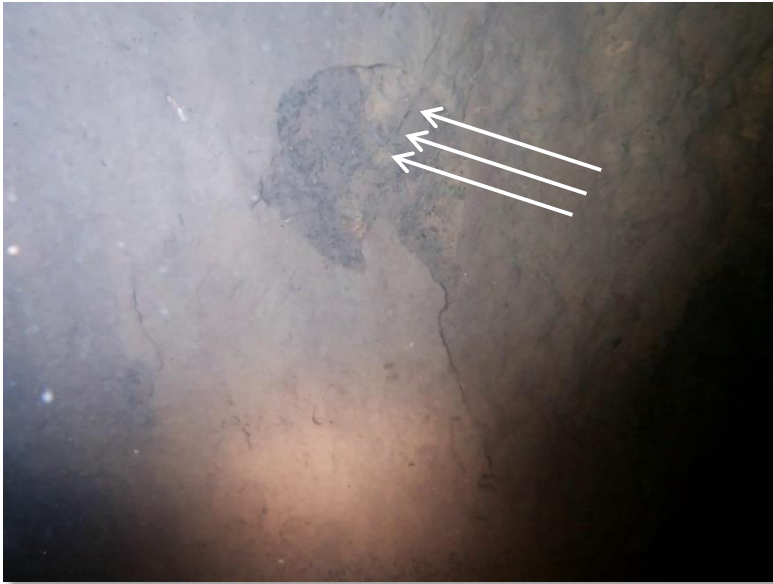
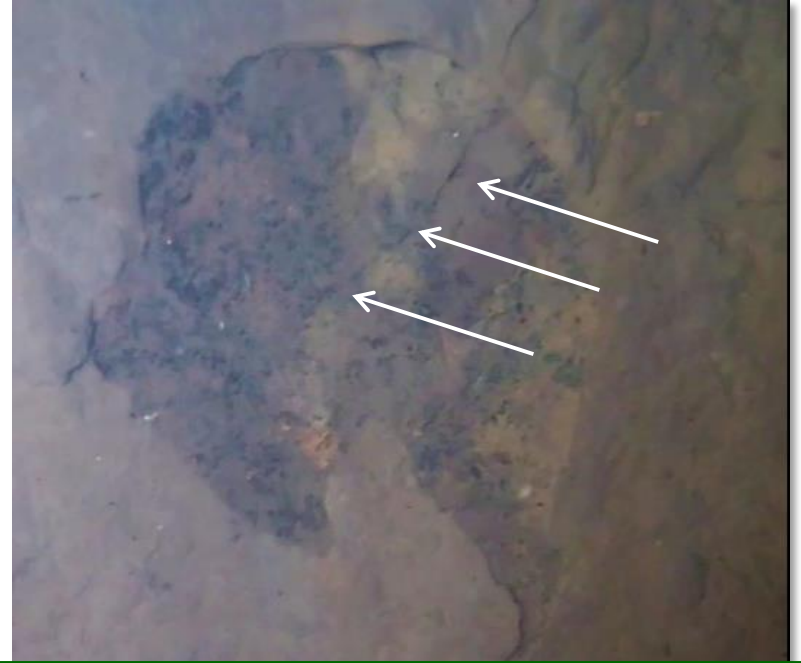
***Confirmed failure of internal lining and cracking by
ROV***
