Case Study: The Importance of Adequate Development Compliance from an Asset Managers Perspective

This paper outlines a case study by Sunshine Coast Council's stormwater asset managers, and highlights the lessons learnt from investigating community concerns raised over a prior subdivision. These particular concerns had been ongoing since development handover and were investigated by various council officers over a number of years. By referencing the original development conditions set by council, it was possible to identify that there had been an issue with the compliance of those conditions, and ultimately the problems were able to be better understood and appropriate resolution actions undertaken.

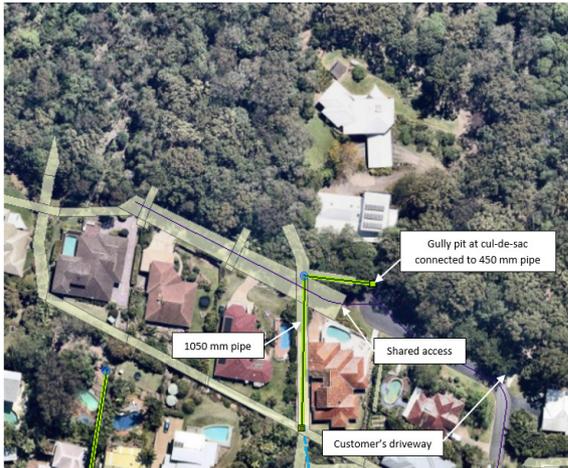
Figure 2: Stormwater network layout
(Sunshine Coast Council, 2018)

As shown in Figure 2, there is little stormwater infrastructure located in the street; the council network consists of a single gully pit at the end of the cul-de-sac that connects to a 450mm dia. pipe, discharging into a pre-existing drainage line located within the customer's property. There is also a 1050mm dia. pipe

that conveys the overflow from an upstream pond that discharges into the same easement. There is also private inter-allotment drainage provided within easements throughout the surrounding properties that discharges into the customer's property through drainage easements. These private assets however, at the time of investigation, remained unidentified according to council's available mapping.

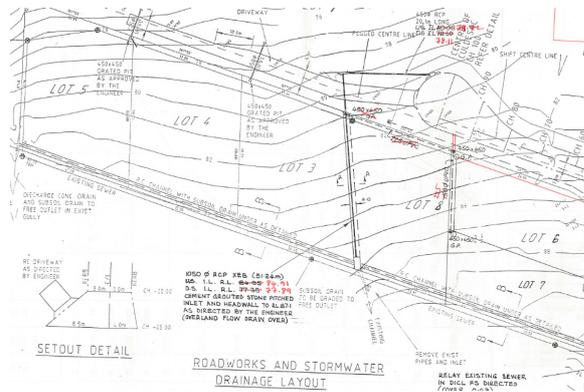
Figure 3: Excerpt from development archive file - civil works

- The portion of the council owned road was extended in 1996 when the original property subdivided. Figure 3 is an excerpt from the original archive file that displays the relevant civil works associated with the subdivision.

- The original developer of the road extension and subdivision was the current customer who was insisting the road drainage was undersized. This meant that the original developer, and in this case the current customer, was responsible for the design of the stormwater drainage located in the street that is now of their concern.

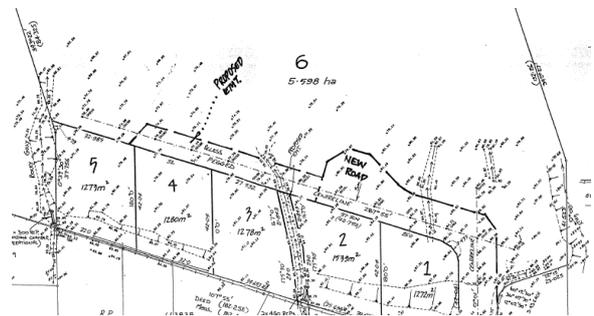
Figure 4: Excerpt from development archive file - original proposed layout for subdivision that demonstrates the existing drainage lines

- The survey plan from the development, identified that there was previously a natural gully in the location that the stormwater is currently flowing down the customers' driveway (shown in Figure 4). At the time of development, the recorded correspondence showed that council conditioned this area to contain a stormwater easement, however this decision was appealed by the developer. The appeal was granted under the condition that should the property owner/customer experience any stormwater issues in future, an easement would be granted in favour of council at the expense of the property owner.

The development documentation and compliance determined that the customer was in fact the original developer who was responsible for the design of the stormwater infrastructure. It was identified by council at the time of development that the eastern portion of their frontage would experience overland flow and that a drainage easement would be appropriate over this area. However, the developer contested this decision and it was removed with a condition should they ever experience issues in the future, an easement would be donated to council.

outcome of the investigation and that council would not be upgrading the stormwater drainage at this stage. However, should the customer continue to have concerns of water flowing through the eastern portion of their property, they have the opportunity to donate a drainage easement in favour of council.

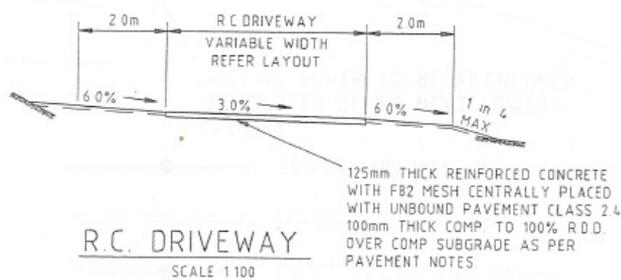
Figure 5: Excerpt from development archive file (as-constructed drawings) - reinforced concrete driveway detail

- The private access driveway at the end of the western cul-de-sac that services three other properties did not appear to be constructed as per the as-constructed plans that reference the slab as being reinforced concrete (shown in Figure 5). There is significant cracking to the concrete driveway that appears to have been an issue since 1998 according to previous complaints from neighbouring properties shortly after construction. Furthermore, upon recent visual inspection, the driveway did not show signs of steel reinforcing as per the detail on the next page.

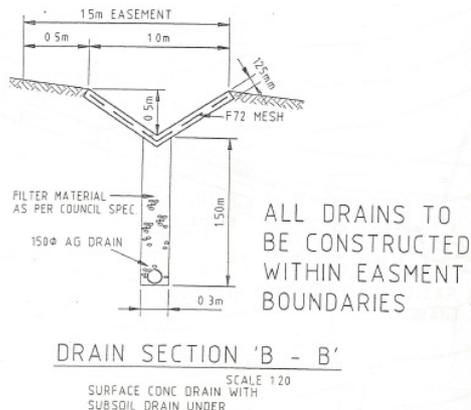
Figure 6: Excerpt from development archive file (as-constructed drawings)

- The as-constructed plans indicated that there was a concrete v-drain (Figure 6) constructed in the back of lots 5, 4 and 3 to protect those properties from overland flow. Although this was detailed in the plans, the recent easement inspection undertaken by council officers did not reveal any existence of a concrete v-drain. Instead, Lots 4 and 5 contained an underground PVC pipe and Lot 3 did not contain any drainage infrastructure.

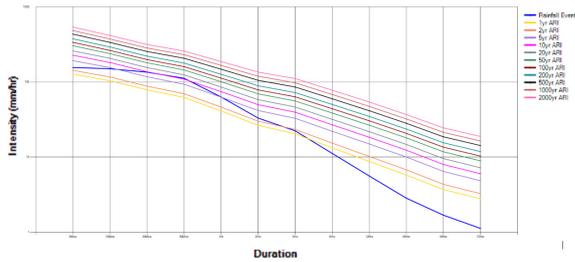
Figure 7: TARDIS rainfall station Intensity Frequency Duration (IFD) chart

Sunshine Coast Council have rain gauges throughout the region that feeds data to a live database with a system portal known as TARDIS. This system provides an estimation of what frequency storm was experienced for the broader catchment. In this case, a storm exceeding a 10 year ARI was experienced (Figure 7). It is expected that a storm of this size exceeds that of what underground drainage is designed to cater for.

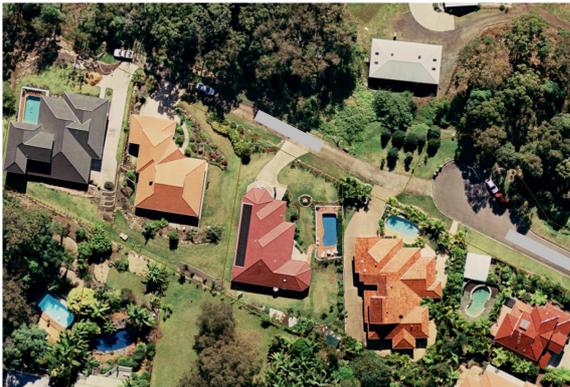
Figure 8: Sunshine Coast Council 2000 aerial image (Sunshine Coast Council, 2018)

Sunshine Coast Council store historical imagery retrieved from previous flyovers that date back to 1958. Historical aerial imagery was reviewed to determine if the concrete v-drain was ever in place in the back of the subdivided properties; the aerial image from 2000 showed a swale, but no presence of a concrete v-drain (Figure 8)

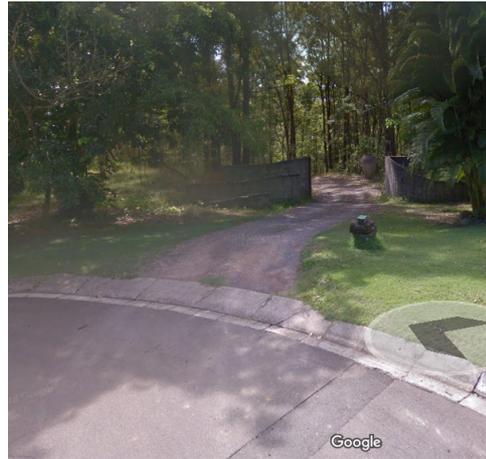
Figure 9: Google Street view image of customer's driveway (Google Maps, 2018)

- The customer's gravel driveway had been washed out and had minimal freeboard, indicating that it was substandard for a residential driveway.
- The road profile did not allow water to take the 90° bend, causing water to travel down the customer's driveway in the eastern corner of their property.

Street view images were able to provide detail on the condition of the driveway in years prior to the 2017 storm event. An extract of the 2014 condition is illustrated on the following page (Figure 9). It is evident that the driveway did not meet the engineering guidelines for a residential driveway (IPWEA Standard Drawing RS-049 and RS-050); the height of the driveway above the invert of channel did not reach the recommended 250mm and was constructed with loose gravel material.
