# Stormwater pipe condition assessments – if only animals could talk

Clarissa Campbell

Moreton Bay Regional Council, Strathpine, QLD

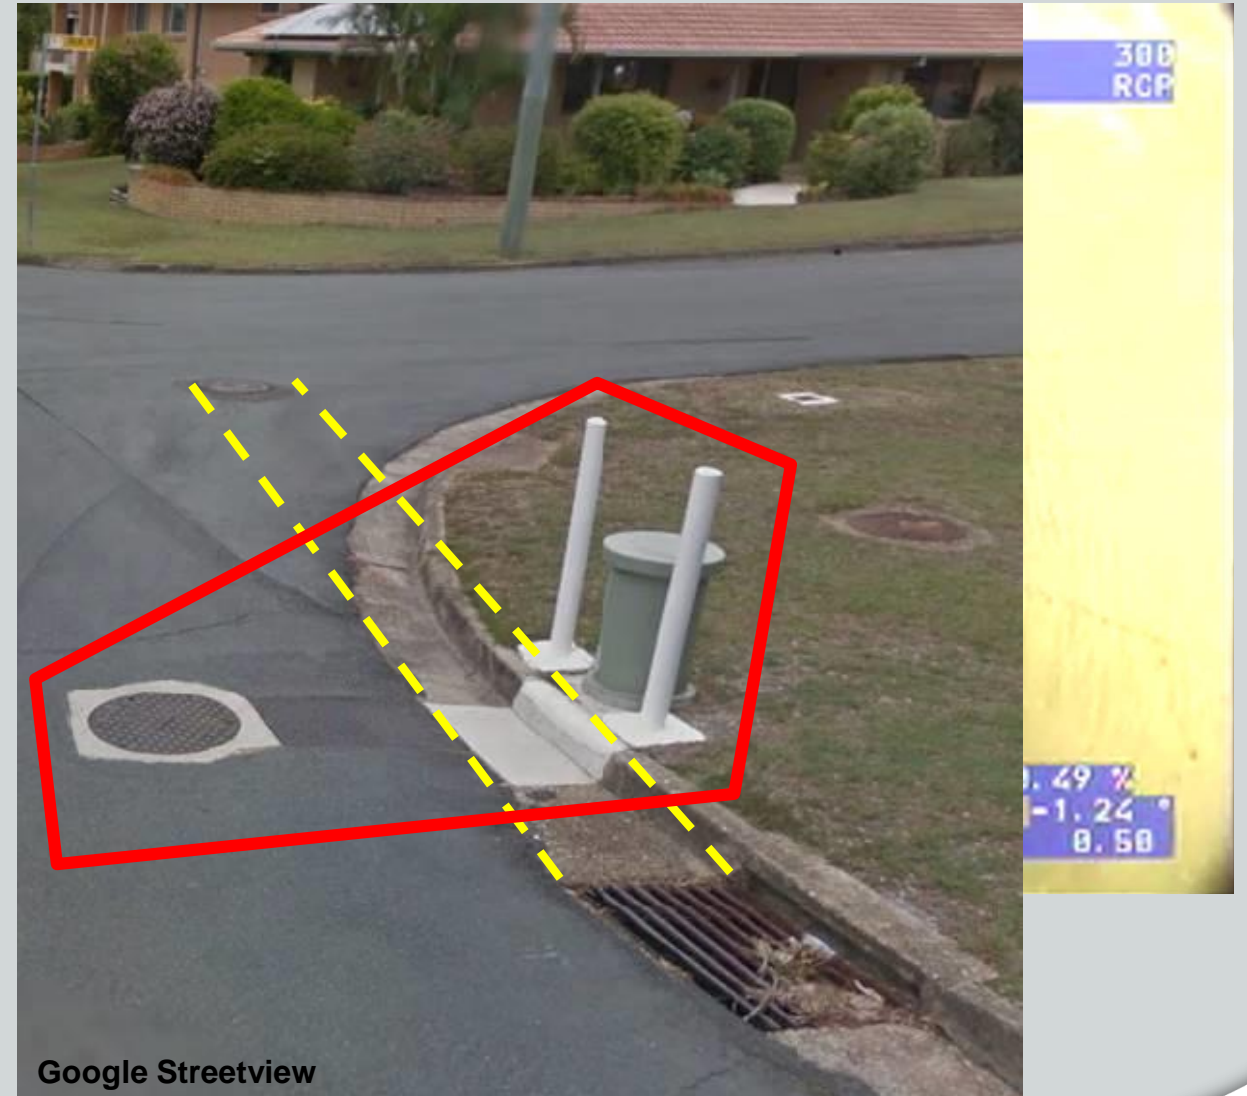
# Case Study 1: Clontarf Service Conflict Investigation

- Issue: Sewer vent pole connection built through stormwater pipe
- Outcome: Council are still working with Unitywater to get service relocated and stormwater pipe replaced

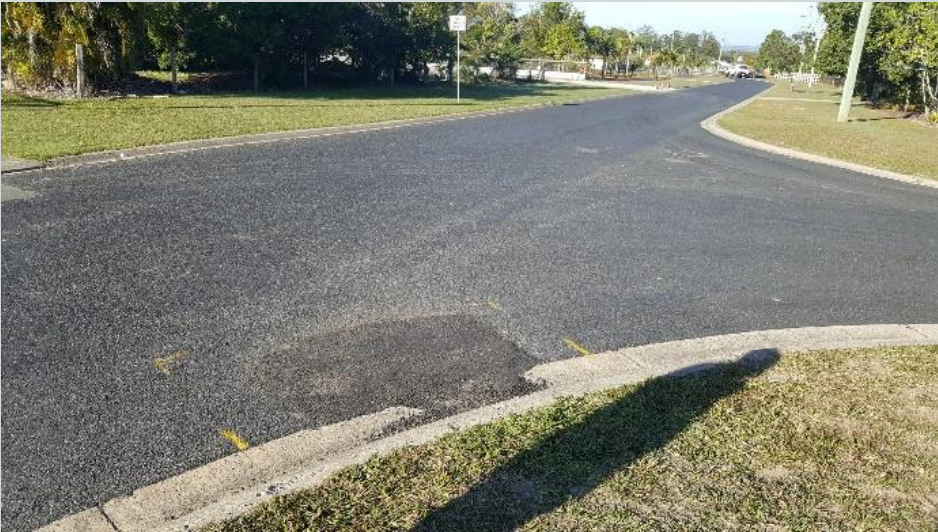
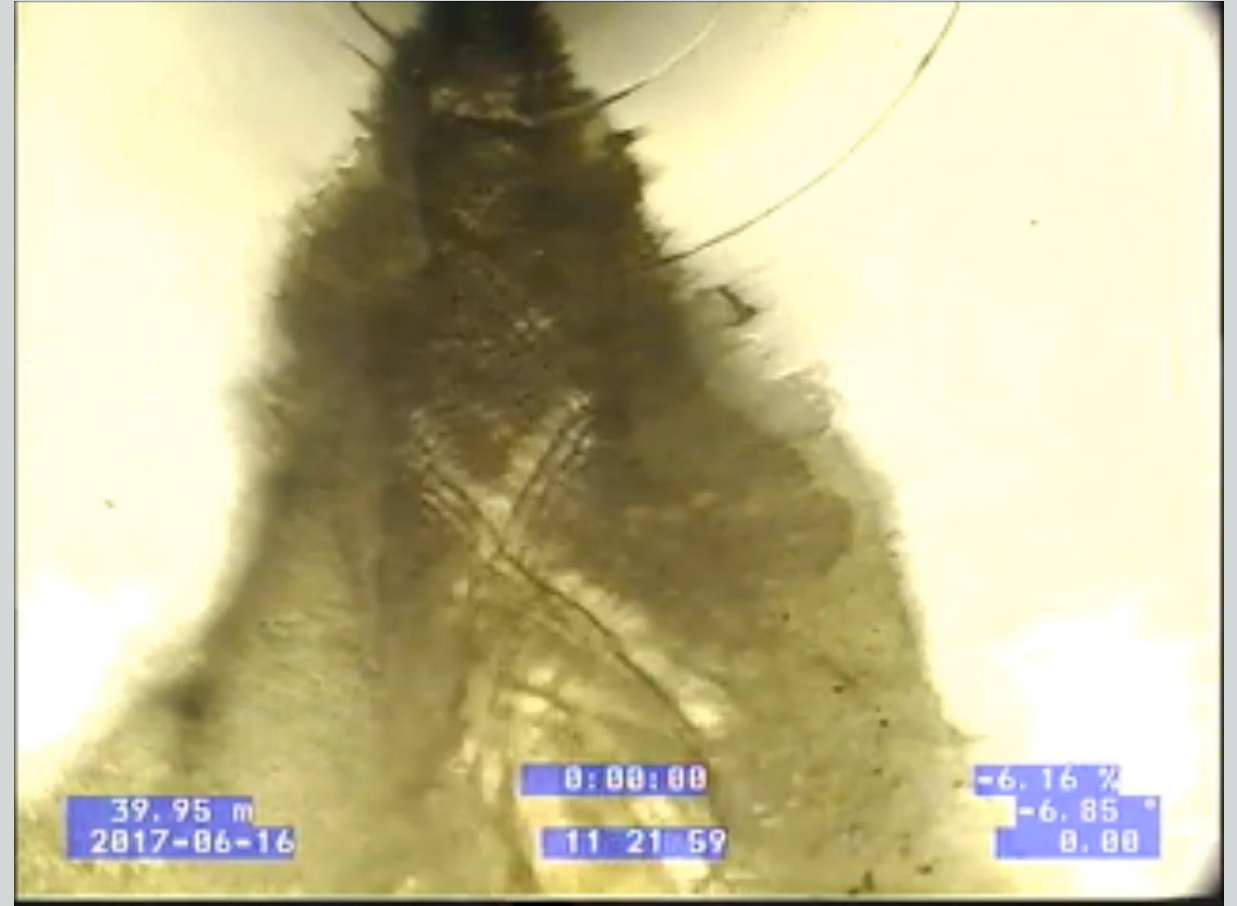
# Case Study 2: Elimbah Stormwater Network Renewal

- Issue: Two entire stormwater networks whose inverts had corroded away
- Outcome: Council replaced all 500m of FRC pipe with HDPE pipe (and imported fill)

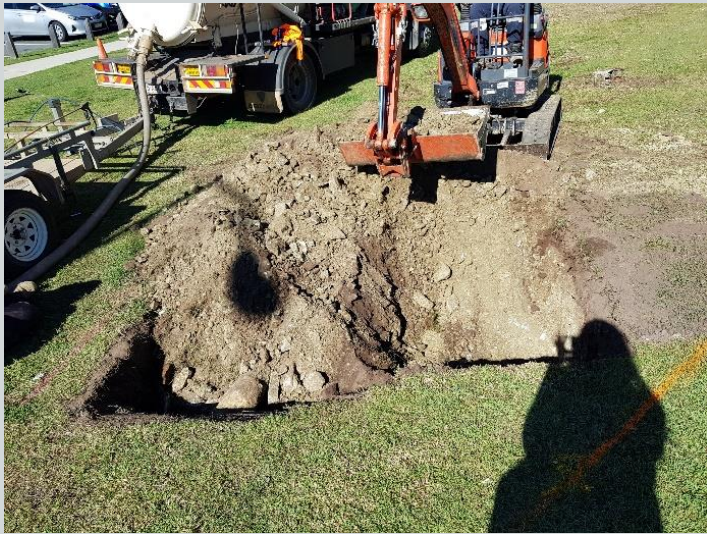
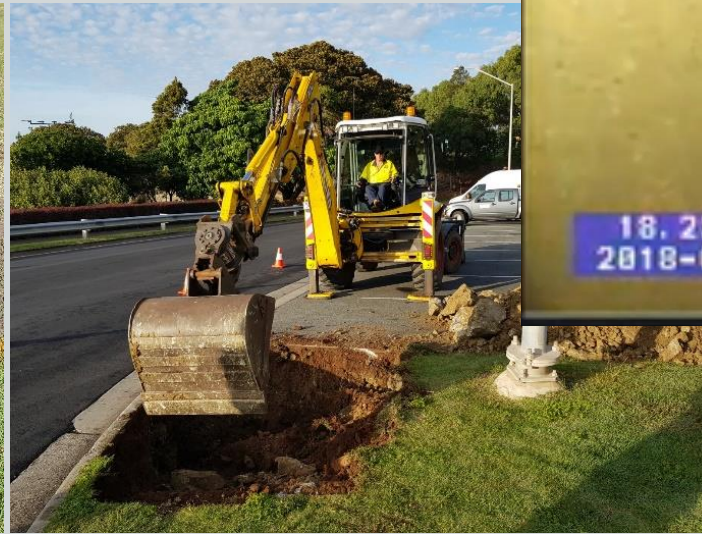
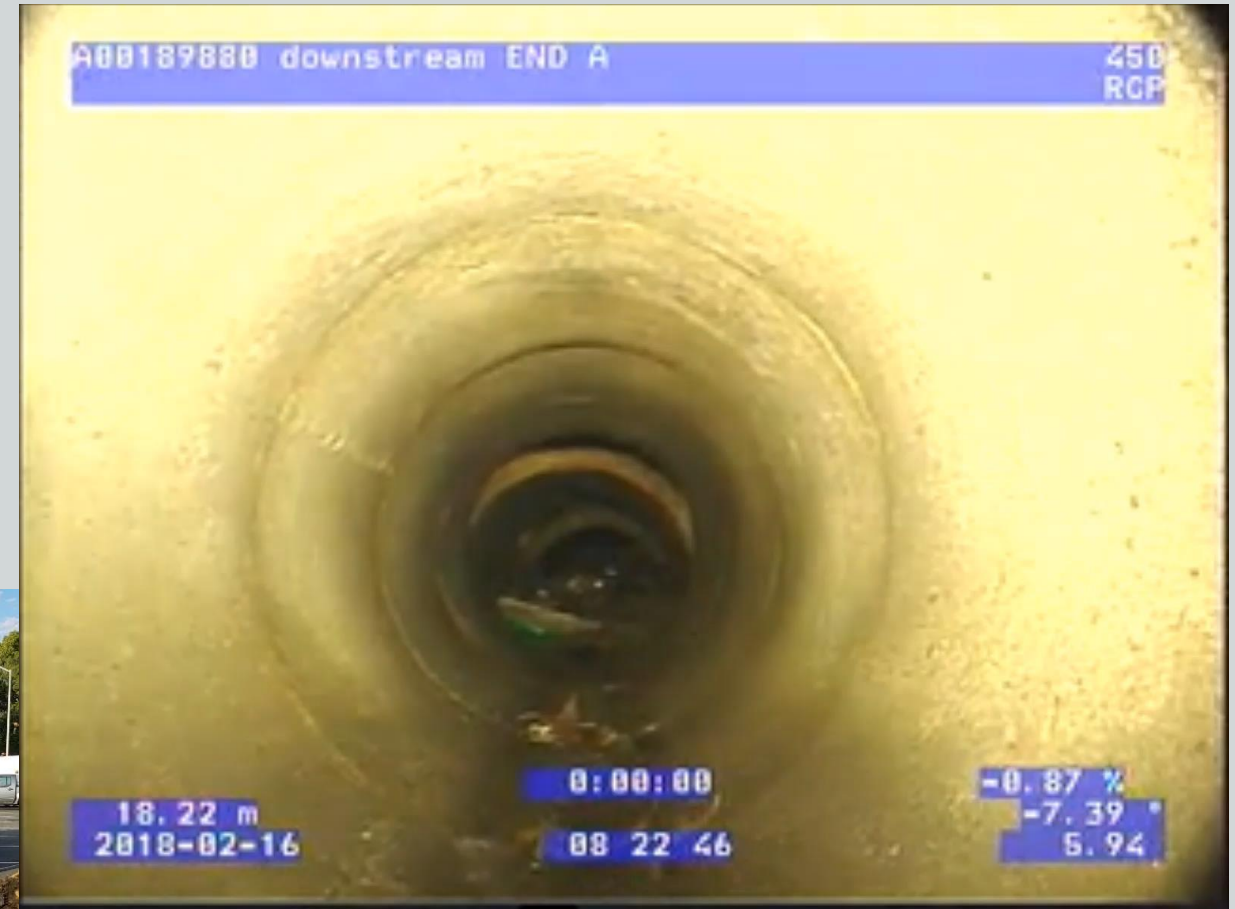
# Case Study 3: Redcliffe Stormwater Network Investigation

- Issue: Collapsed pipe in a network that could not be located
- Outcome: Council plan to abandon this pipe at the upstream manhole and will monitor the location of the defect

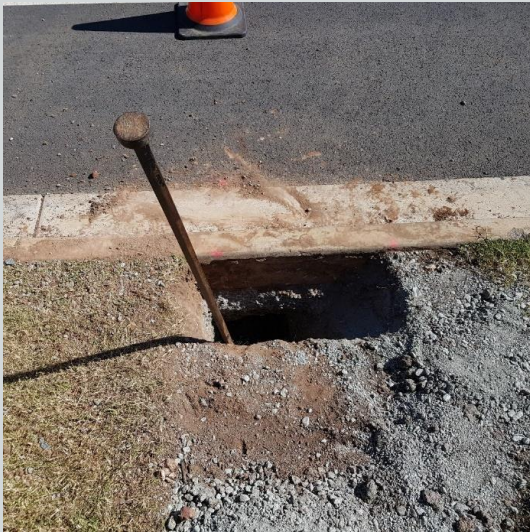
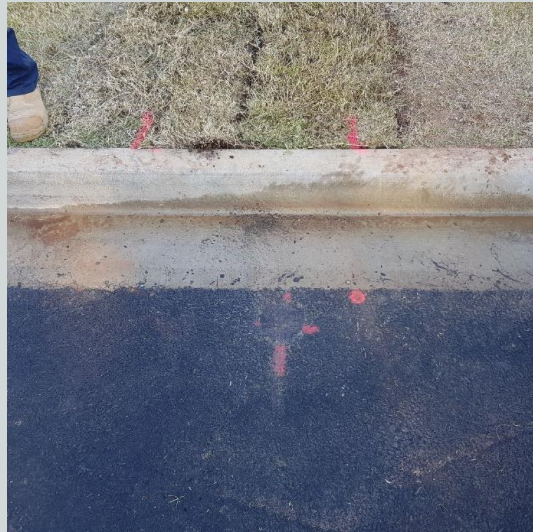
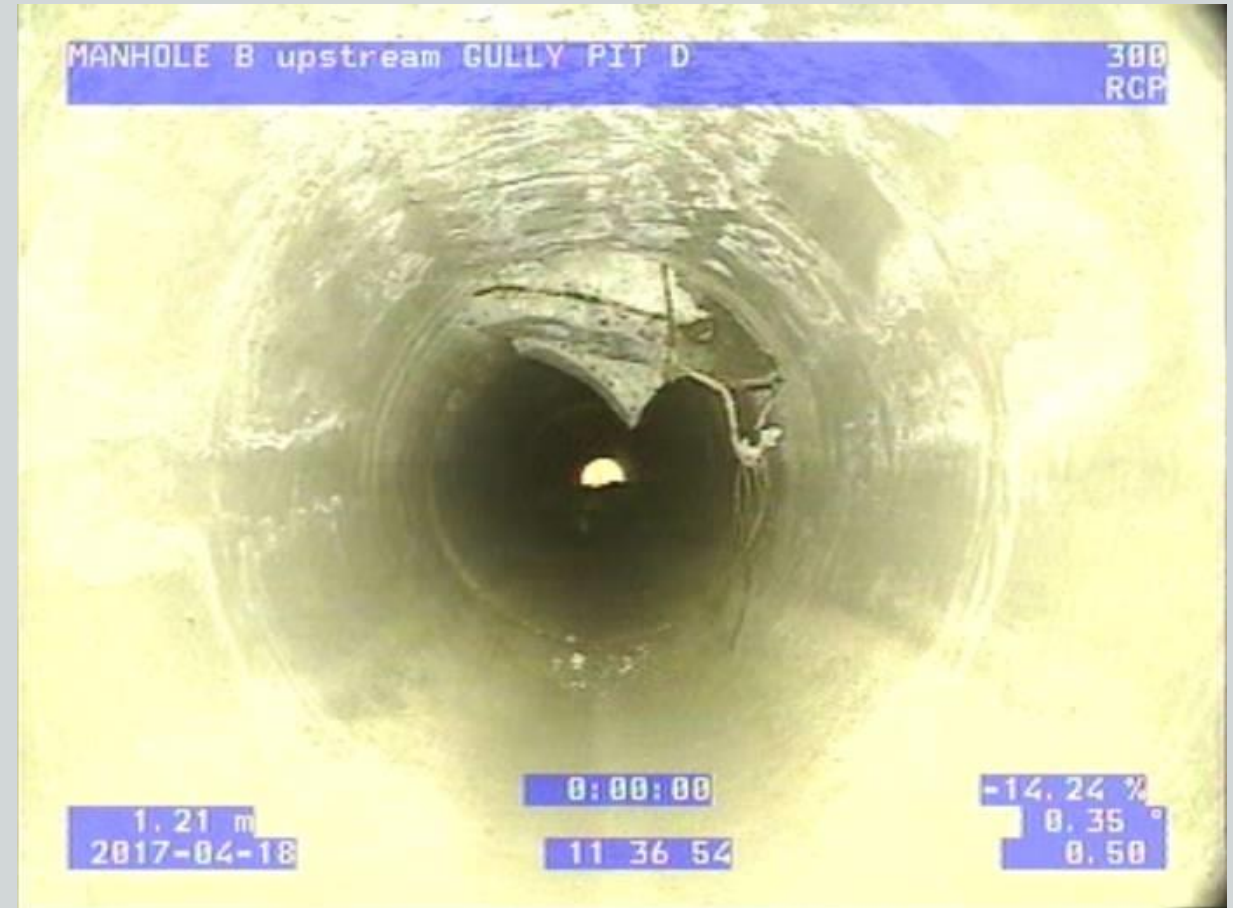
# Case Study 4: Murrumba Downs Stormwater Pipe Renewal

- Issue: Large break in a pipe under a recent road rehabilitation
- Outcome: Council cut-back the concrete, patched the hole in the pipe and filled the void by core-drilling through the asphalt

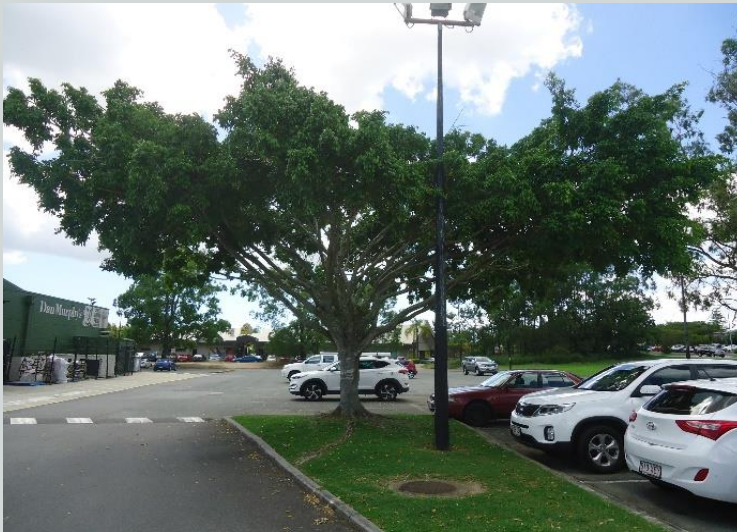
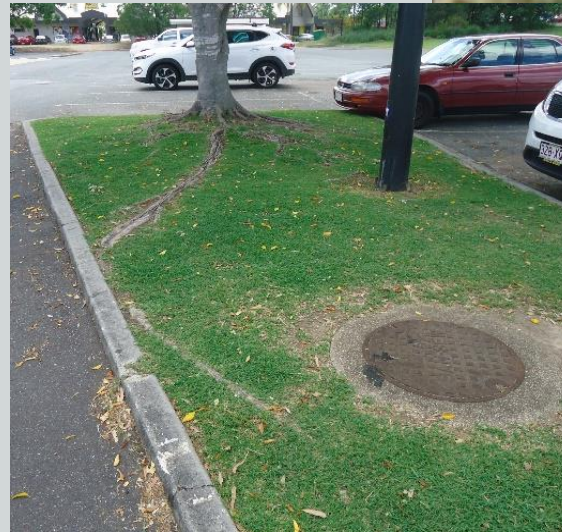
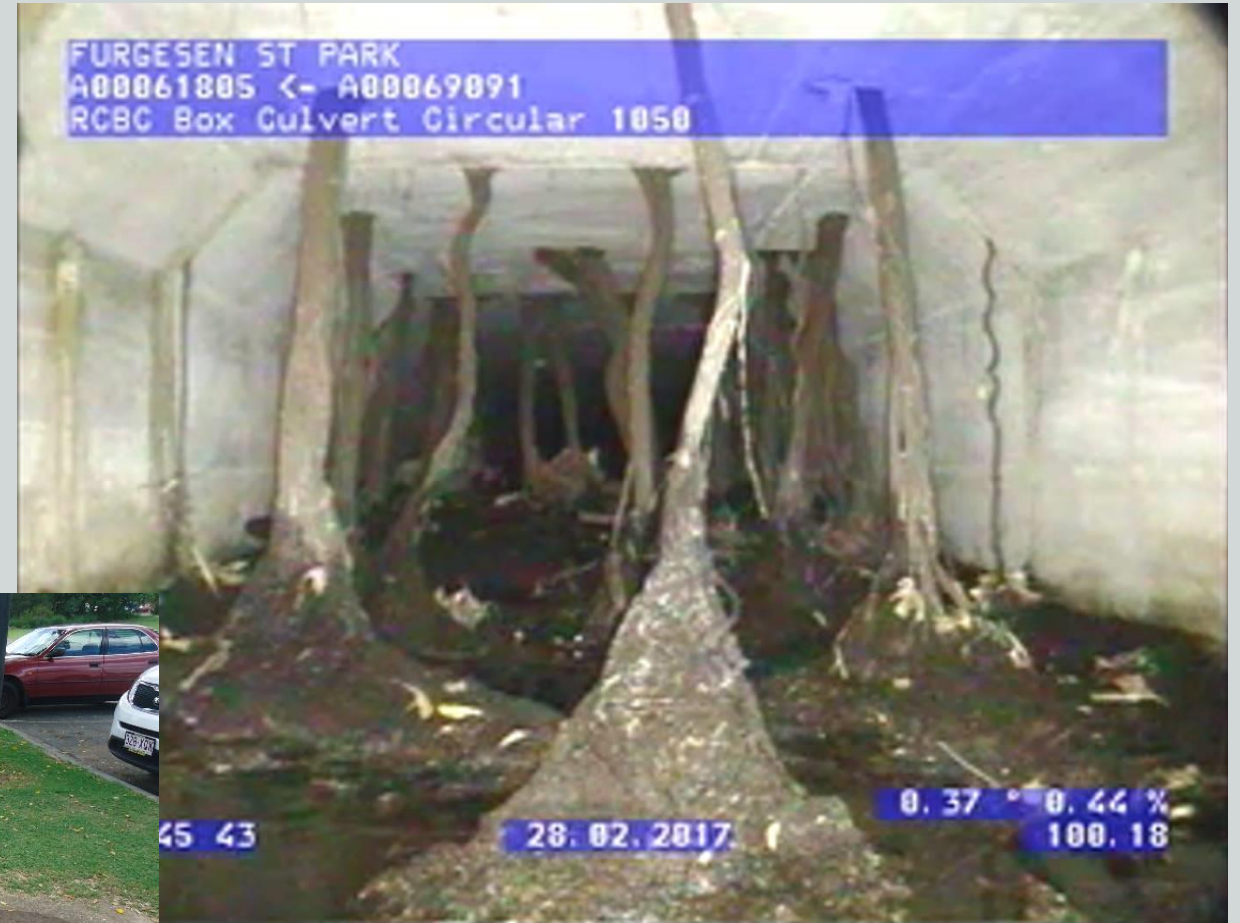
# Case Study 5: Albany Creek Root Blockage Investigation

- Issue: Twin box culverts in private property blocked by tree roots
- Outcome: Council plan to remove the tree, install two manholes and remove the roots
