Presentation by Malcolm Styles

International Public Works Engineering Conference

# Can Marginal Materials Matter? — You Bet! Unsealed road trial results at Central Goldfields

Unsealed road trial conducted at Possum Gully Road, Central Goldfields Shire Council between December 2016 and December 2018

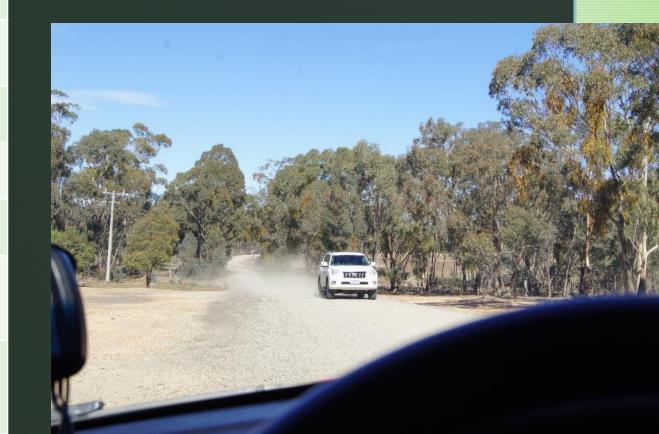
# Dust

Trial Section	Observ.
1.Daisy Hill material with 3% foam bitumen and 3% cement stabilisation	4.1
2. Daisy Hill sourced with 3% polymer	2.6
3. Daisy Hill material with enzyme 1 litre to 30 m <sup>3</sup>	1.9
4. Daisy Hill material with 46% class 4 bluestone FCR plus 8% clay	1.3
5. Dunolly material with enzyme 1 litre to 30 m <sup>3</sup>	2.6
6. Dunolly material crushed and screened	2.7
7. Dunolly material crushed and screened with 3% cement	2.9
8. Dunolly material crushed and screened with 5% clay mixed at the source	3.2
9. Dunolly material uncrushed with citrus organic binder dust suppressant	2.5

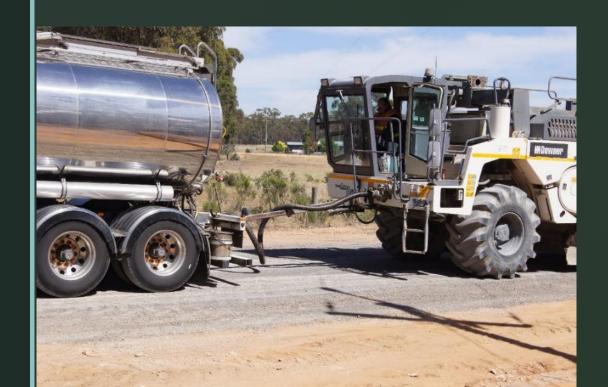
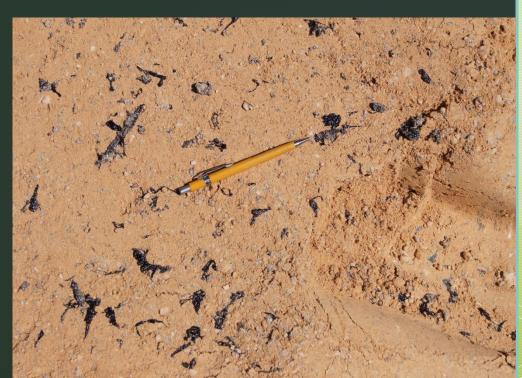
Section 1 Cement and foam bitumen emulsion additives to Daisy Hill material

Section 1 Mixed preparatory to grading, watering and rolling

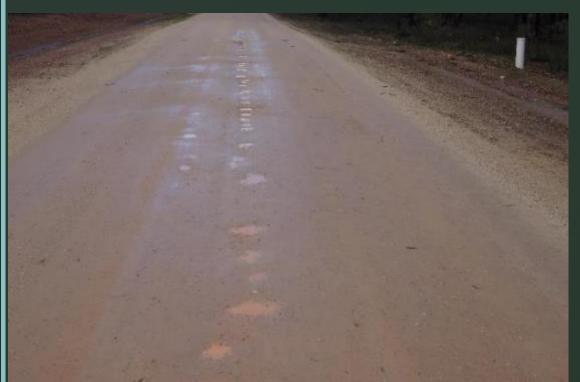
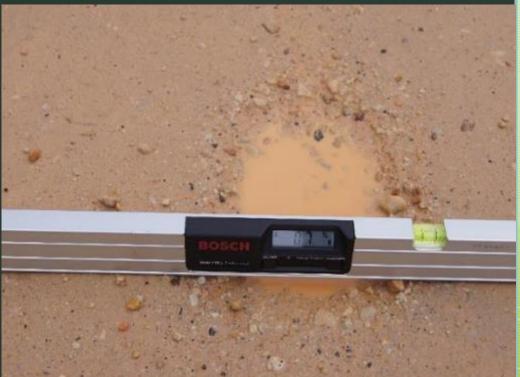
e.g. Result of inattention to crossfall

At crown

Section 3 at 8 months

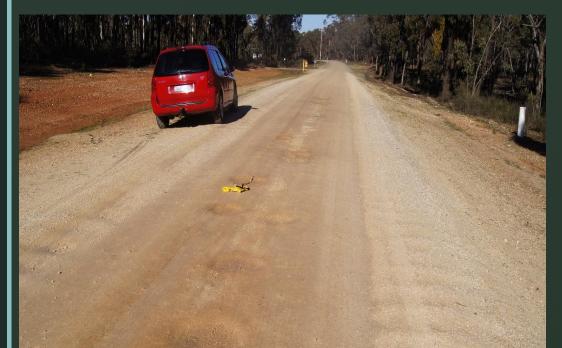
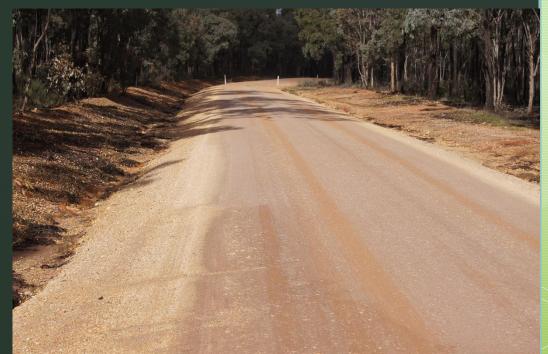
- ✓ Daisy Fill material too marginal for purpose?
- ✓ Some merit in blending with bluestone
- Trial Section 3 Daisy Hill material at 18 months

- Screened and crushed Dunolly material fits
- ✓ Section 8 with 5% clay best performer at end of 2 years
- Establish with care pays!
