The Importance of Adequate Development Compliance from an Asset Managers Perspective

Case Study

Property damage believed to be caused by
insufficient drainage infrastructure

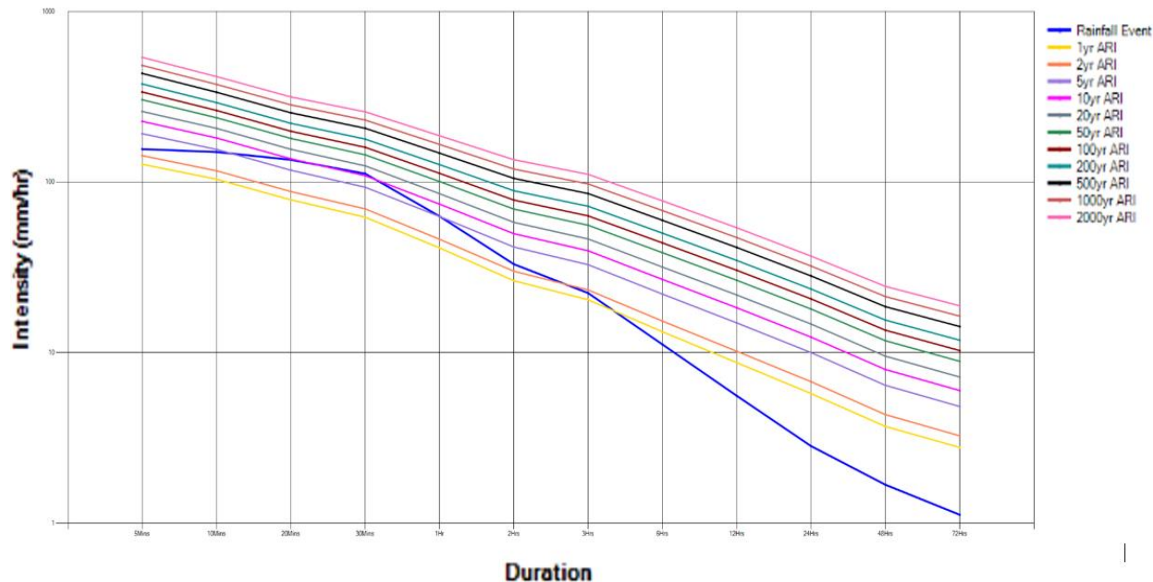
TARDIS rainfall station Intensity Frequency Duration (IFD) chart

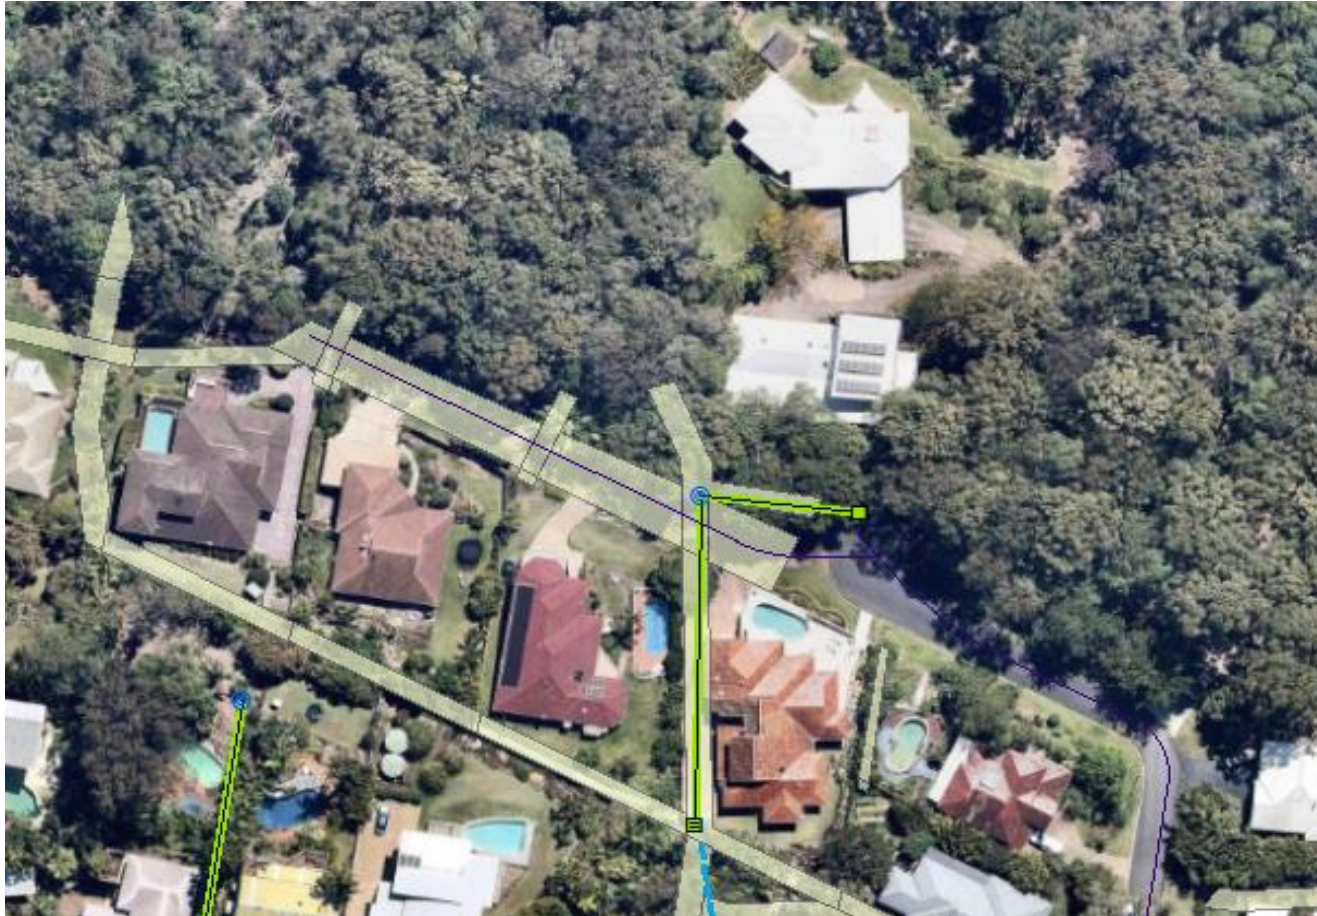
Site Layout

- Easement
- Pipe
- CatchPit
- Stormwater End Structure
- Stormwater Open Drain

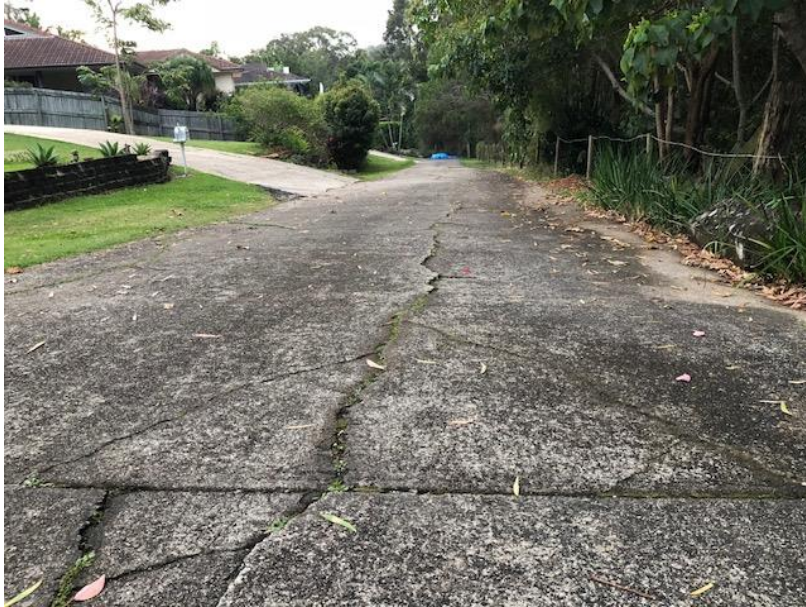
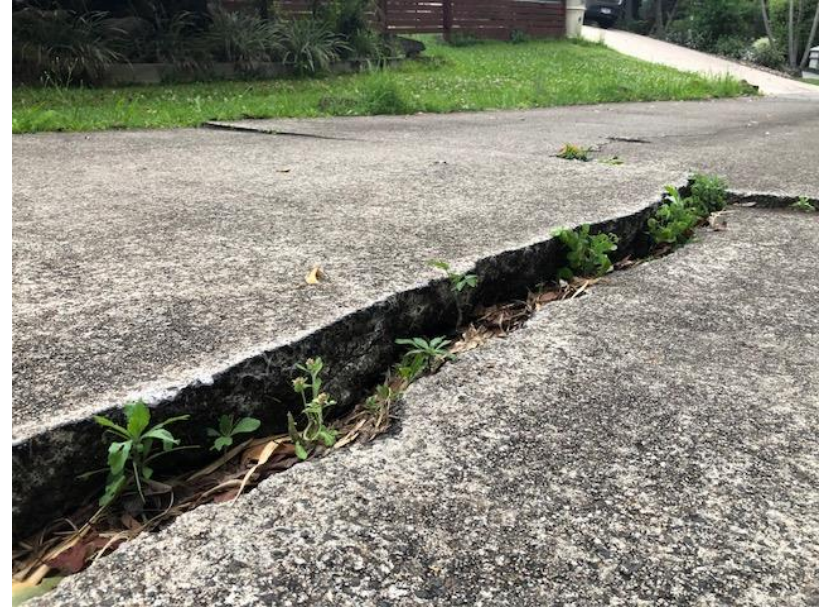
Shared Driveway

- Customers are original developers
- Shared driveway had no reinforcing and damaged
- Main driveway had no freeboard and in poor condition
- Unknown whether inter-allotment concrete v-drain was installed during development. (Council has since completed rectification works)
- Customer experiencing stormwater problems where easement was originally conditioned
- Customers have current development application with drainage conditions
- Customer advised council will not undertake drainage improvement works
- All information regarding investigation has been recorded against the property

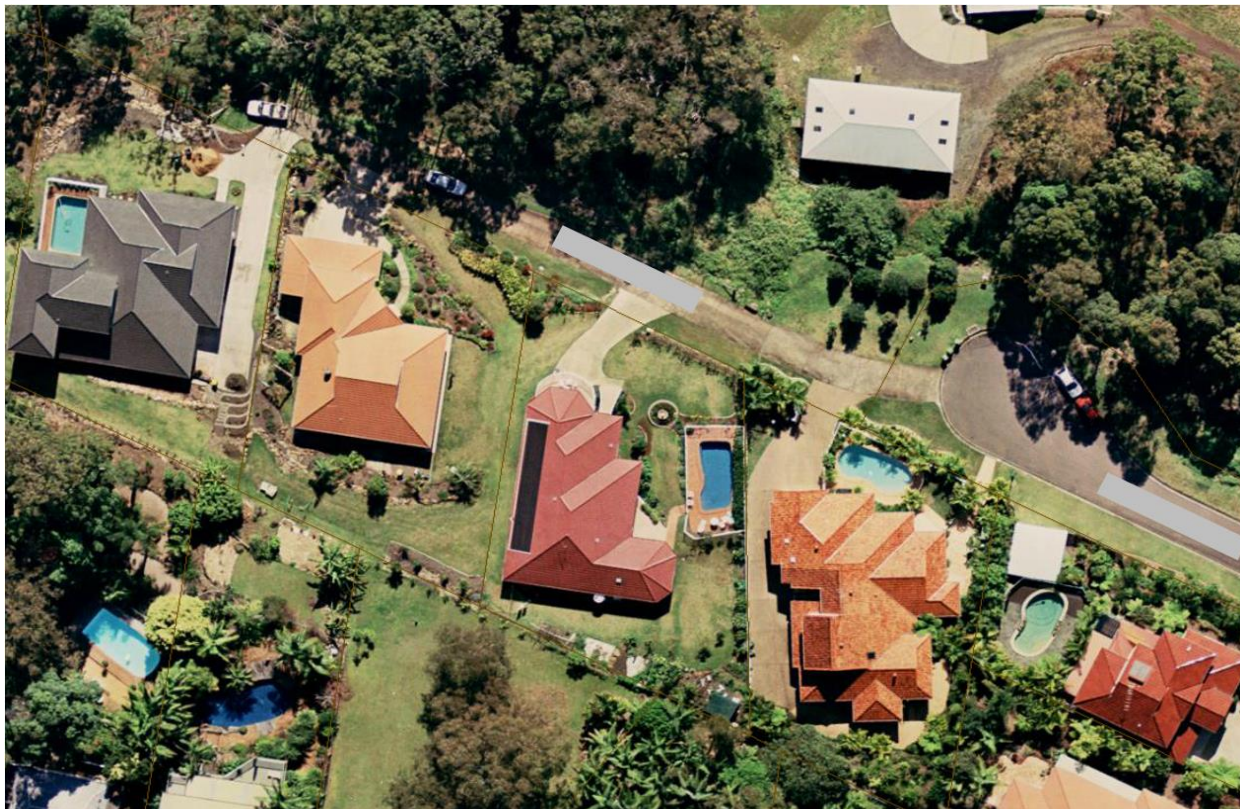
- Current subdivision application with drainage conditions
- Historical complaints from customer and surrounding properties
- Aerial imagery doesn't show evidence of "concrete v-drain"
- Street View demonstrates condition of driveway prior to storm event

Sunshine Coast Council 2000 aerial image (Sunshine Coast Council, 2018)

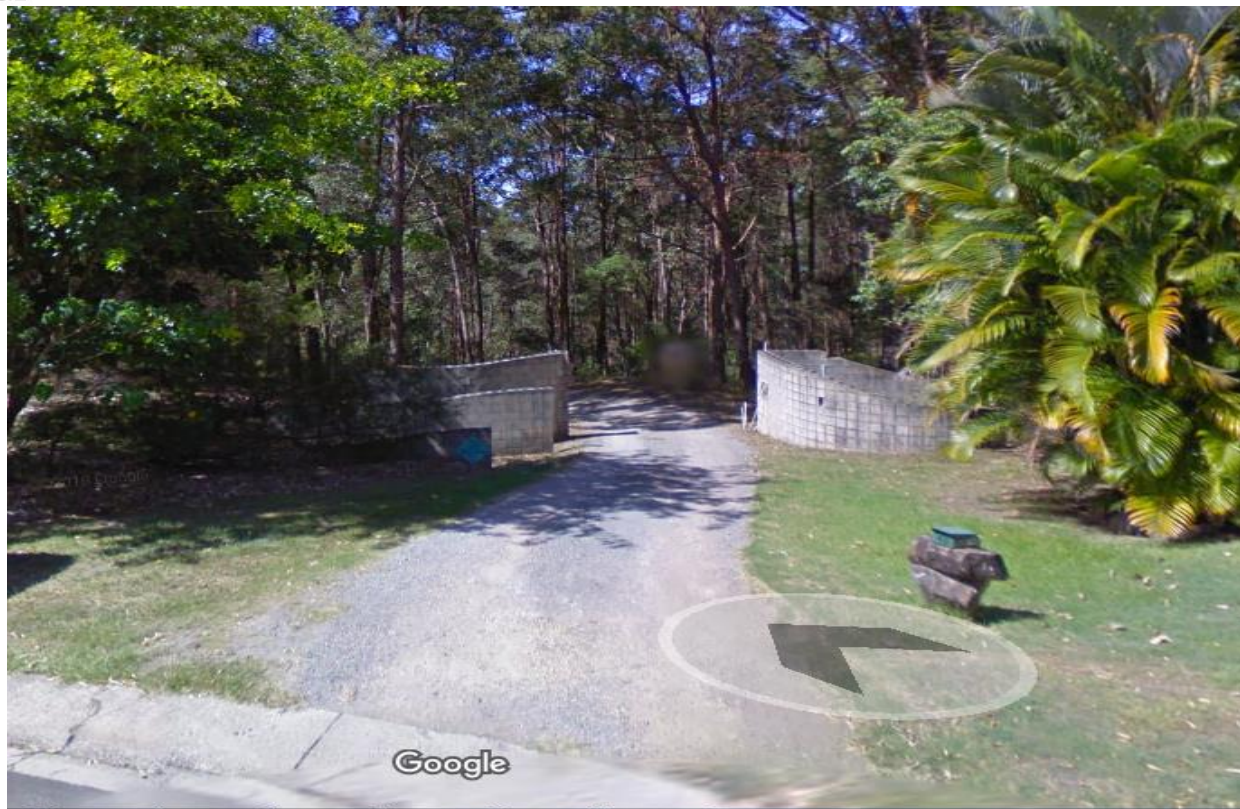
Google Street view image of customer's driveway (Google Maps, 2018)
