City of Hobart presents

Rejuvenating kunanyi / Mt Wellington's Great Short Walk

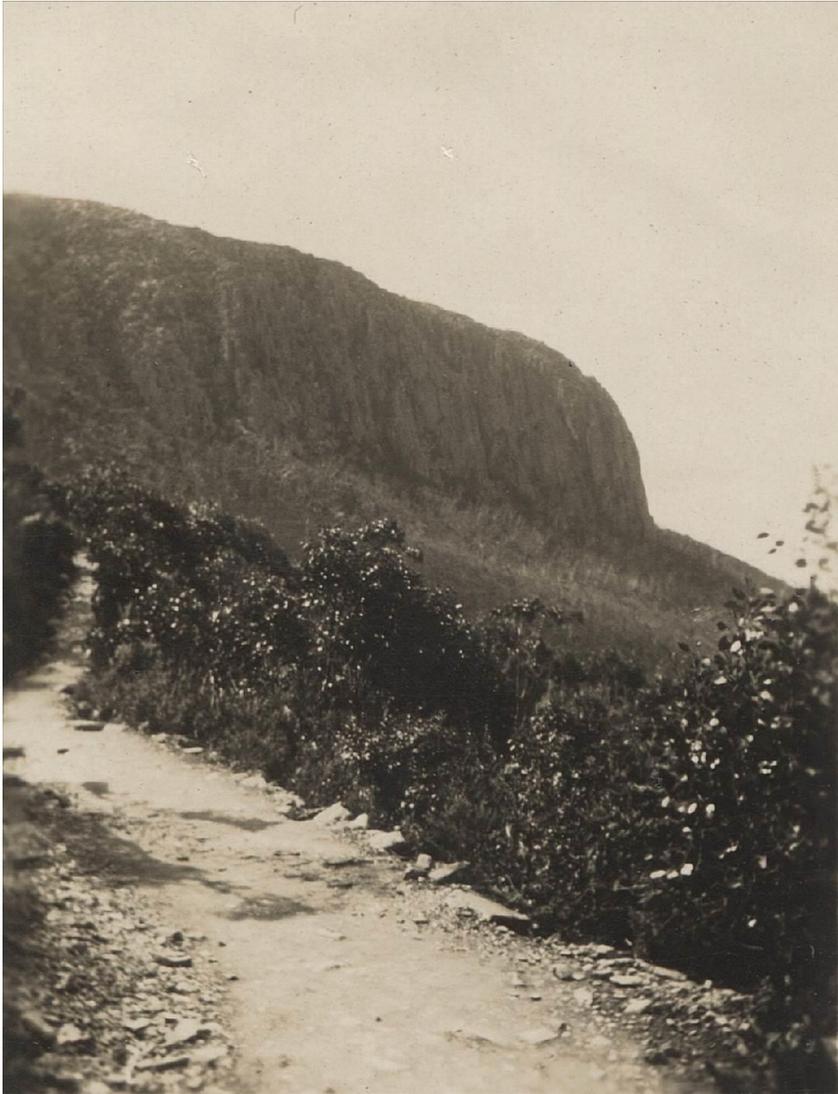
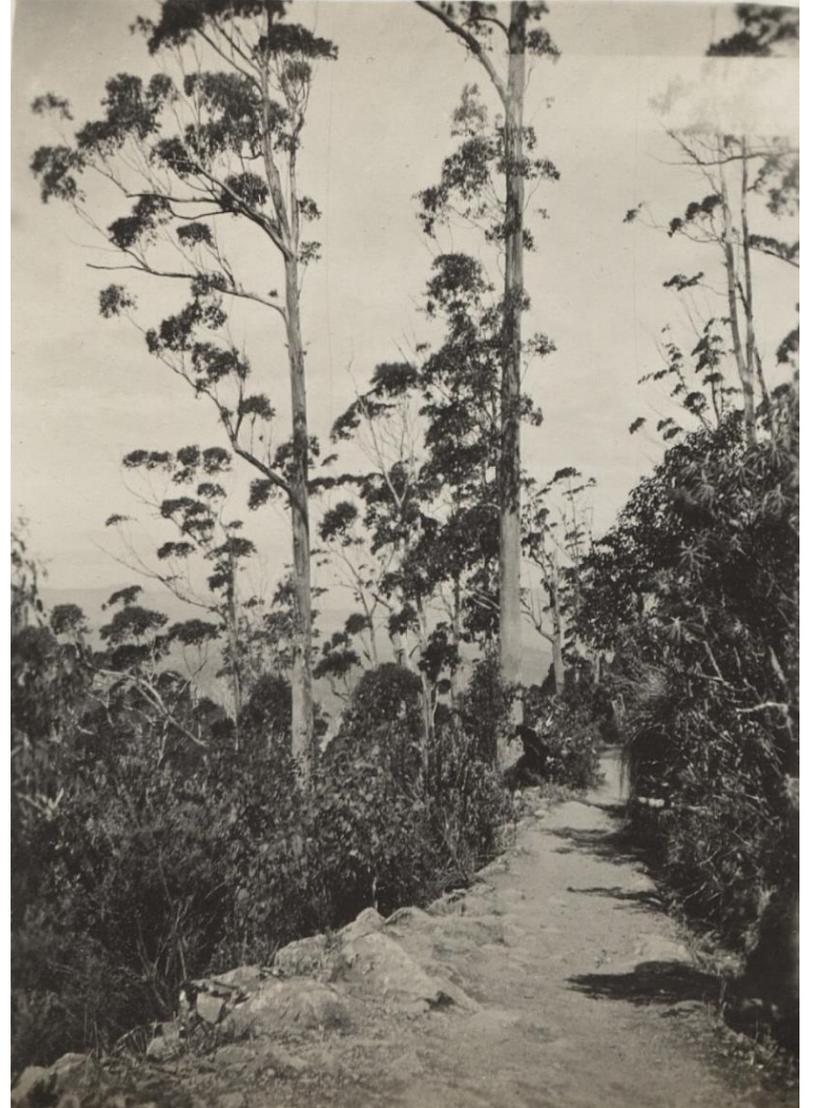
2016 condition – Organ Pipes Track

Collapsed embankments, unstable and uneven surface, poor drainage

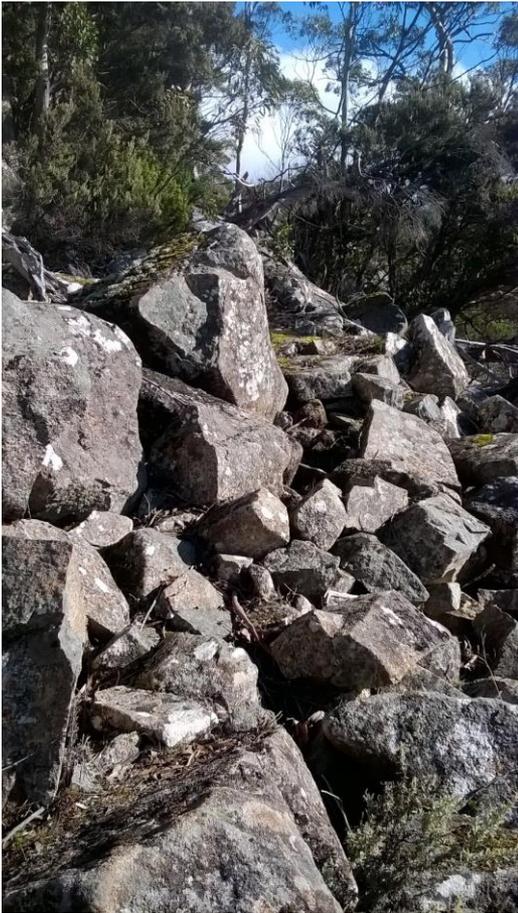
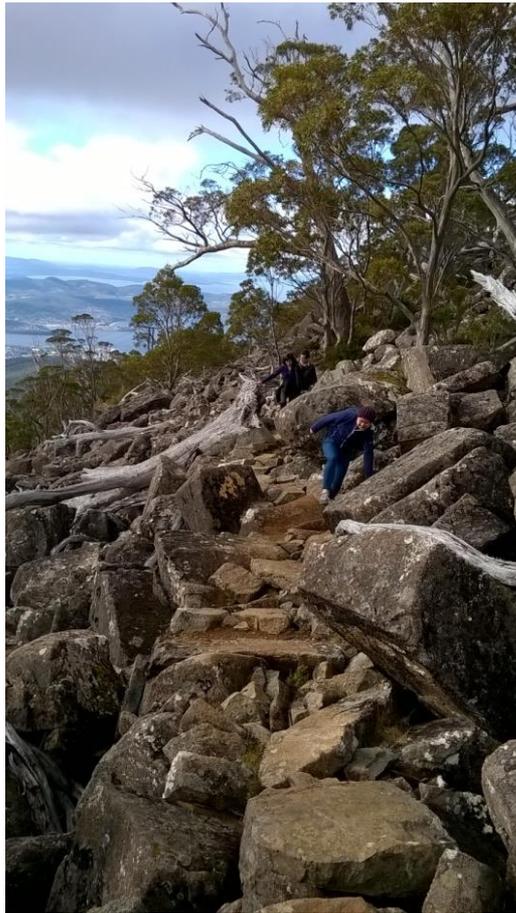
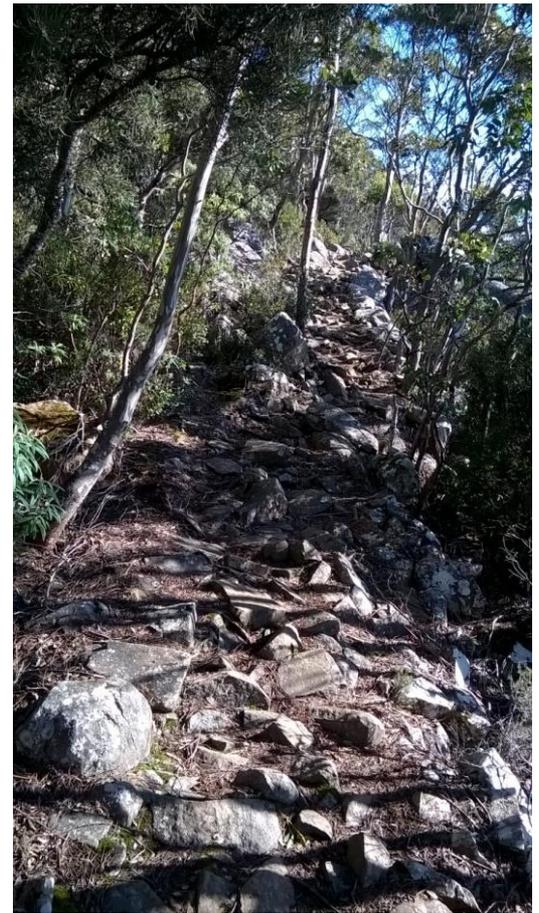
2016 condition – PinnacleTrack

Intrusive services, massive erosion, poor drainage.

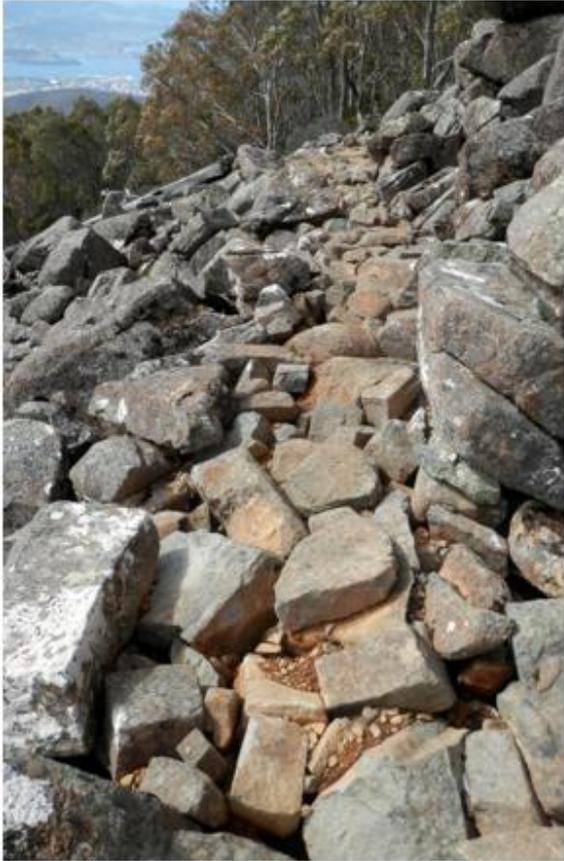
Figure 15: Mock-up of proposed track works across unstable and collapsed boulder field

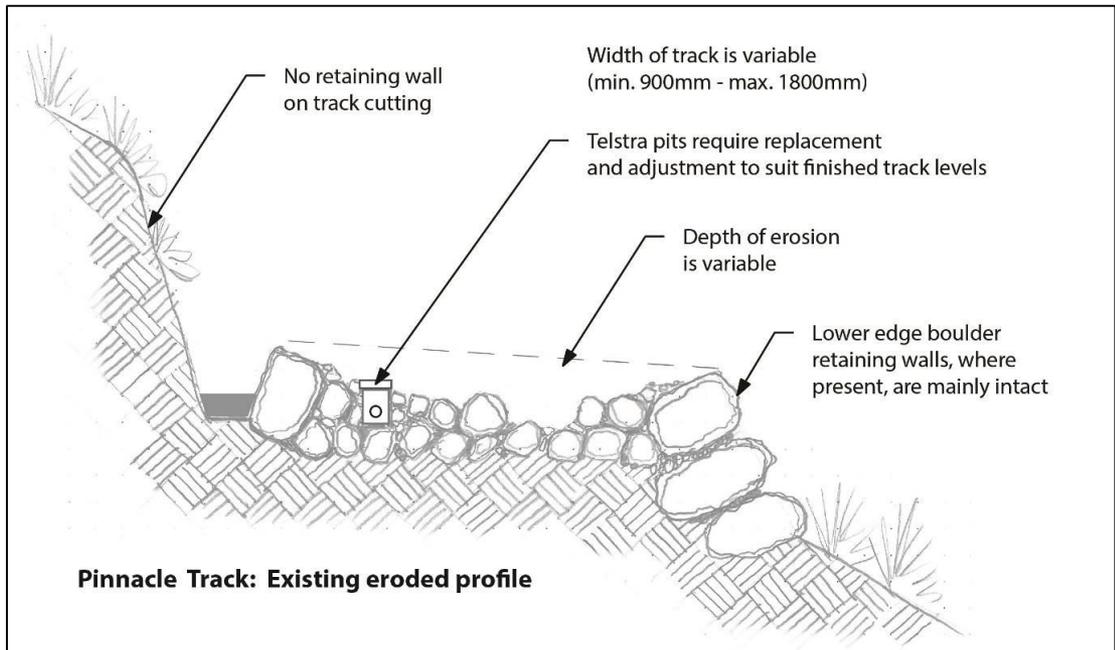
Pinnacle Track: Existing eroded profile

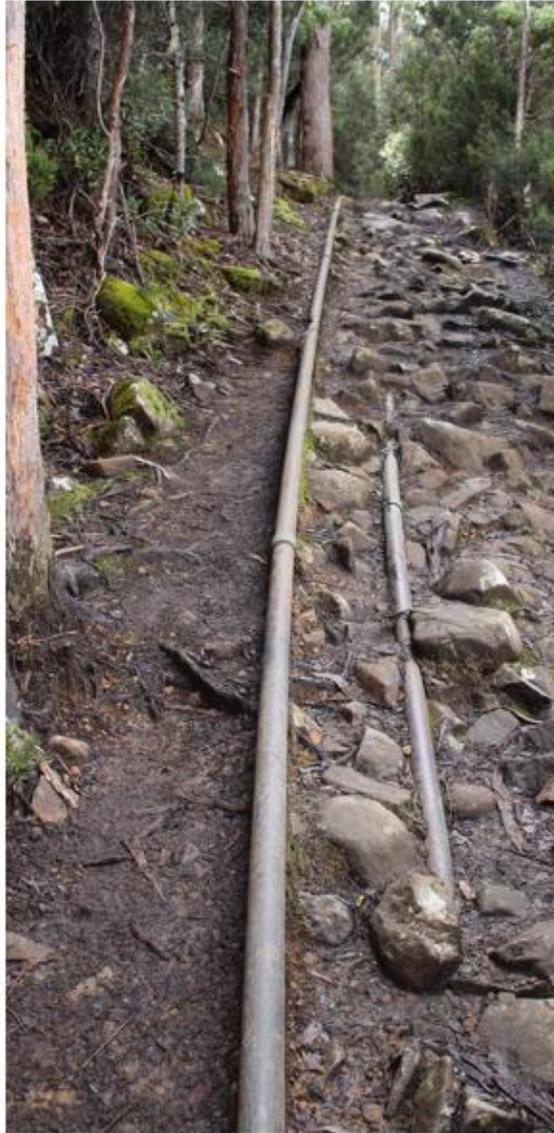
Existing: Steep, rocky section with intrusive pipe supplying water to The Springs amenities
