Sports Complex Design

Case Study of Griffin Sports Complex

Presentation at IPWEA Hobart Conference 2019

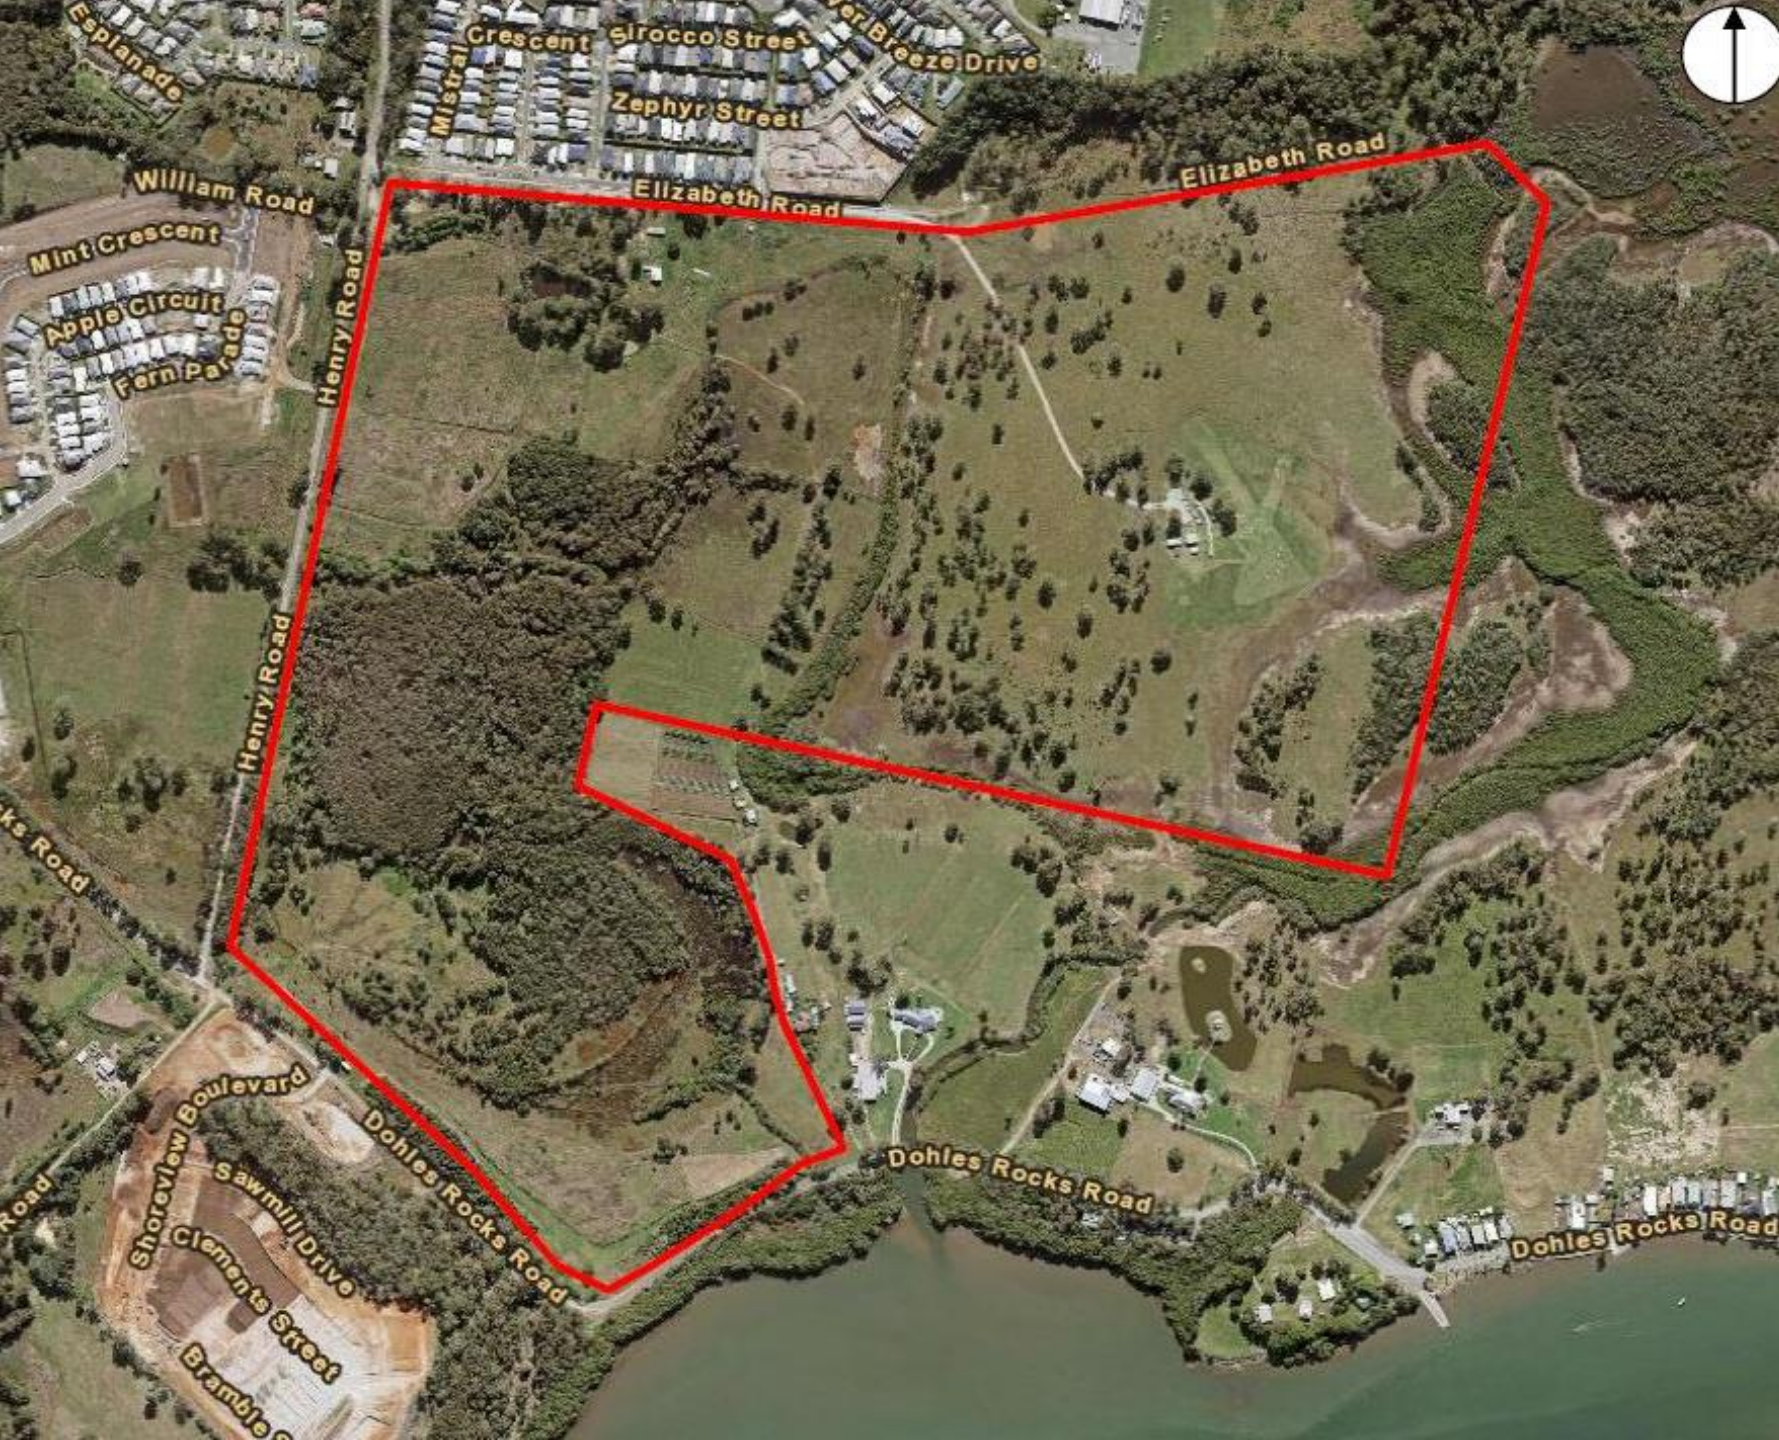
- Multiple Lots
- Large site - 90.7ha
- Bounded North and West by Elizabeth Rd and Henry Rd
- Bounded on the South by Pine River
- Steep embankment to the North

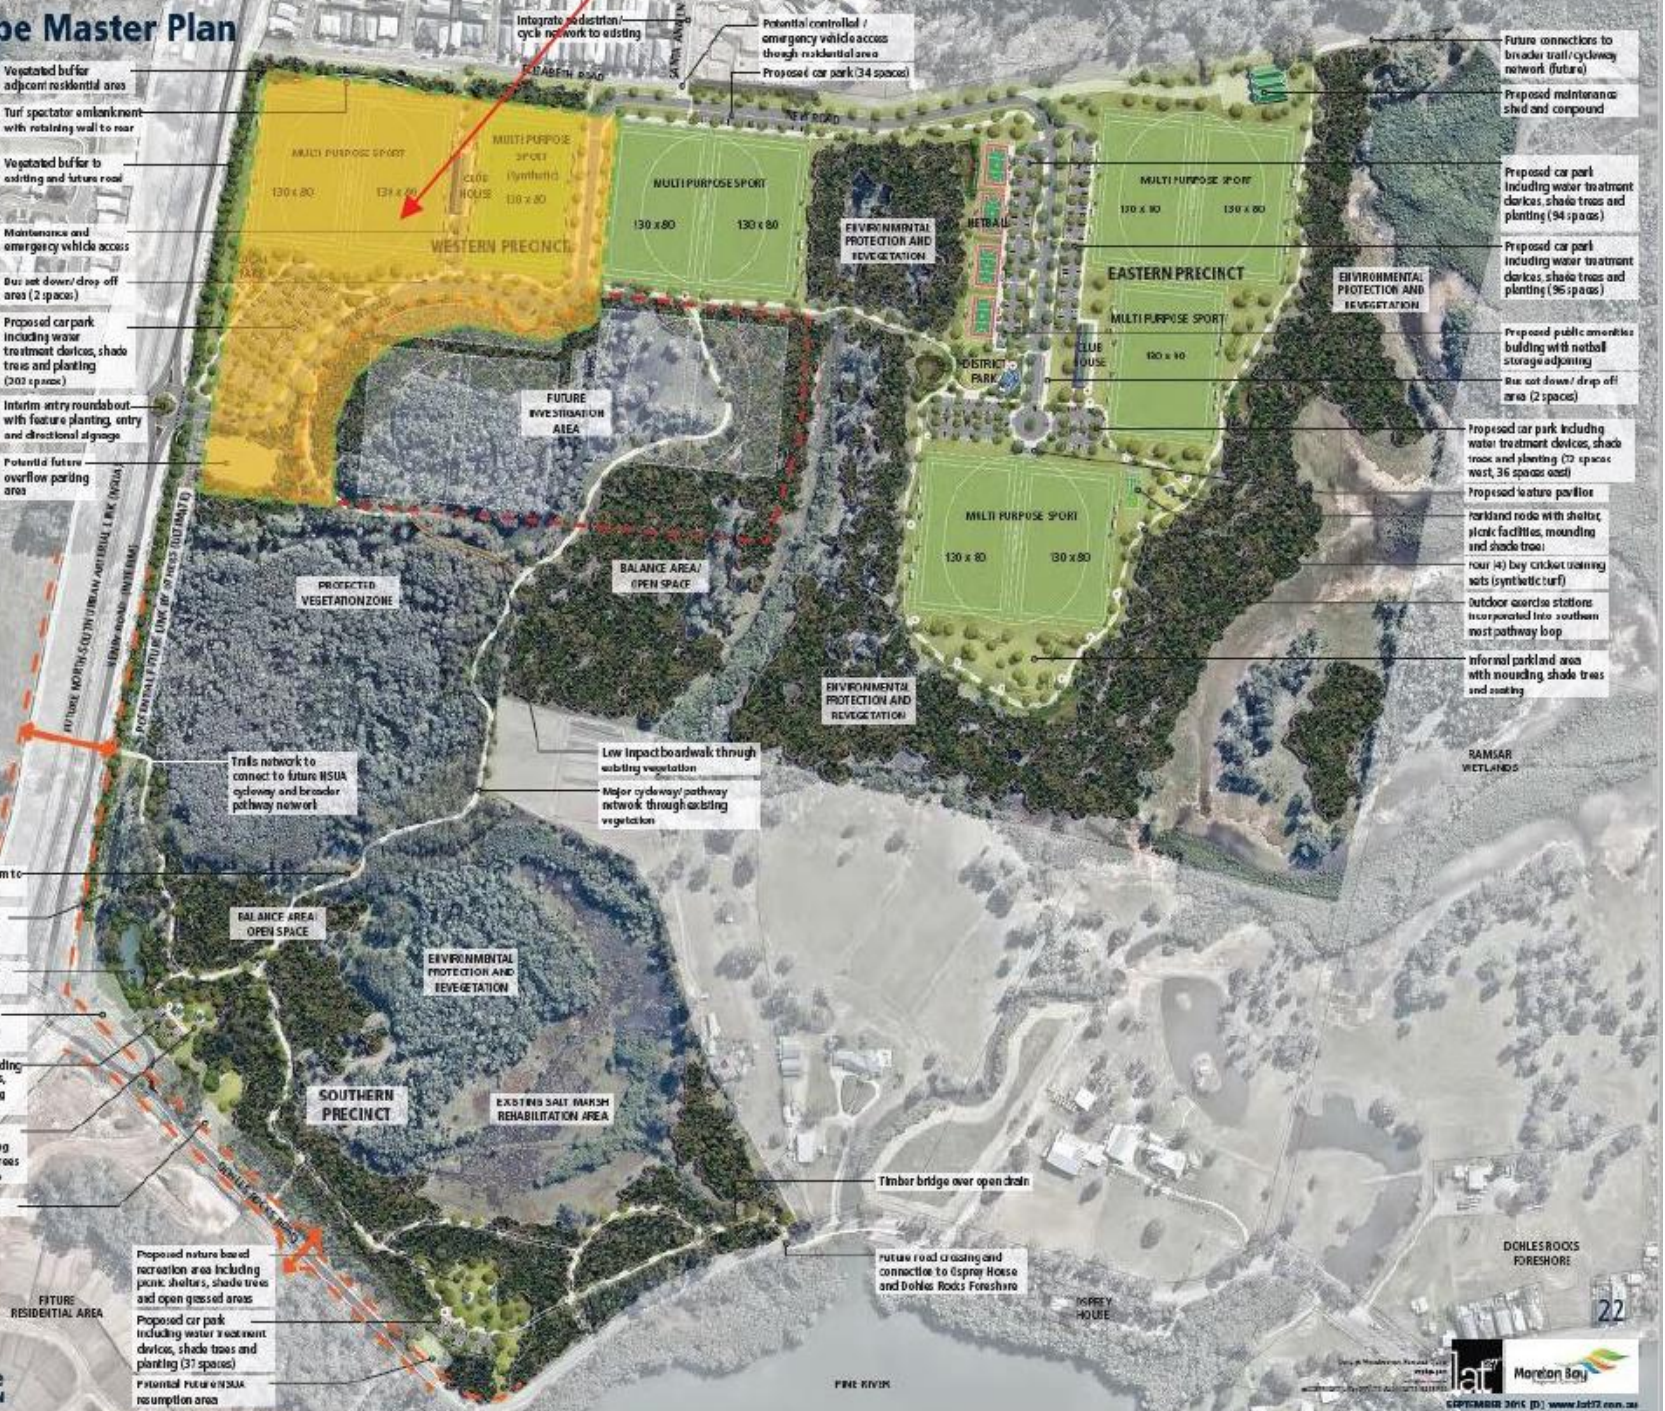
The Final Landscape Master Plan

- Original intention for the project
- Western Precinct – Stage 1

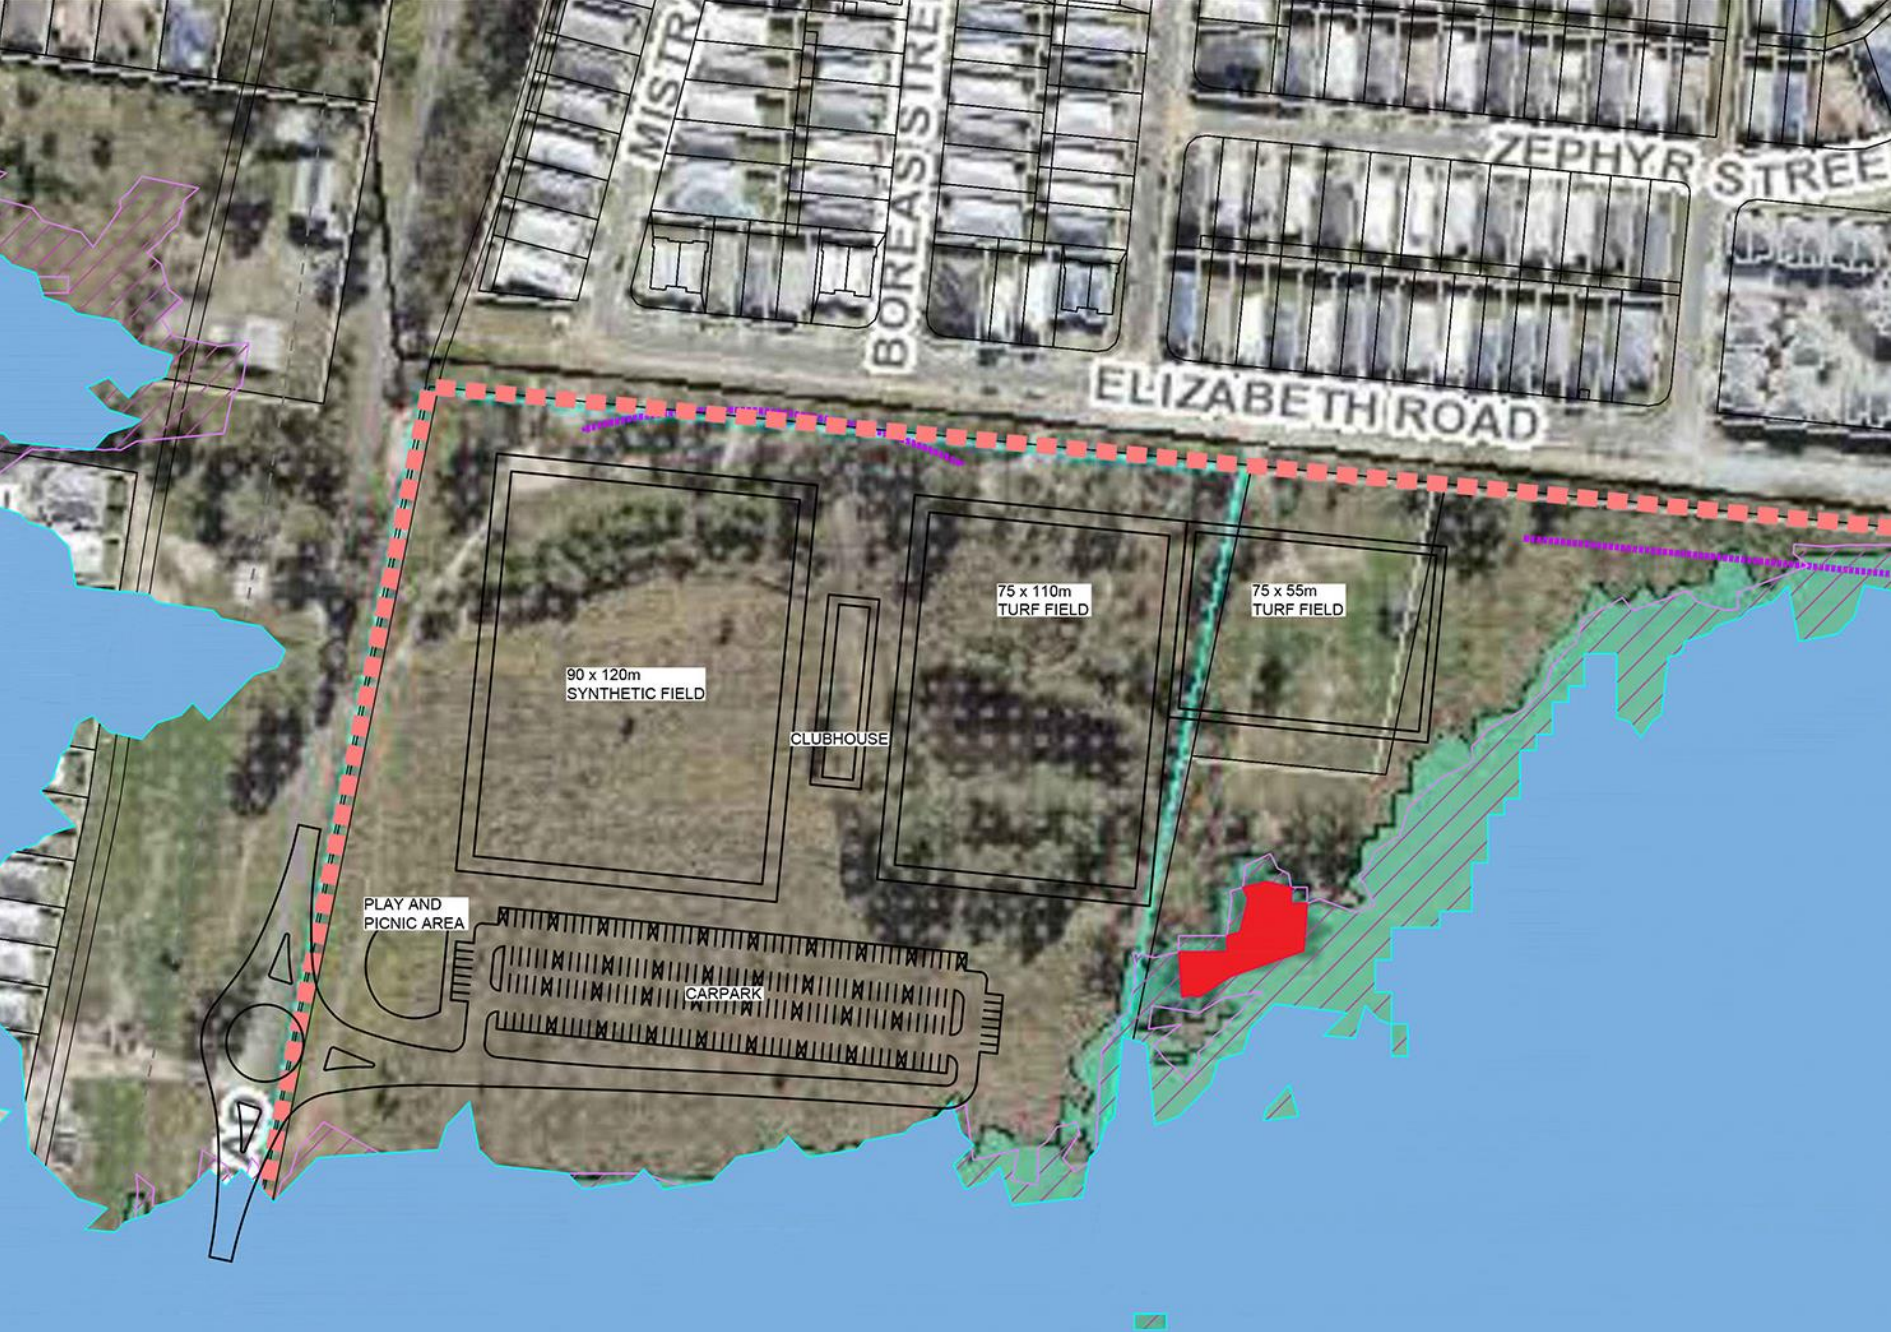
- Restrictions on the Southern side due to flood and tidal levels
- No filling in this area
- Planting permitted
