# Mitigating Shape Loss on Roads Prone to Deformation Using Geosynthetic Reinforced Pavements

Rod Fyfe  
Geofabrics

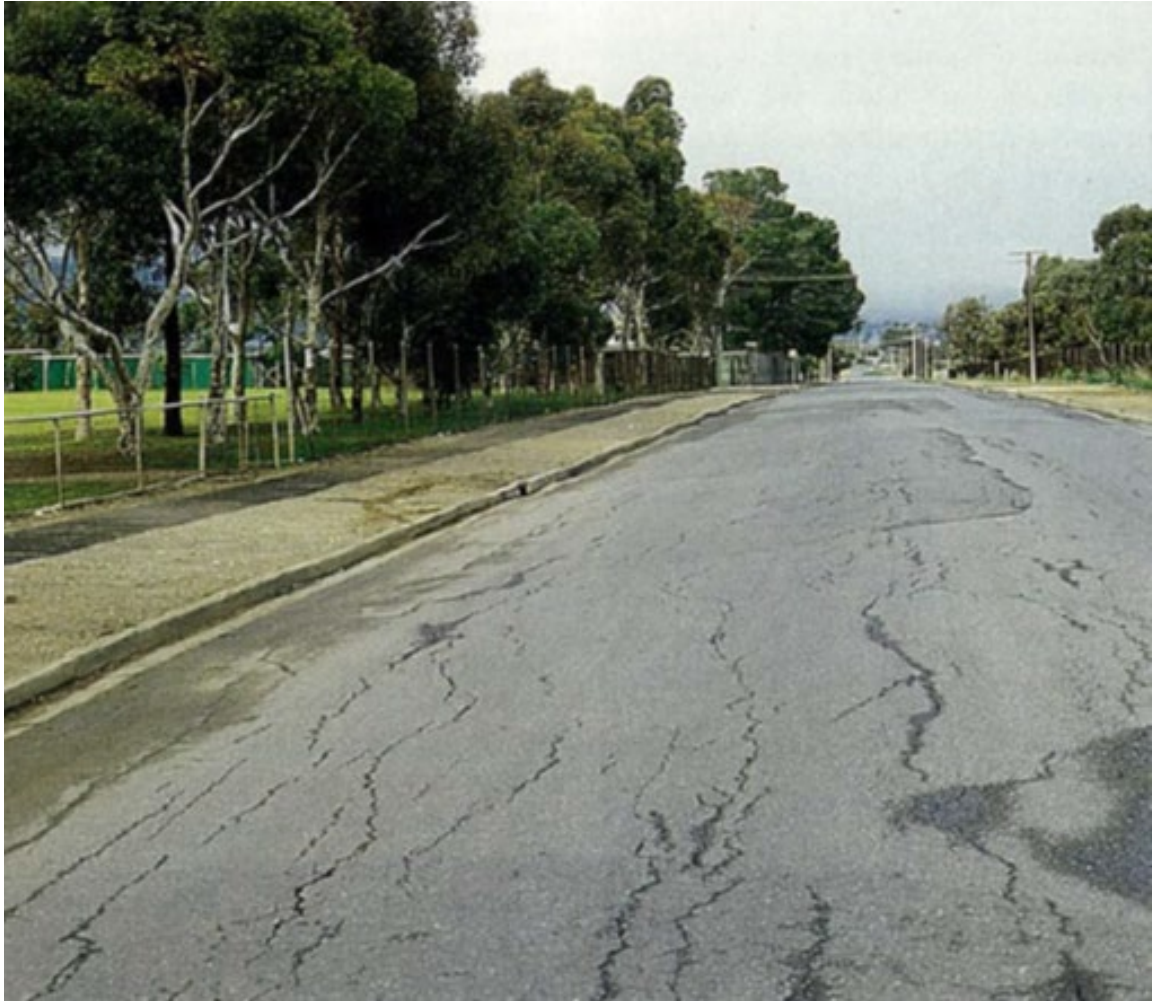
- » East/North East suburbs of Adelaide - areas of black and red/brown clays
- » Full depth pavement deformation and longitudinal cracking
- » Old local street pavements with 150mm depth FCR
- » Local Govt utilised geosynthetic solutions since mid 1990's
- » Full depth pavement solutions trialled over last 10 years

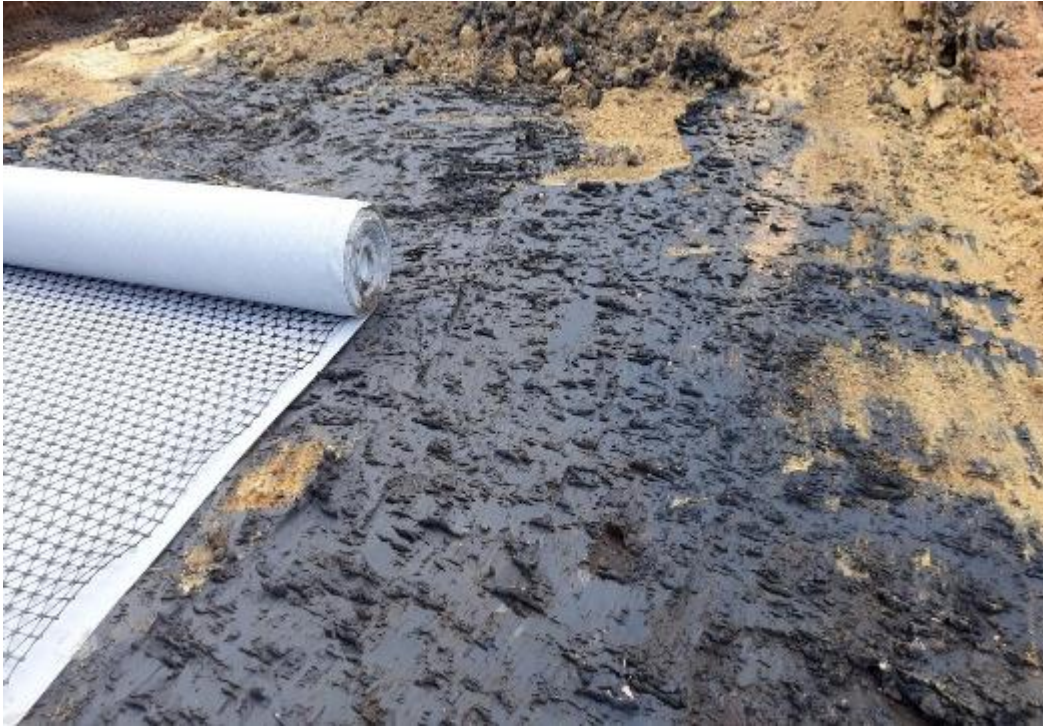
- » W'proofing existing cracked asphalt seals
- » Replacement of old thin pavements
- » Substitution of rock sub-base layer
- » Reconstruction to full depth needed
- » Shape correction/ride quality issue
- » Mitigation of expansive clay effects
- » Improve pavement life span

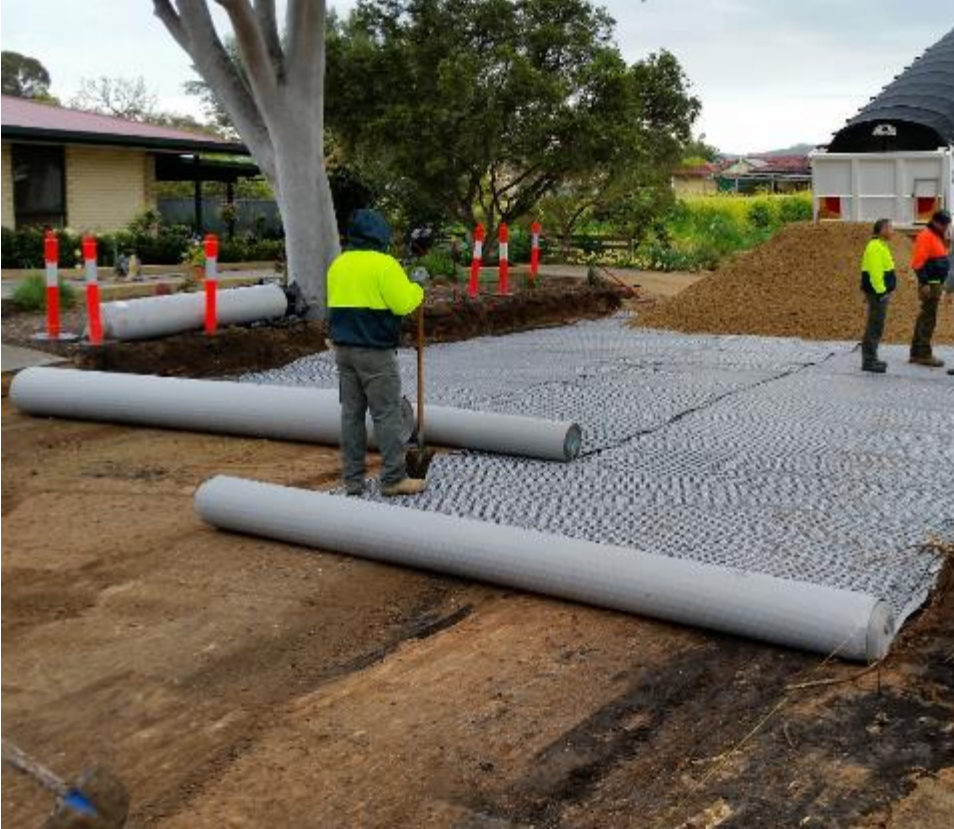
- » Paving Fabric 140 gsm for waterproofing of asphalt overlays
- » Replacement of 150mm rock layer up to 400mm deep with;
  - Geotextile 200 gsm for clay separation
  - Triaxial geogrids for subgrade reinforcement

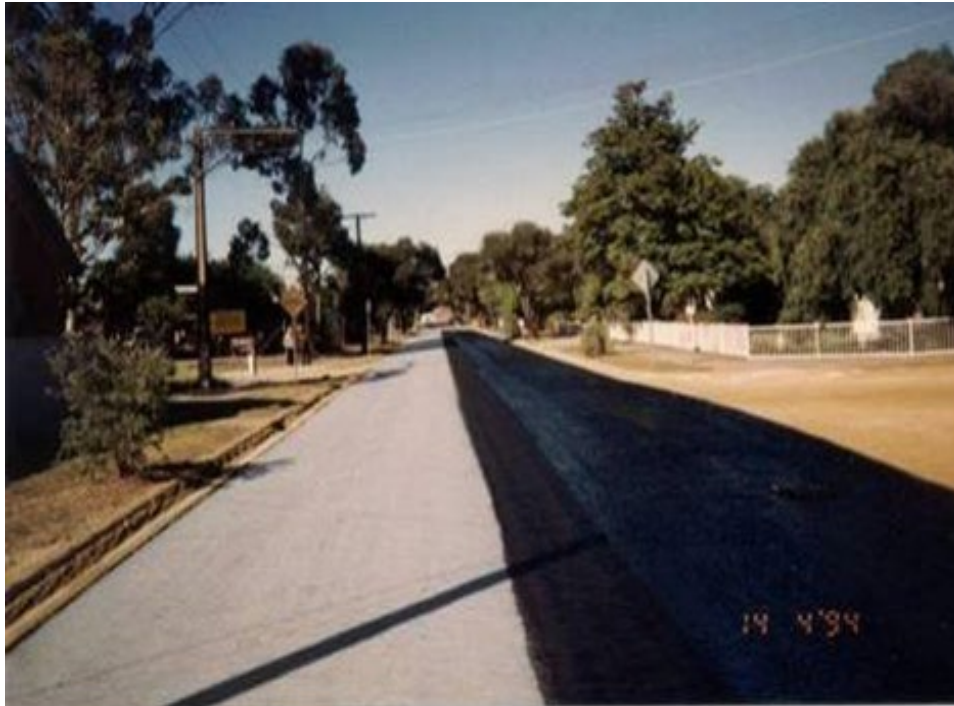
Vasey St. Greenacres  
1994

- » City of Port Adelaide Enfield
- » Reconstructed 1994
- » 30mm asphalt overlay with Sealmac 140gsm PET paving fabric
- » 40 FCR base course 200mm deep
- » Area ~ 4000 sqm
- » Reflective cracking as a result of shallow depth pavement over expansive clay subgrade
- » 15+ year performance success

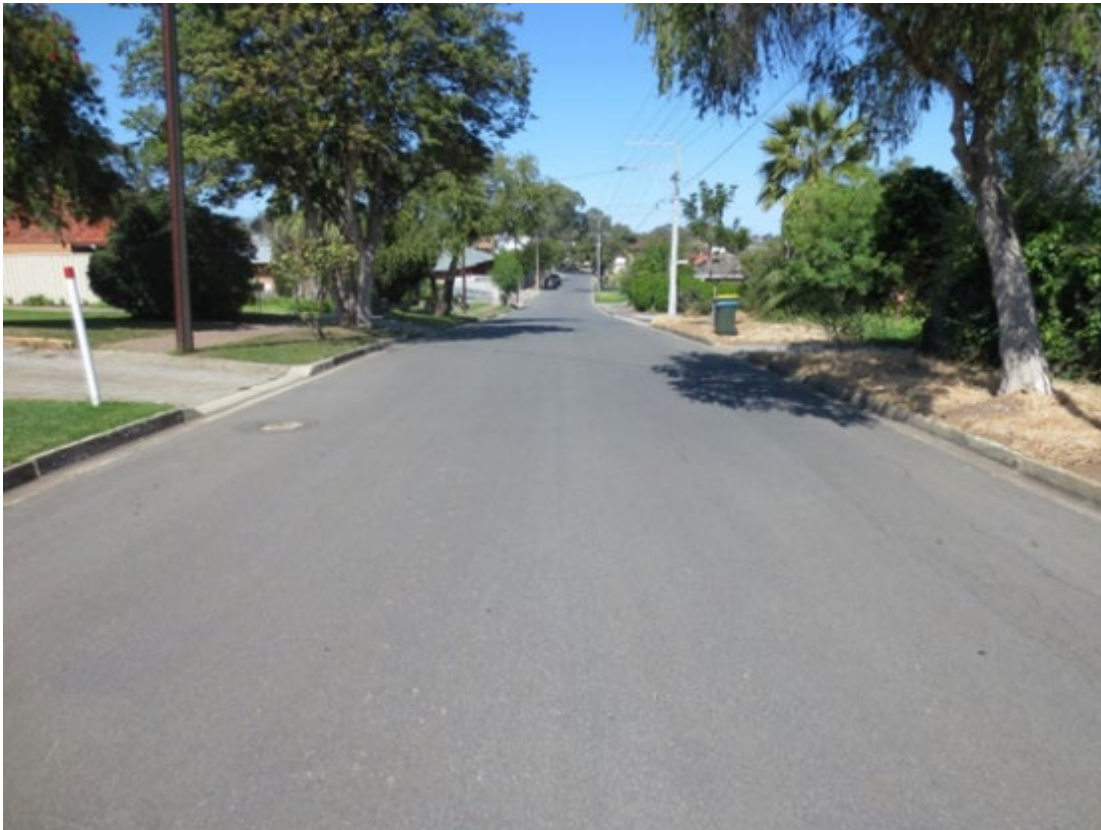
Deans Rd Campbelltown  
2018

- » City of Campbelltown
- » Reconstructed 2000
- » 30mm asphalt overlay
- » Reconstructed 40 FCR base course 150mm deep
- » Tensar SS20 + bidim A24 subgrade stabilisation
- » Area ~ 7500 sqm
- » Reflective cracking as a result of shallow depth pavement over expansive clay subgrade – very poor original condition.

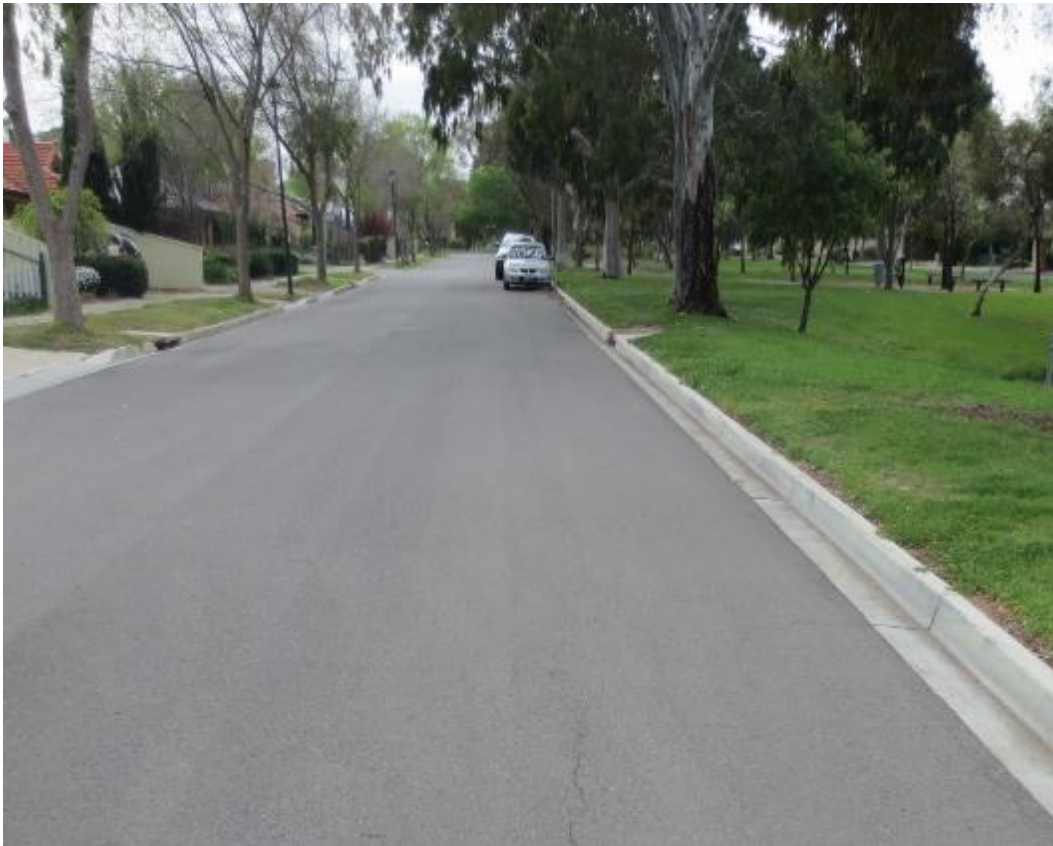
Duthie St, Regent Gardens  
2015

- » City of Port Adelaide Enfield
- » Reconstructed 2015
- » 30mm asphalt overlay
- » Reconstructed 40 FCR base course 400mm deep
- » TX160/A24 geo-composite subgrade stabilisation
- » Area ~ 3000 sqm
- » Reflective cracking as a result of shallow depth pavement over expansive clay subgrade
- » Located adjacent park with water retention pond.

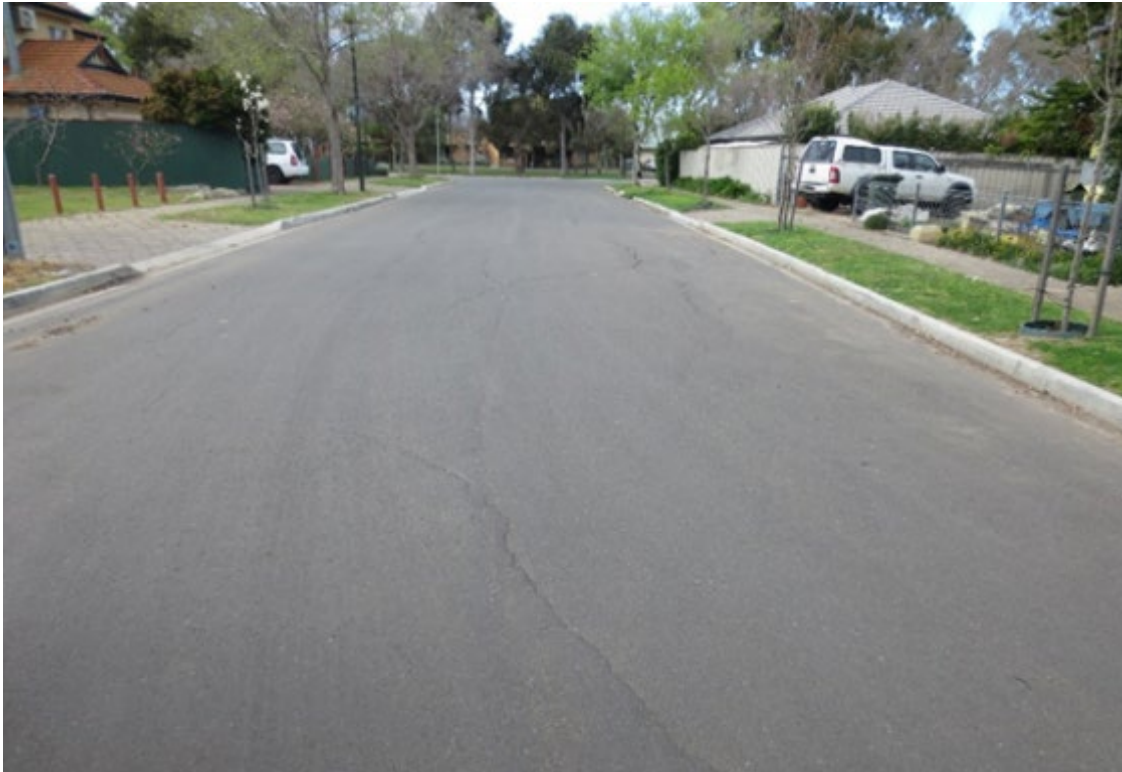
## Voss St Regent Gardens - Control 2015

- » City of Port Adelaide Enfield
- » Reconstructed 2015
- » 30mm asphalt overlay
- » Reconstructed 40 FCR base course 400mm deep
- » Area ~ 3000 sqm
- » Reflective cracking as a result of shallow depth pavement over expansive clay subgrade
- » Located adjacent park with water retention pond.

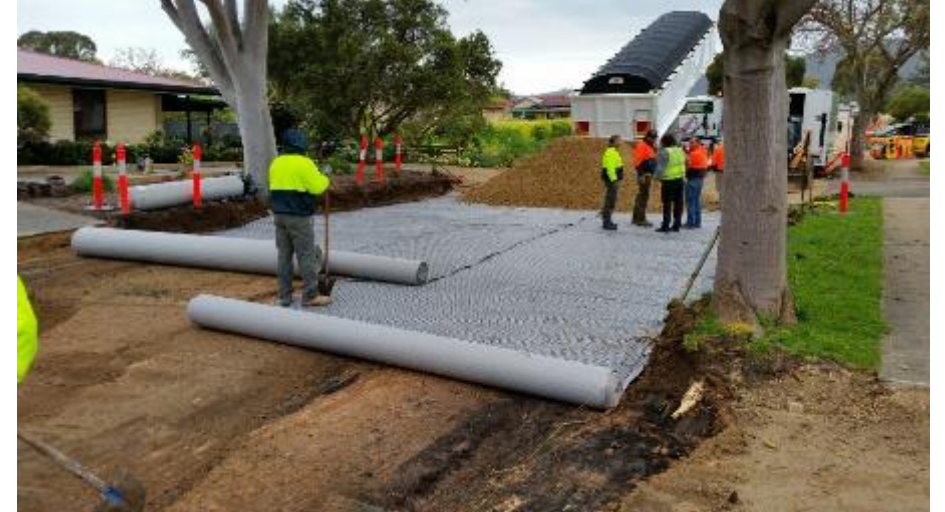
- » City of Campbelltown
- » Reconstructed 2016
- » 30mm asphalt overlay
- » Reconstructed 40 FCR base course 400mm deep
- » TX160/A24 geo-composite subgrade stabilisation
- » Area ~ 2200 sqm
- » Reflective cracking as a result of shallow depth pavement and environmental factors over expansive clay subgrade
- » Located with large gums in close proximity

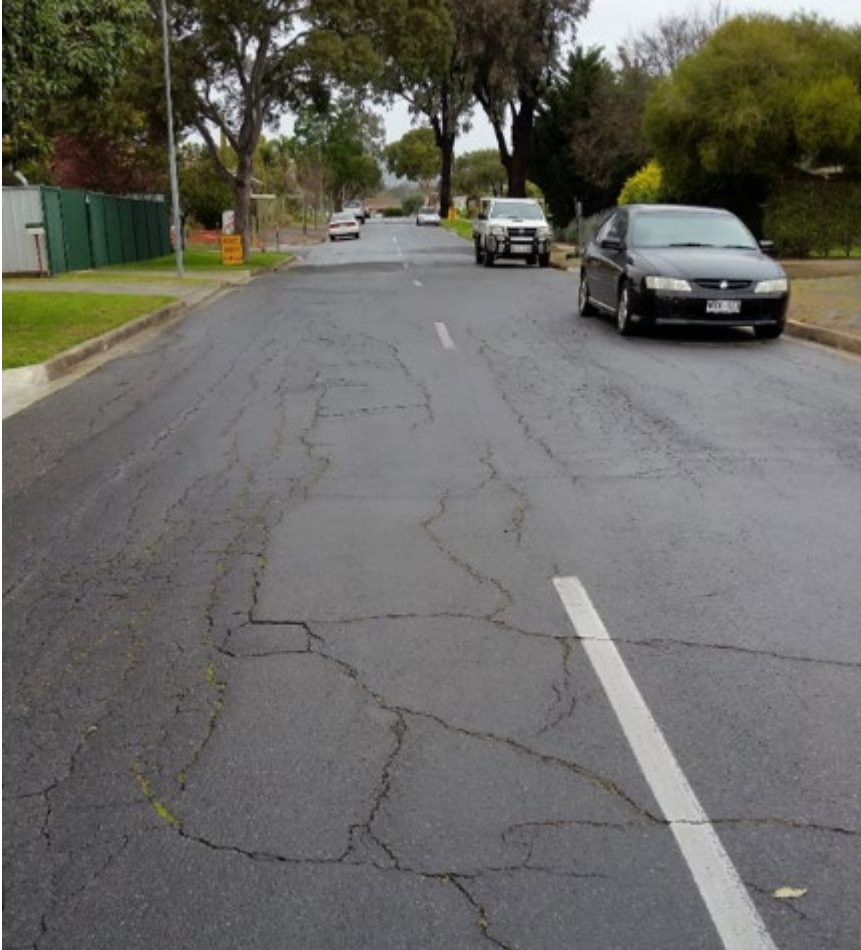
Chatswood Grove, Newton  
2016

- » City of Campbelltown
- » Reconstructed 2016
- » 30mm asphalt overlay
- » Reconstructed 40 FCR base course 300 - 400mm deep
- » TX160/A24 geo-composite subgrade stabilisation
- » Area ~ 2200 sqm
- » Reflective cracking as a result of shallow depth pavement over expansive clay subgrade
