Onslow
Town
Area.

Assessment Data for Consideration.

Moving Forward.

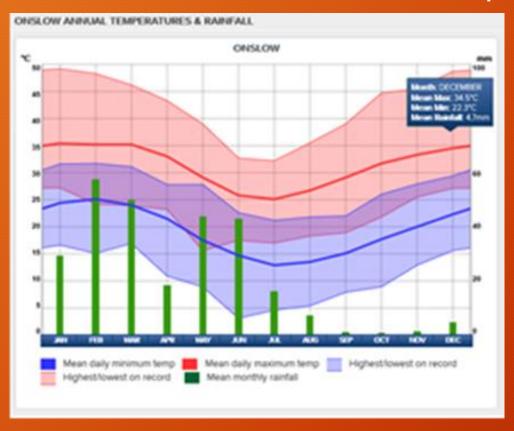
Onslow Temperature & Rainfall Data.

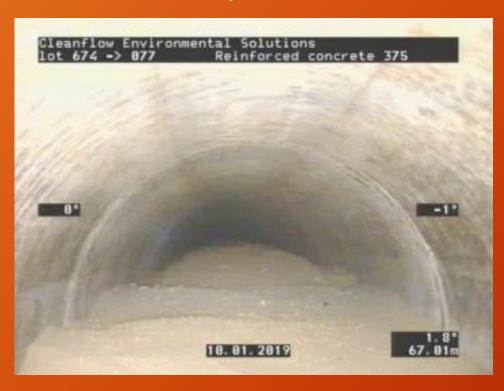
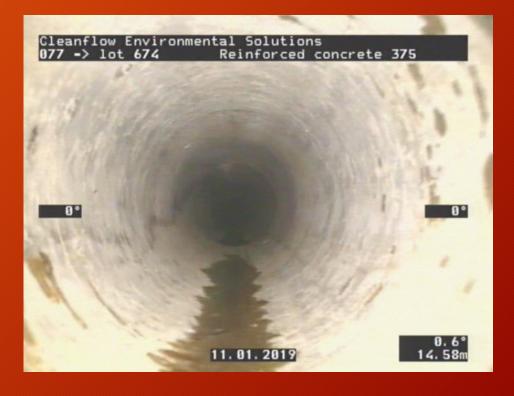
BEFORE

20 YEAR OLD PIPE

AFTER

375 mm Pipe 90% Blocked

Pipe after jetting works completed.

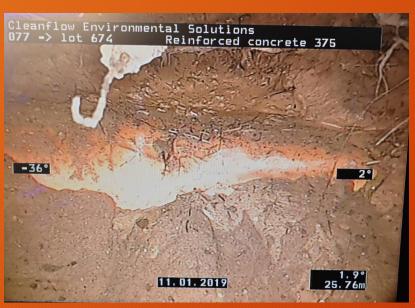
Horizon Power Low Voltage Supply conduit.

Examples of COMPROMISED PIPES found during this project.

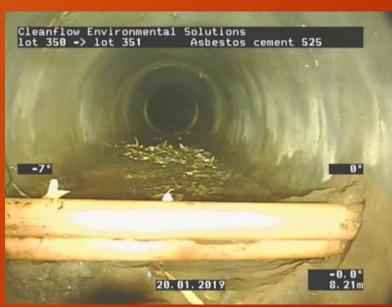
Horizon Power Service conduits.

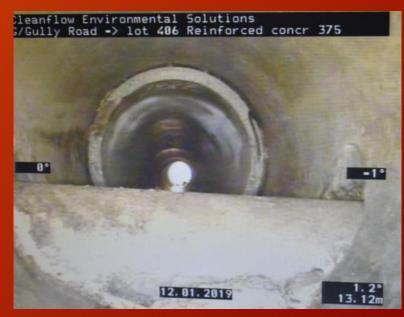
WaterCorp. Asbestos Cement Watermain.

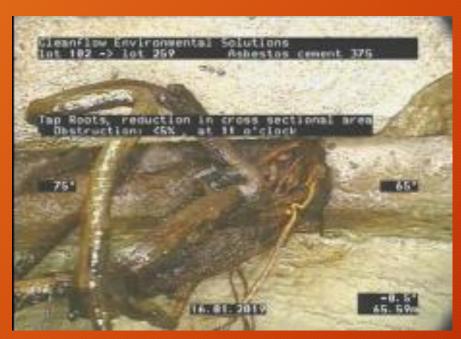
Examples of compromised sections due to tree roots entering stormwater pipelines.

Second Avenue outside the Shire Administration Building.

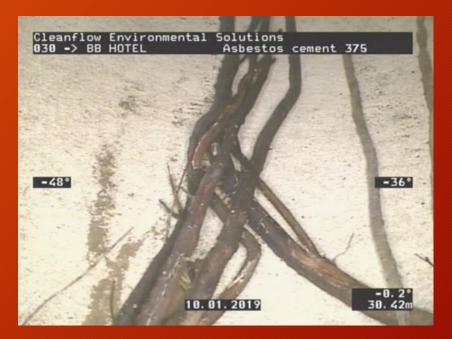
Outside the Beadon Bay Hotel.

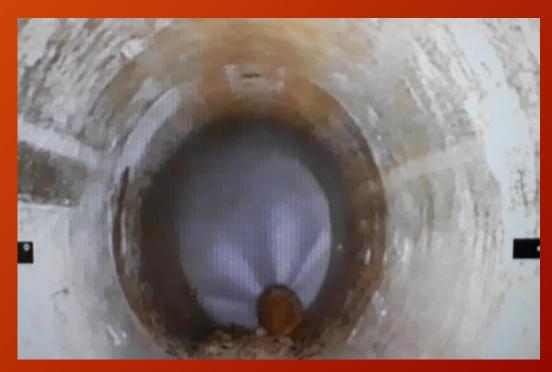
High Pressure Jetting Process (Cleanflow Environmental Services).

This CCTV footage shows how effective the pressure head can clear sediment and debris from a blocked pipe at 40%

Some pipes were found to be completely blocked on this project.

Stormwater network and disposed of approximately 25 tonnes of "Well Everything"
