Measure and Report Luminaire Dirt Depreciation (LDD) in LED Luminaires for Street and Roadway Lighting Applications

**Final Report prepared for the
Illuminating Engineering Society of North America**

January 2016

**Center for Infrastructure-Based Safety Systems
Virginia Tech Transportation Institute
3500 Transportation Research Plaza
Blacksburg, Virginia**

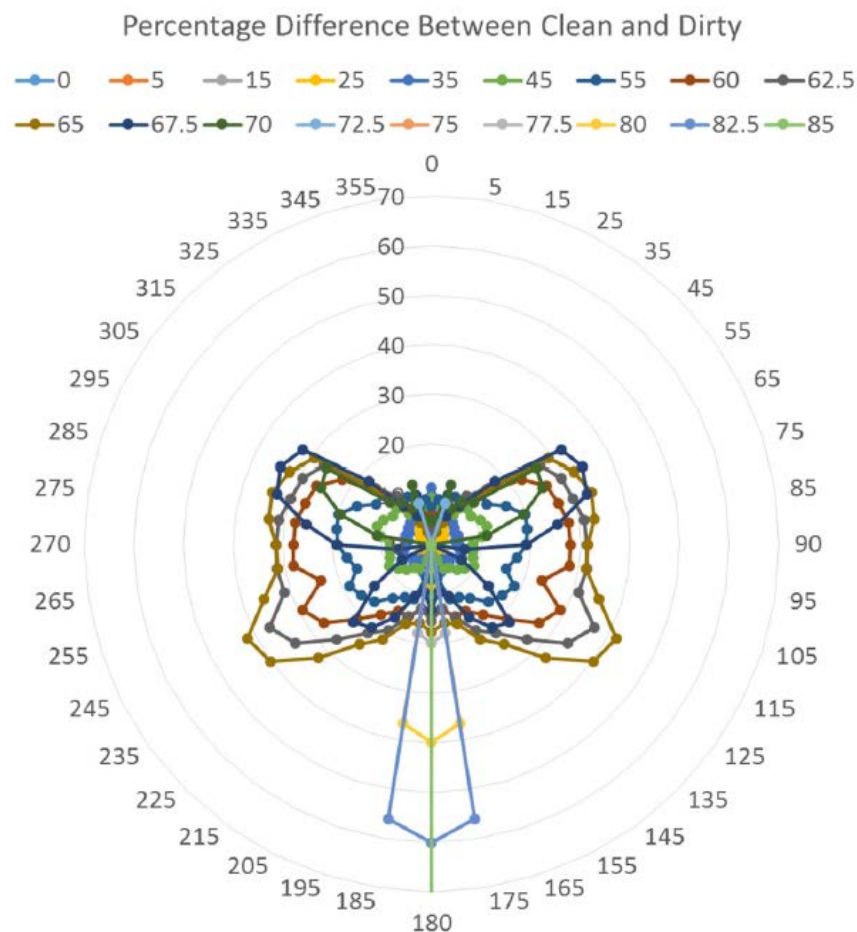
Figure 1. Photometric dirt depreciation polar distribution showing non-uniform LDD.

In previously unpublished, related work from a small investigation performed by the authors, a 400-W HPS luminaire was removed from the Virginia Smart Road for photometric characterization. After photometric measurements were performed, the luminaire was cleaned and the measurements repeated. The results, shown in Figure 1, indicate that the dirt depreciation was greater at the edges of the luminaire’s area of illumination than directly beneath the luminaire. The tested luminaire was a flat-lensed type II medium throw, and a significant portion of its light distribution is projected at low angles through the edge of the glass. These low angles would be more significantly impacted by the dirt on the lens, and the throw of the luminaire would be diminished more there than in the central area. These results indicate that the application of a single factor for dirt depreciation is fundamentally incorrect, because dirt depreciation does not affect light distribution uniformly.

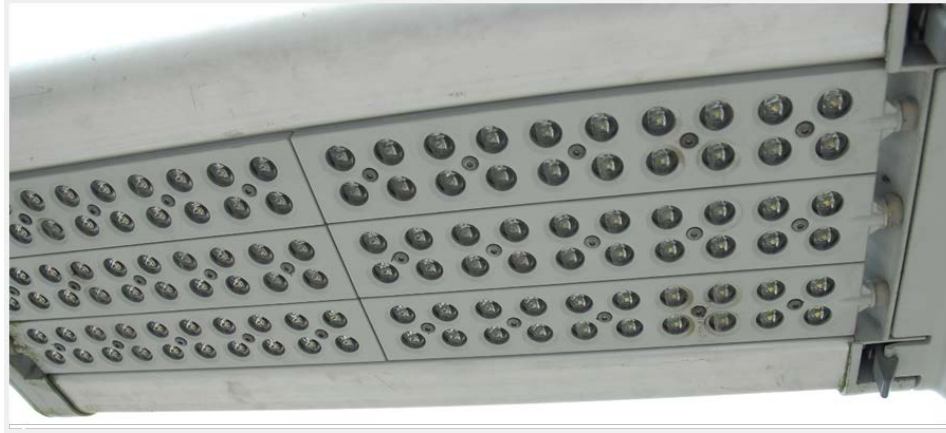
Figure 4. Virginia Smart Road LED luminaires.

The Virginia Smart Road is equipped with two sets of LED luminaires from a single manufacturer. These luminaires have a type II light distribution pattern and differ only in correlated color temperatures: 3500K and 6000K (Figure 4). The luminaires, designated type A, were installed approximately six years prior to this experiment, and were not cleaned during that time. An overhead photo of the location is shown in Figure 5.

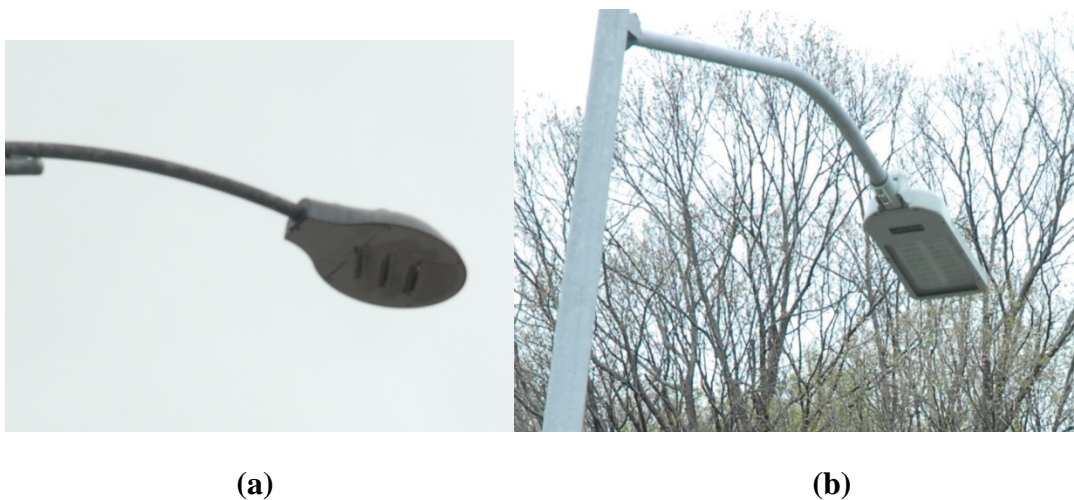
Figure 8. Installed LED luminaires in Charleston, WV: (a) type F; (b) type J.

On I-77, five types of led luminaires were installed: type F (Figure 8a), type G, type J (Figure 8b), type K (Figure 9) and type L. Only the F luminaire was used on WV-61. All of this work, cleaning included, was performed at night at this location due to lane closure restrictions set by the West Virginia Department of Transportation (WV-DOT).

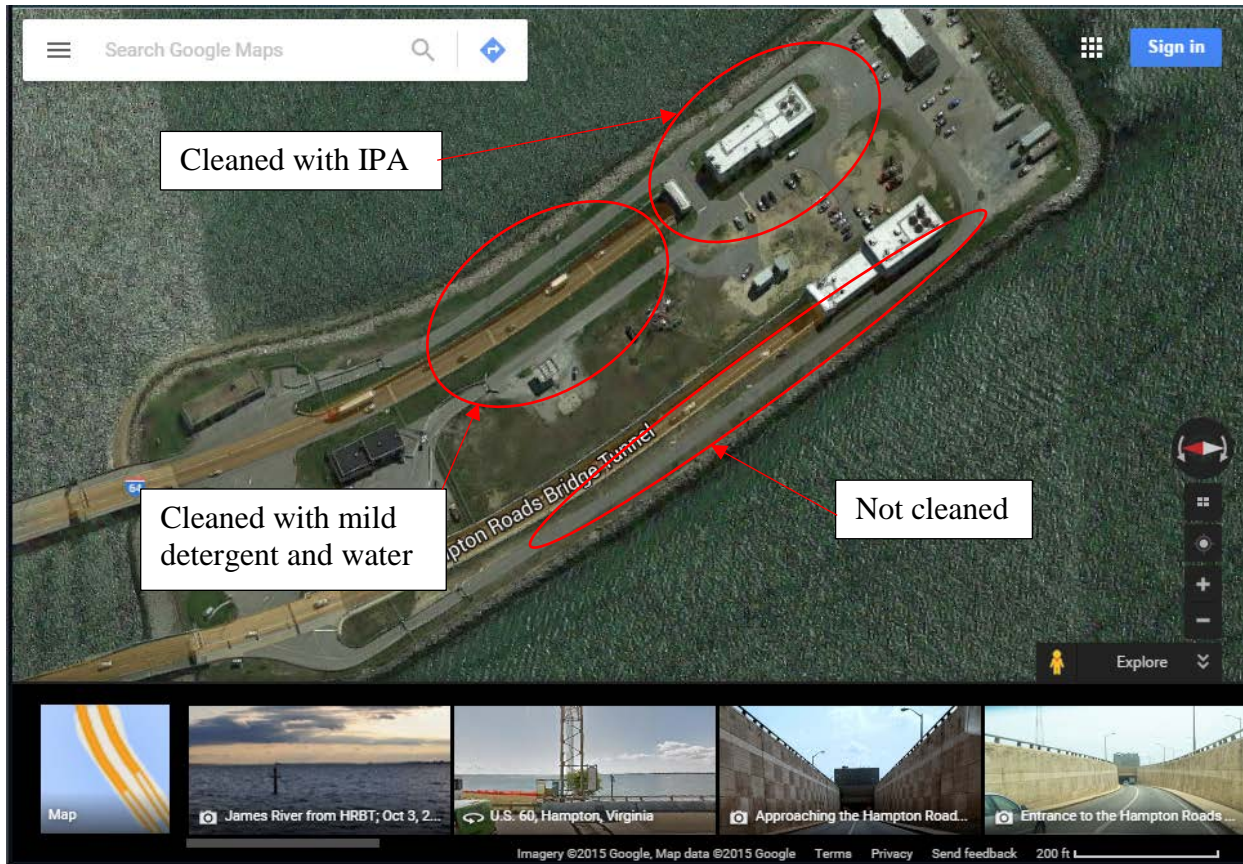
Figure 12. Cleaning plan for Hampton study area.

As illustrated in Figure 12, three luminaires on either side of the northbound lanes of I-64 were cleaned with detergent solution and three luminaires on either side of the tunnel were cleaned with 70% IPA. It was assumed that salt spray would be the major contributor of dirt on these luminaires, so the team wanted to clean luminaires with both cleaning methods on the side edge of the island to provide comparative data for salt-spray conditions.

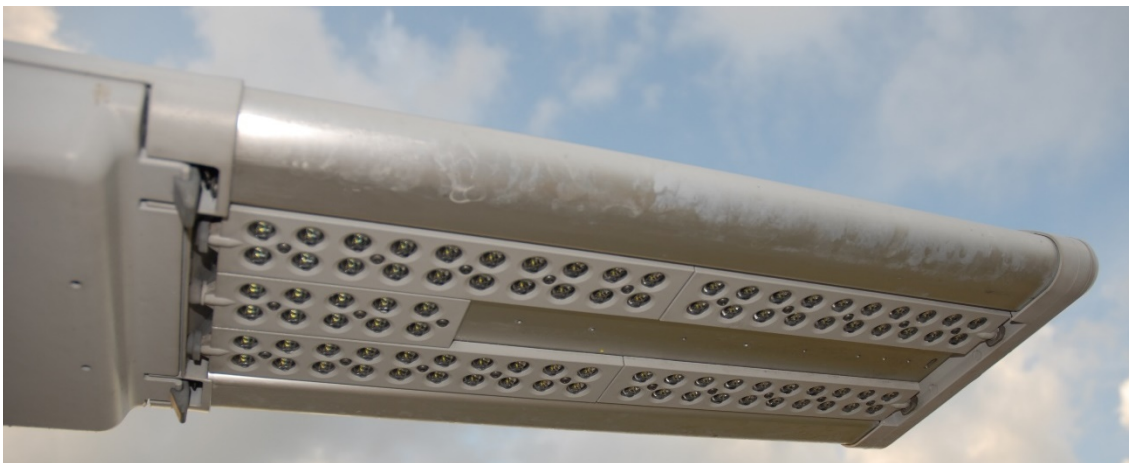
Figure 13. LED luminaire installed at Hampton bridge site.

Figure 13 shows the type of LED luminaire installed, which is very similar to those installed on the Virginia Smart Road and comes from the same manufacturer. Figure 14 shows the installation of the luminaires on the island.

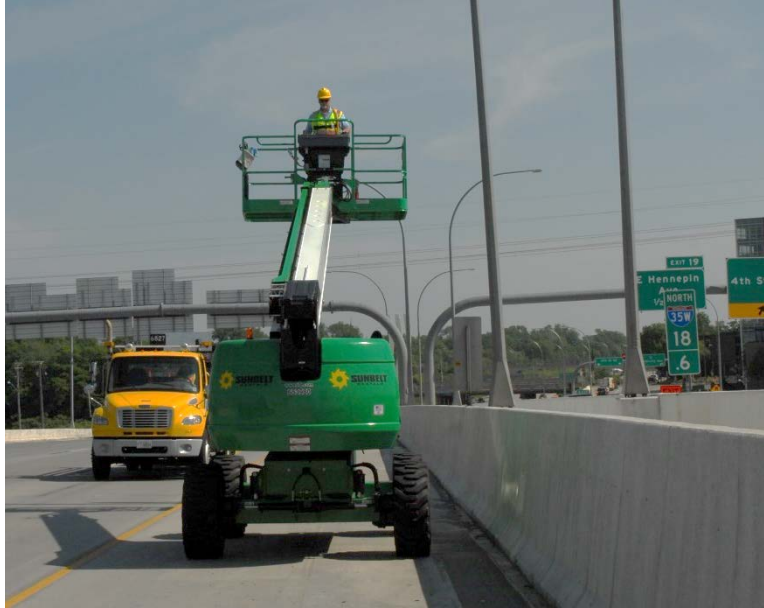
Figure 17. I-35W luminaire cleaning, showing MNDOT lane closure and man lift used.

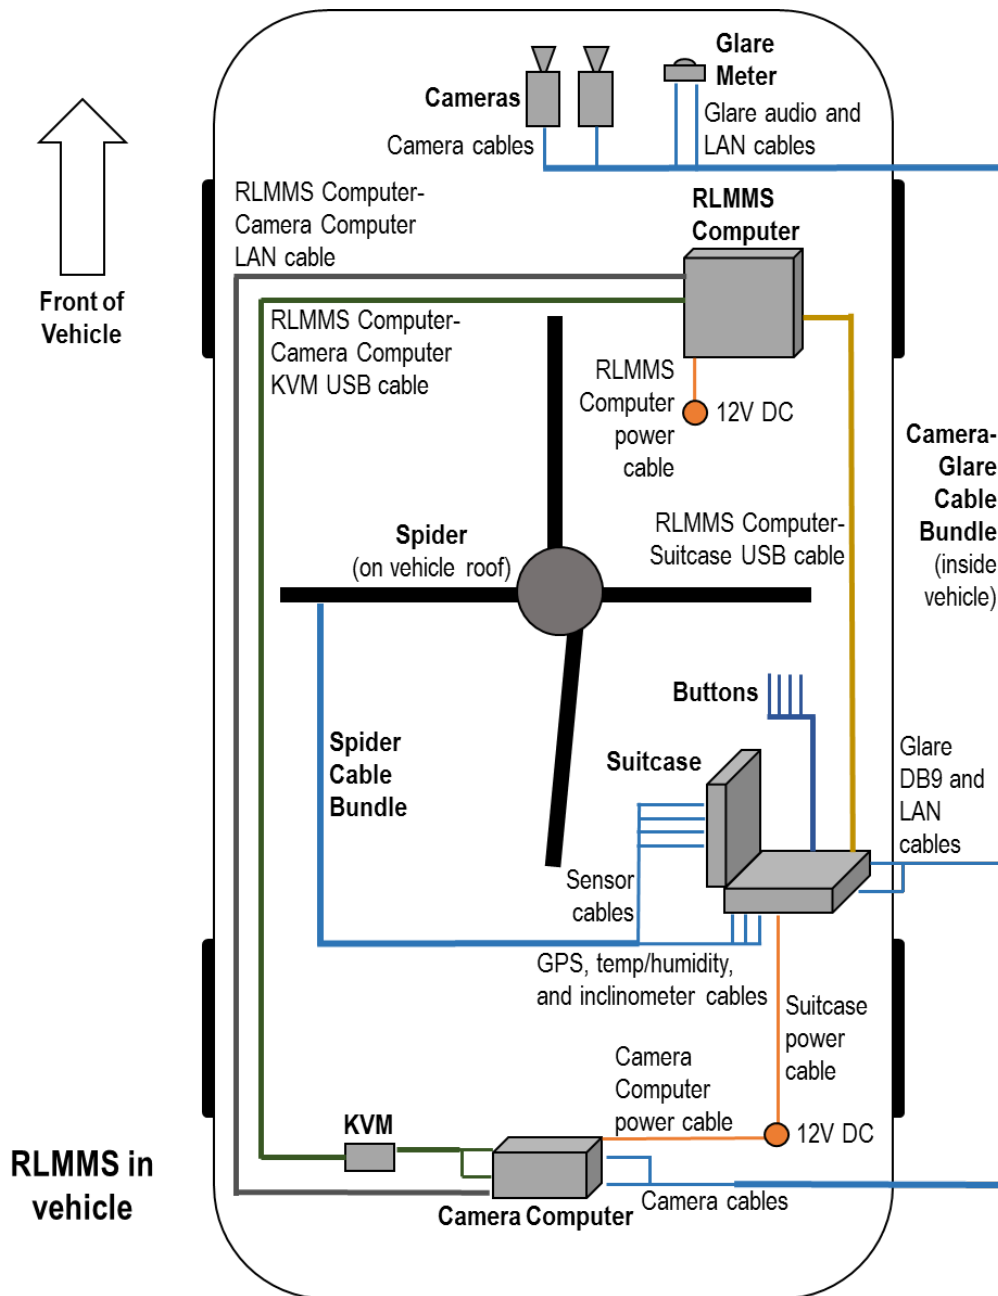
Figure 21. Diagram of RLMMS system.

For the Smart Road pilot study and in situ study, the VTTI-owned Roadway Lighting Mobile Measurement System (RLMMS), a diagram of which is shown in Figure 21, was used to measure illuminance before and after cleaning. The RLMMS system captures dense, accurate photometric data from a moving vehicle. The RLMMS collects horizontal illuminance, vertical illuminance (glare), as well as roadway luminance, along with corrected color temperature (CCT), and by nature of the measurement, lighting uniformity. It couples the measurements with accurate Global Positioning System (GPS) locations that can be then related to the locations of the luminaire poles. The RLMMS can take measurements along a length of roadway, so other metrics along that roadway can also be measured, such as uniformity, glare, and luminance. The RLMMS was selected because it can take photometric measurements from any roadway, so the luminaires did not need to be removed, a time-consuming, and costly procedure. Removal of luminaires may also disturb accumulated dirt, which may result in inaccuracies in the photometric measurements.

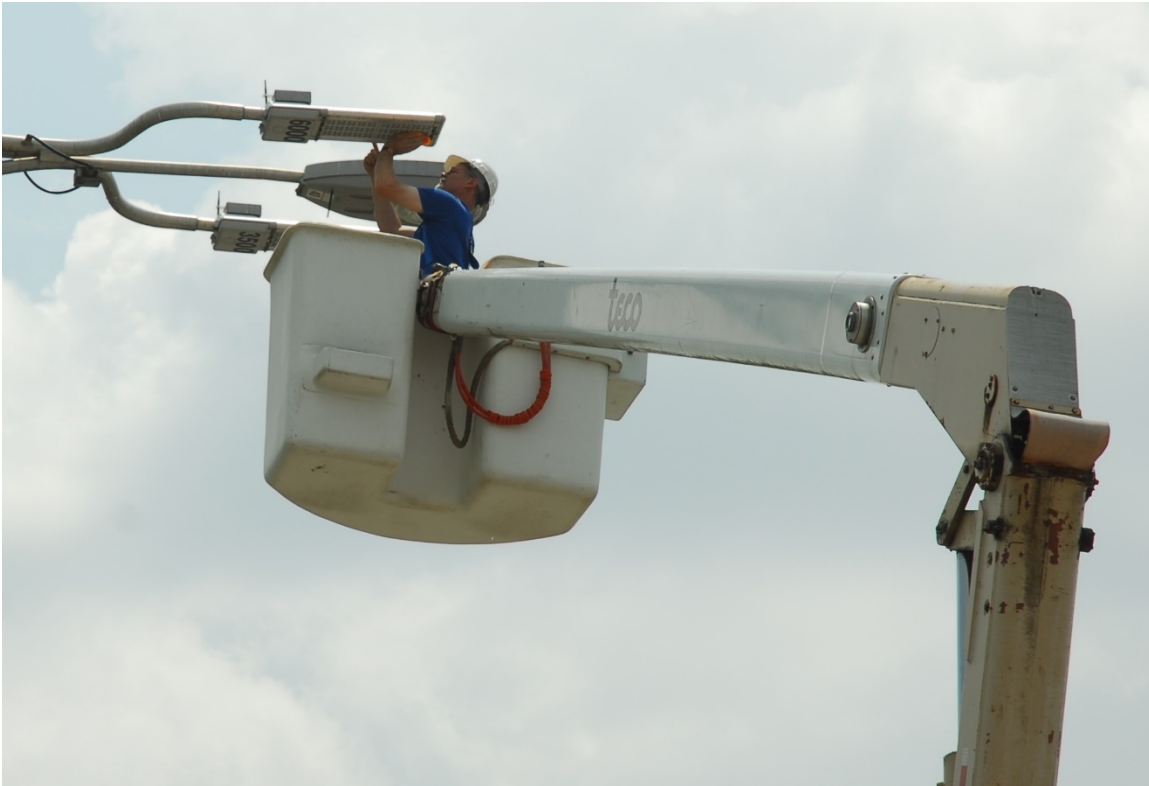
Figure 22. Wiping the Smart Road luminaires with a rag.

Figure 22 shows a team member cleaning a luminaire with a microfiber rag. The procedure in Figure 22 was for Cleaning Method 1 (dry rag), Cleaning Method 2 (wet rag), and Cleaning Method 3 (rag with IPA). For Cleaning Method 2 and 3, the liquid was poured onto the rag, which was then used to wipe the optics. This was followed by a wipe with a dry rag to remove any remaining dirt. The protocol specified spending no more than 1 min cleaning the luminaires. For Cleaning Methods 1, 2, and 3, the cleaning method took approximately 10 min per luminaire, including moving from one luminaire to the next and deployment of the bucket truck.

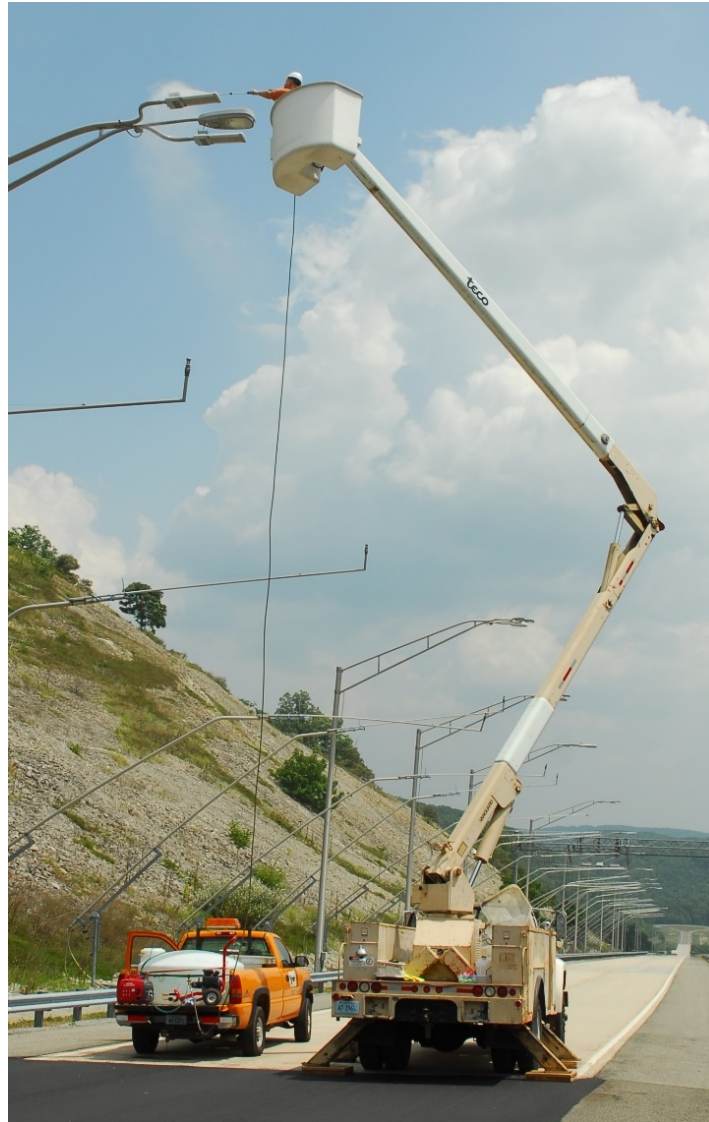
Figure 23. Setup to pressure wash luminaires on the Smart Road.

The team used a pressure washer with 50-ft pressure hose and a support truck providing water and power to pressure wash the luminaires from the VTTI bucket truck (Cleaning Methods 4 and 5). The pressure-washing setup can be seen in Figure 23.

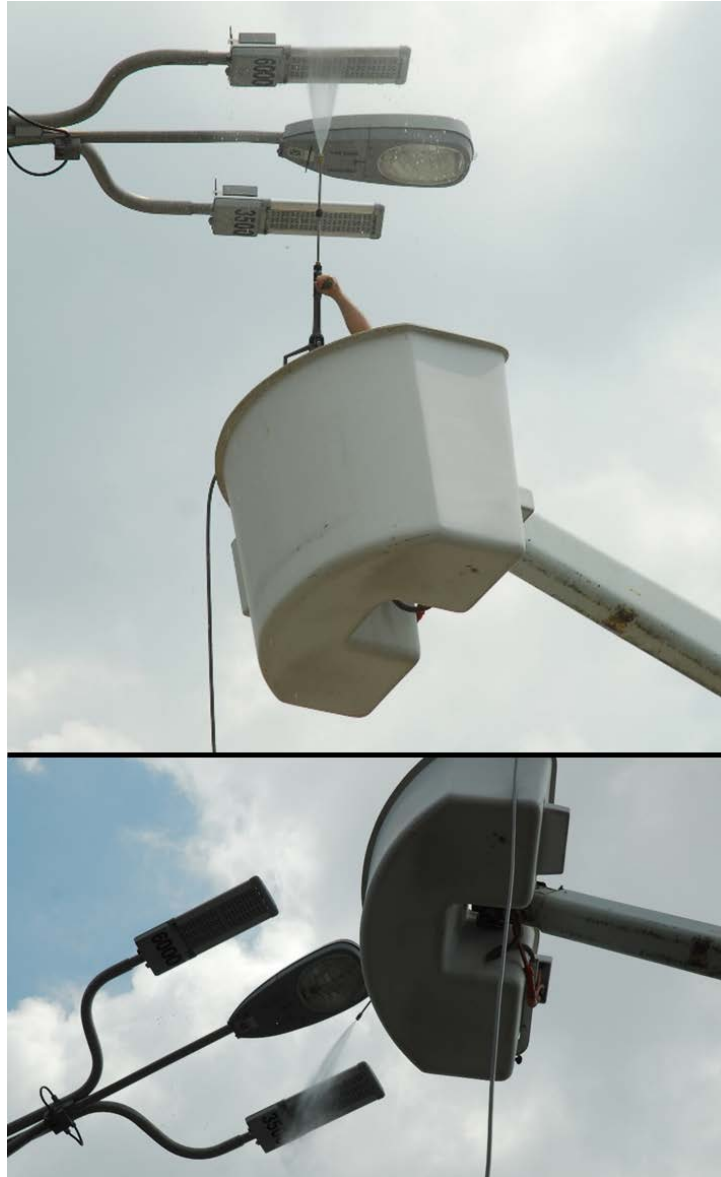
Figure 24. Pressure washing the optics of the Smart Road luminaires (Cleaning Method 4).

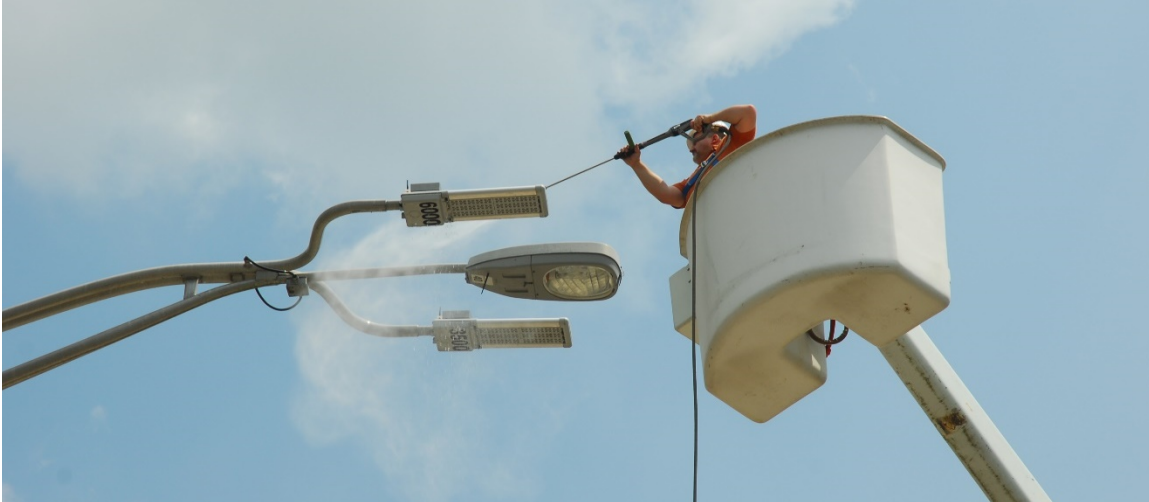
Figure 25. Pressure washing the heat sink of the luminaires (Cleaning Method 5).

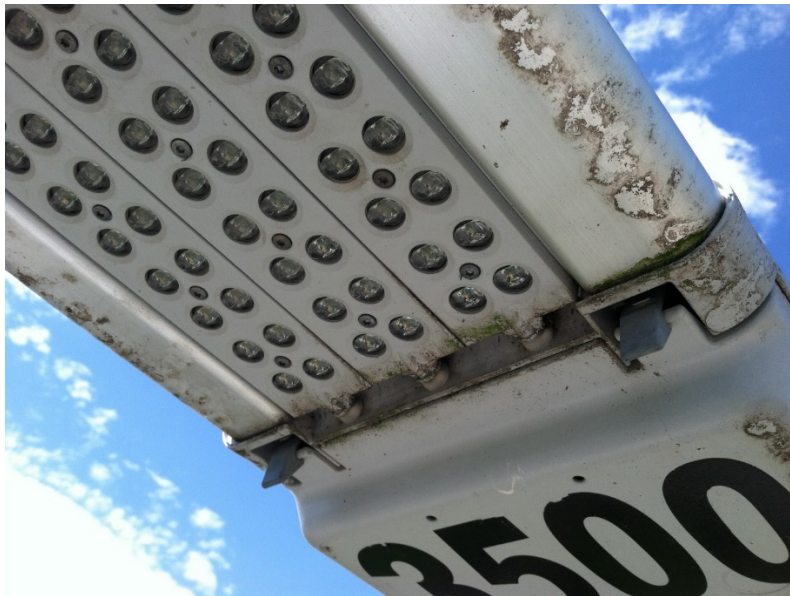
Figure 27. Dirt accumulated on Smart Road LED luminaire type A (3500K).

Observations of the Smart Road luminaires before cleaning revealed that some had collected significant dirt (Figure 27).

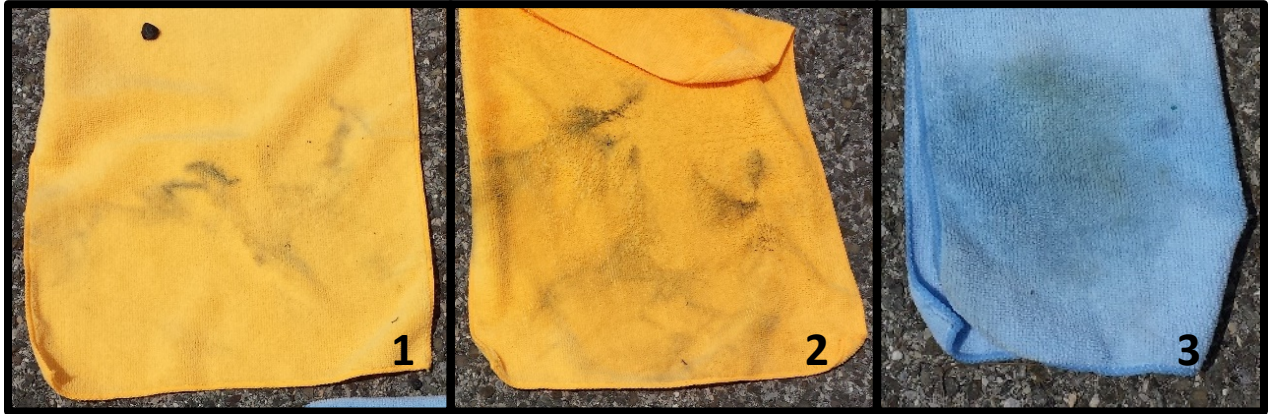
Figure 28. Dirt removed from the luminaires with the first three cleaning methods: (1) dry rag, (2) wet rag, (3) rag with IPA.

Figure 28 shows the dirt left on microfiber rags after they were used to clean a single luminaire using the three cleaning methods requiring a rag. The dirt removed with the dry rag and wet rag was dark grey. The dirt removed with the rag with IPA was more yellow-brown.

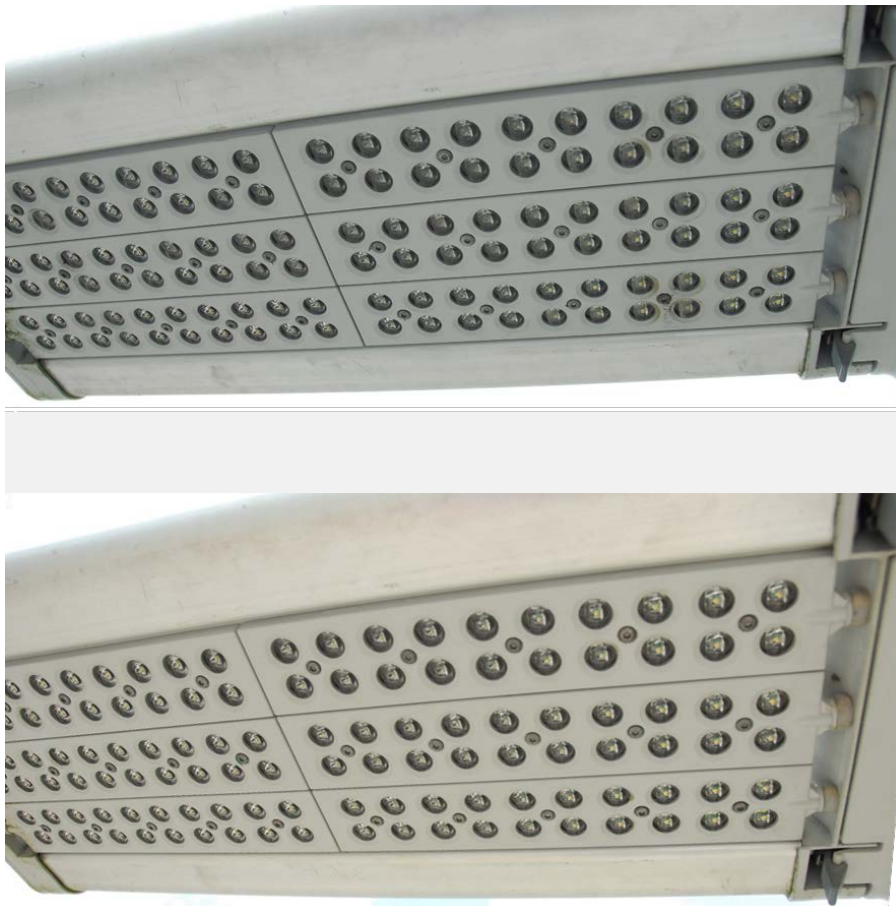
Figure 29. Smart Road LED luminaire before (top) and after (bottom) cleaning with an IPA rag (Cleaning Method 3).

Figure 29 has photographs of a luminaire before and after cleaning with Cleaning Method 3, a rag with IPA. The luminaire's metal casing appears cleaner, but it is difficult to see a difference on the optics.

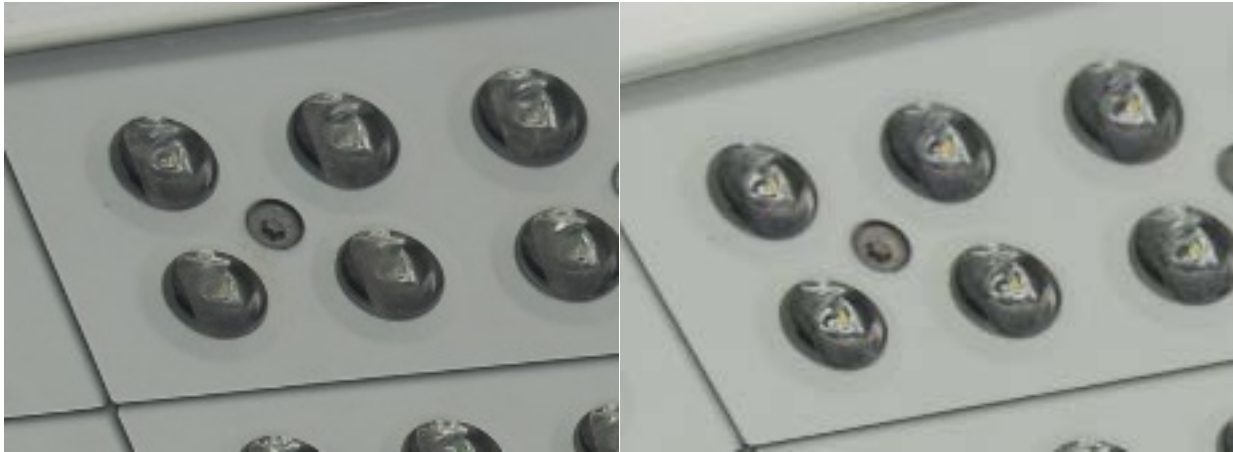
Figure 30. Smart Road LED luminaire before (left) and after (right) cleaning with an IPA rag (Cleaning Method 3), clearly showing removal of gray-colored dirt from the optics.

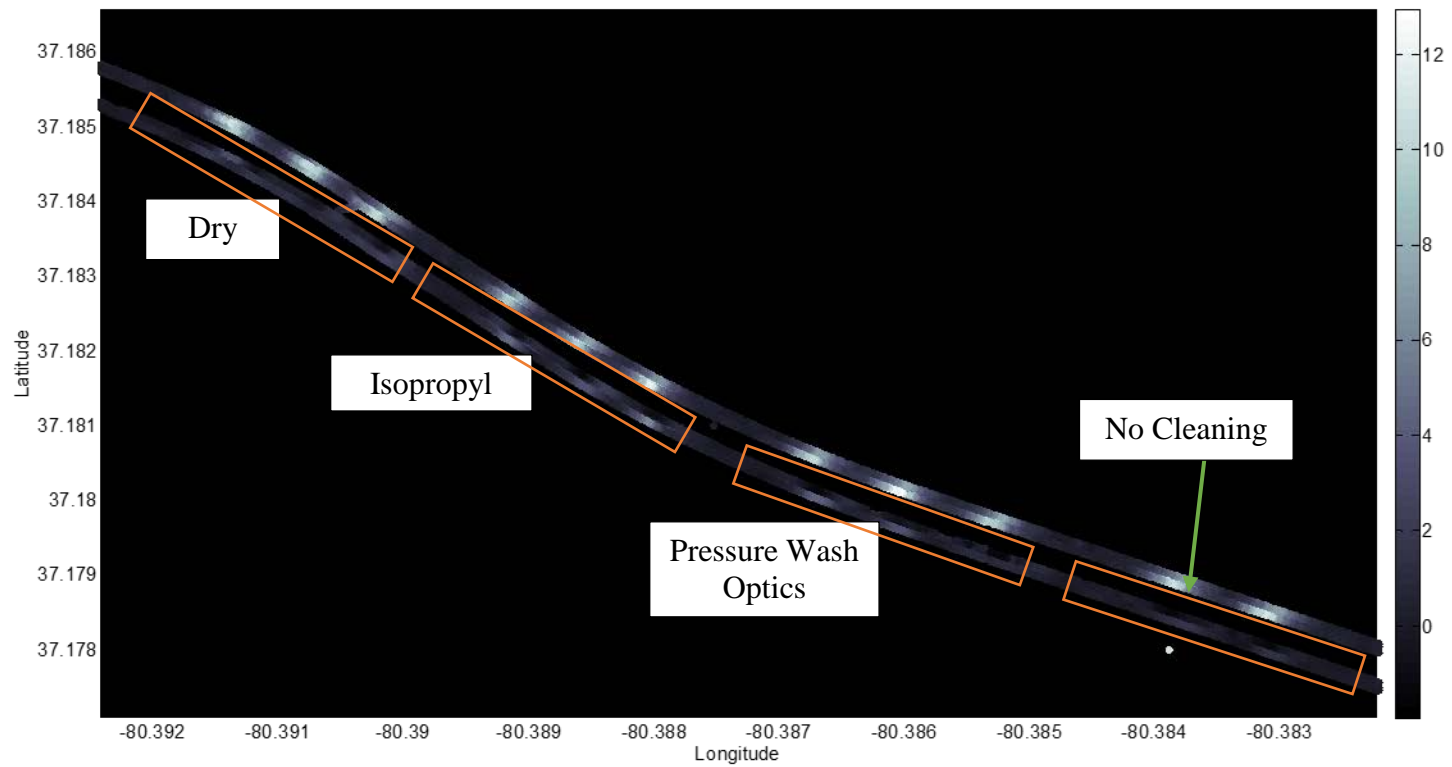
Figure 31. Illuminance vs. latitude and longitude on the Smart Road. Top trace is the illuminance before cleaning. Lower trace is the difference between before and after cleaning. Bottom trace was displaced downward by 0.0005° longitude for display purposes. Gray scale is in lux (lx).

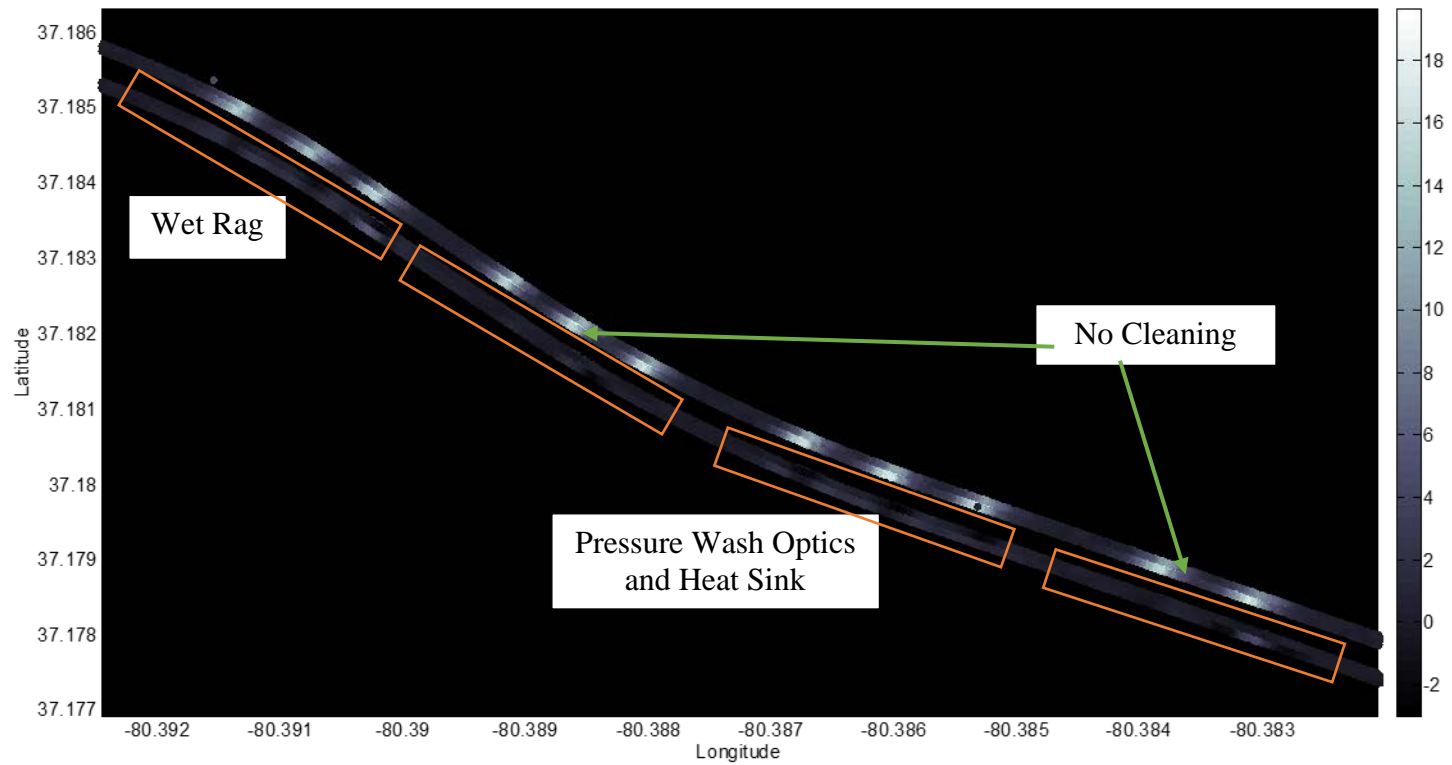
Figure 32. Illuminance vs. latitude and longitude on the Smart Road. Top trace is the illuminance before cleaning. Lower trace is the difference between before and after cleaning. Bottom trace was displaced downward by 0.0005° longitude for display purposes. Gray scale is in lux (lx).

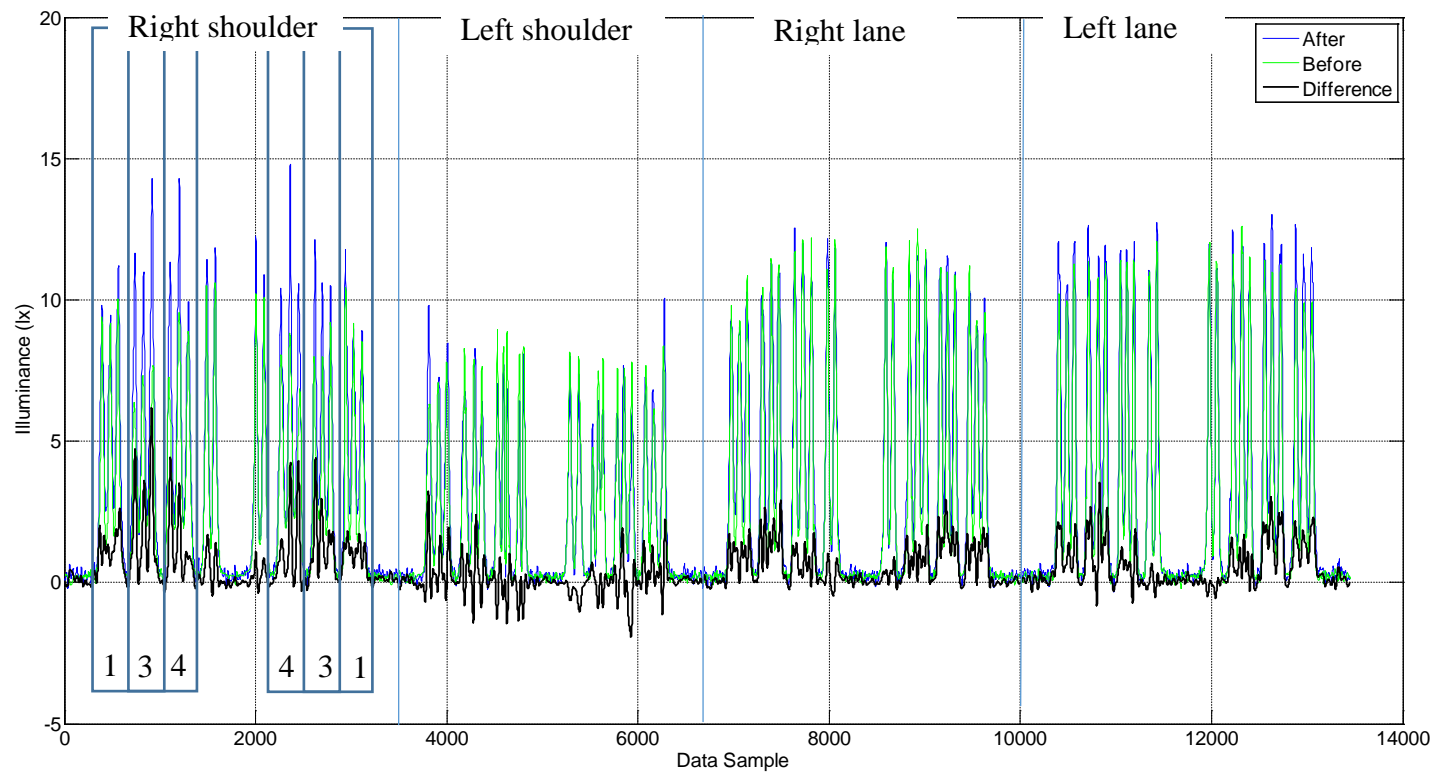
Figure 33. Type A luminaire (3500K) data. From left to right, the groupings are right shoulder for two laps, traveling southeast, and then a return traveling northwest, left shoulder for two laps, right lane for two laps, and left lane for two laps. Each box shows a group of three luminaires, the after, and before measurement with the difference in black. The boxes are numbered with the cleaning method used. The biggest effect appears to be in the right shoulder (far shoulder).

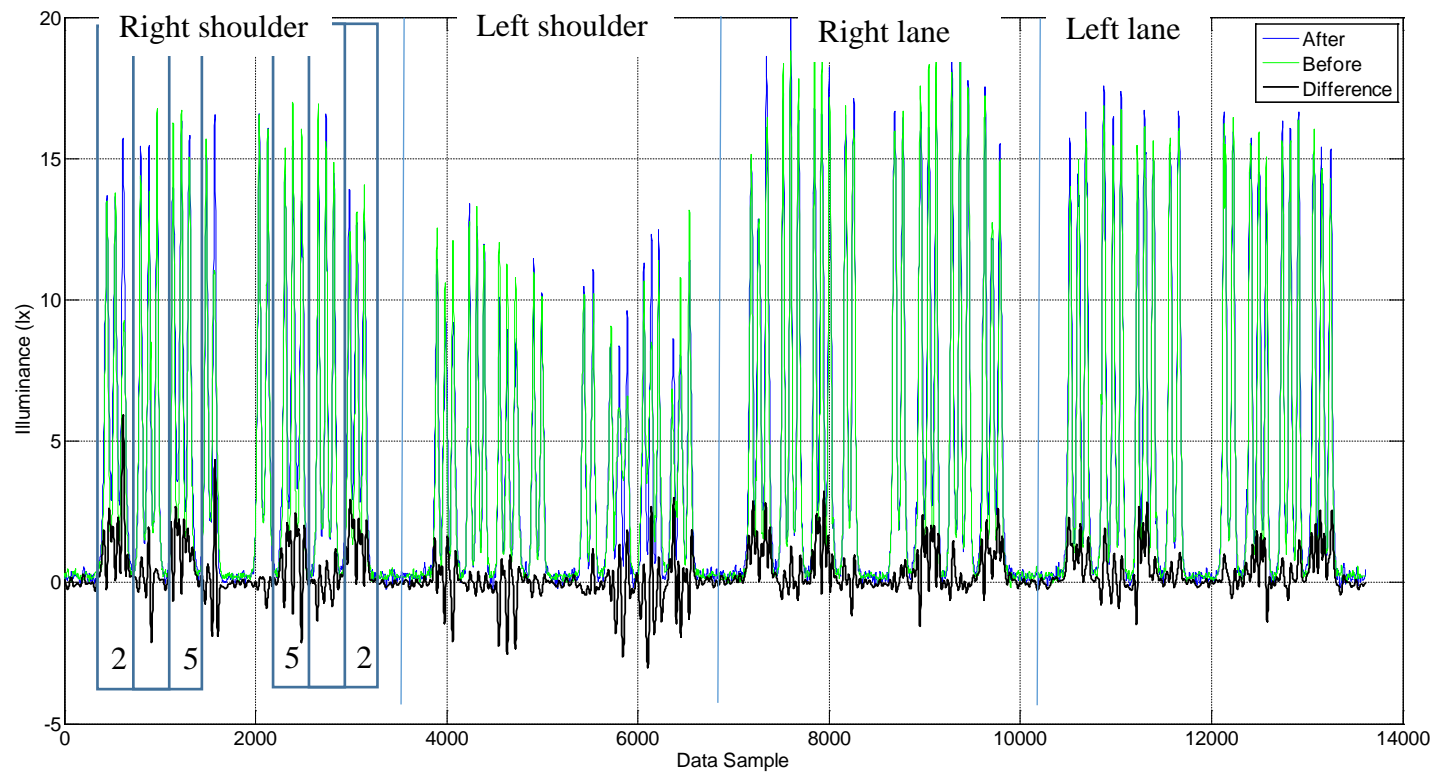
Figure 34. Type A luminaire (6000K) data. From left to right, the groupings are right shoulder for two laps, traveling southeast, and then a return traveling northwest, left shoulder for two laps, right lane for two laps, and left lane for two laps. Each box shows a group of three luminaires. The before and after horizontal illuminance measurements are shown with the difference in black. The boxes are numbered with the cleaning method used. Again the biggest effect appears to be in the right shoulder (far shoulder).

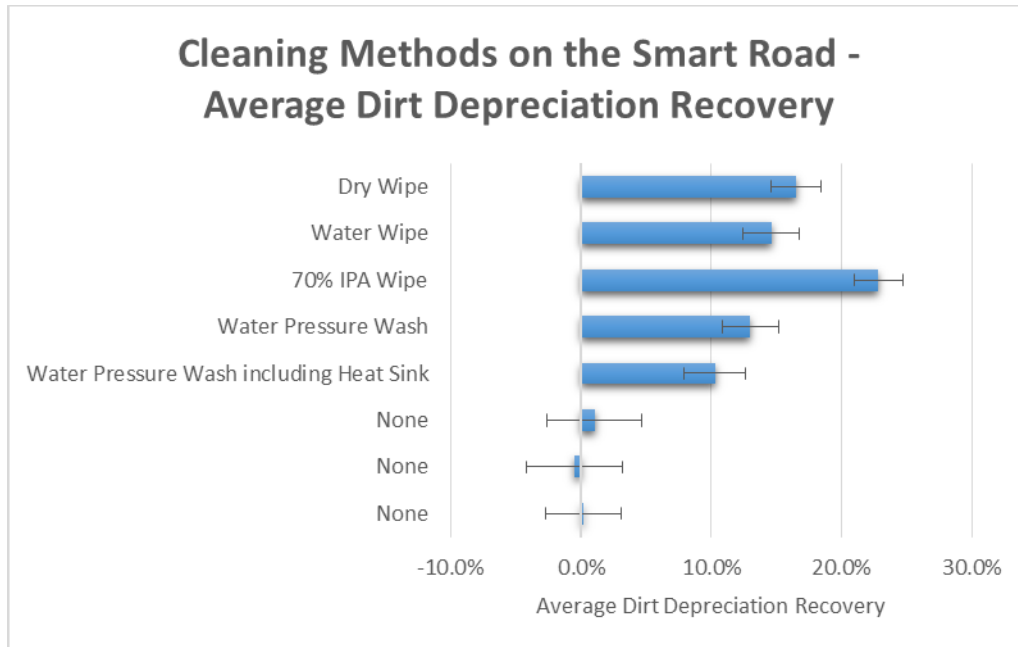
Figure 35. Cleaning method results in terms of average dirt depreciation recovery. The three controls were included as a measure of the measurement accuracy. The error bars indicate standard error, while the “None” bars indicate specific errors in the control measurements.

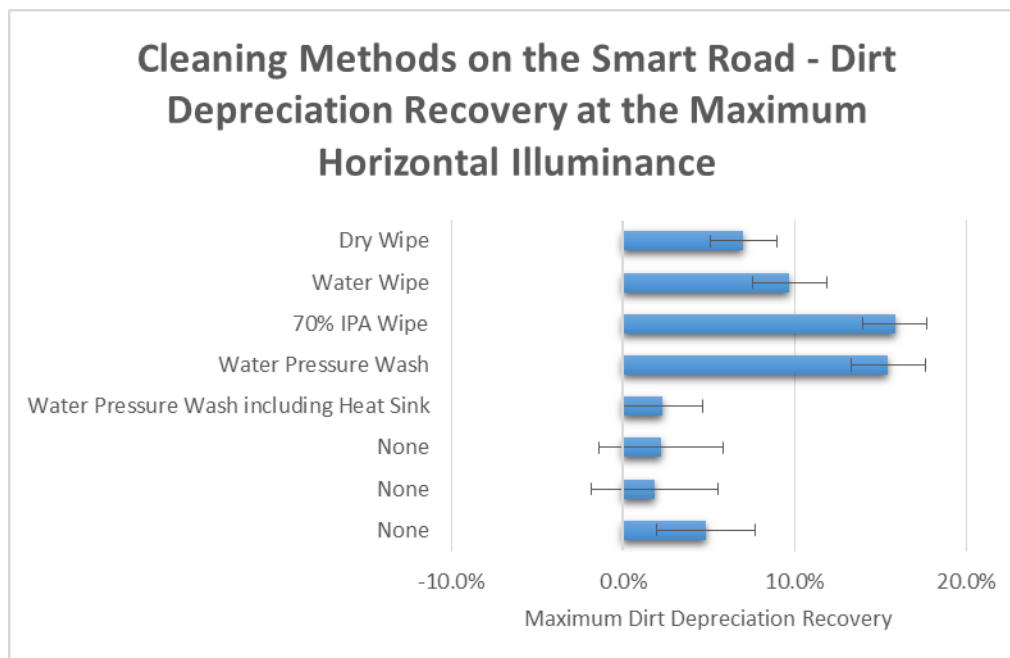
Figure 36. Cleaning method results in terms of dirt depreciation recovery at the point of maximum horizontal illuminance. The three controls were included as a measure of the measurement accuracy.

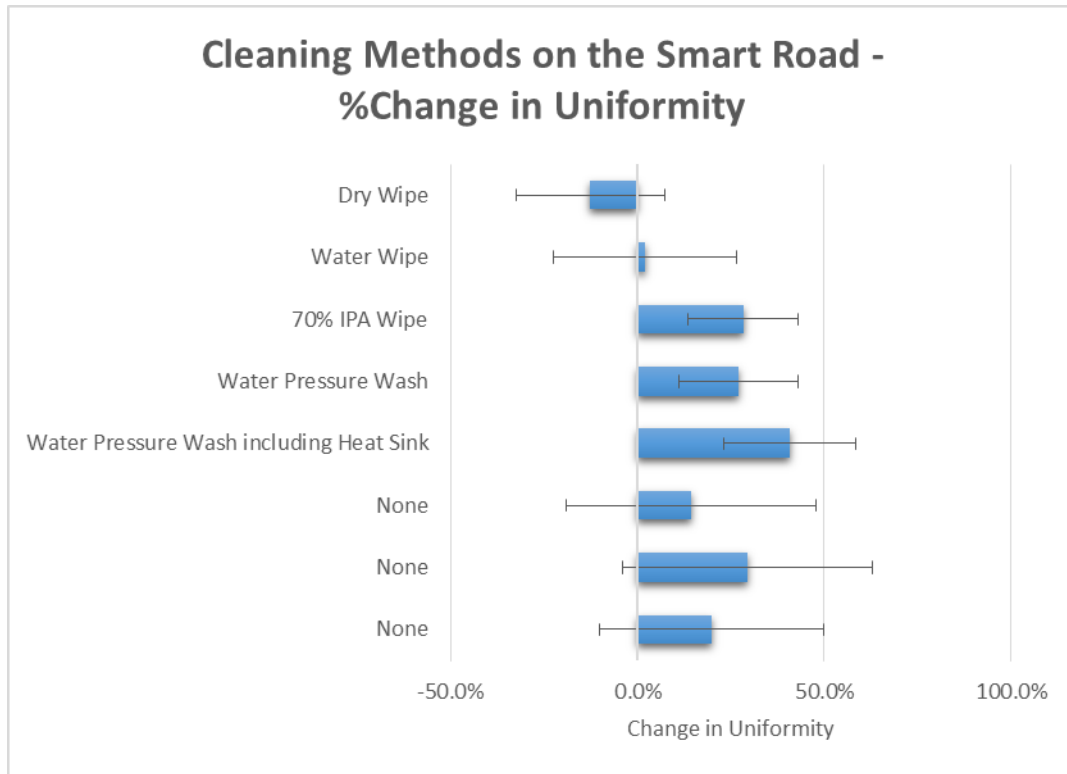
Figure 37. Uniformity change due to cleaning and error in the measurement.

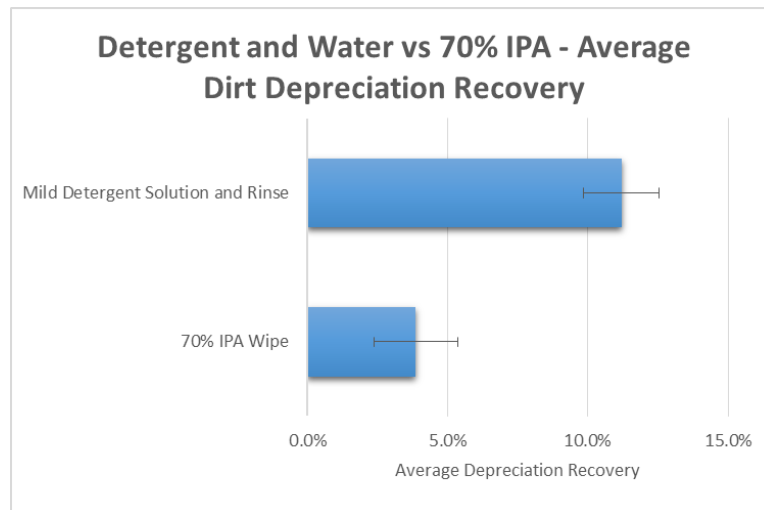
Figure 38. Cleaning method results in terms of average dirt depreciation recovery. These are results from the Hampton field study.

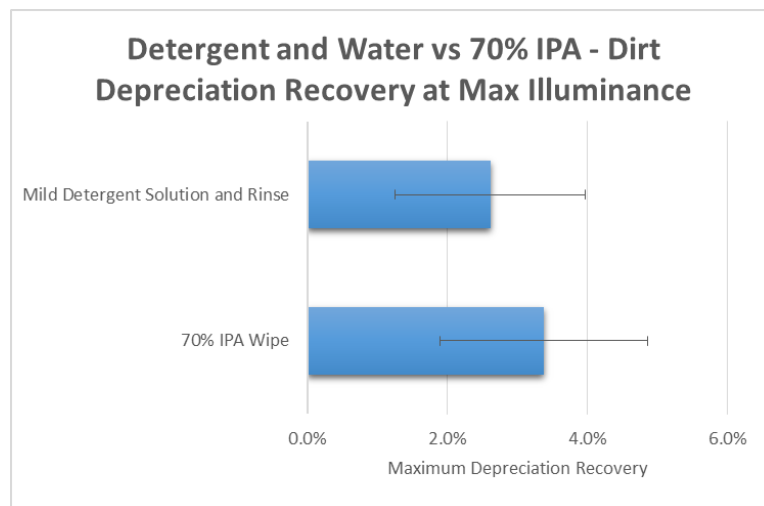
Figure 39. Cleaning method results in terms of maximum dirt depreciation recovery. These are results from the Hampton field study.

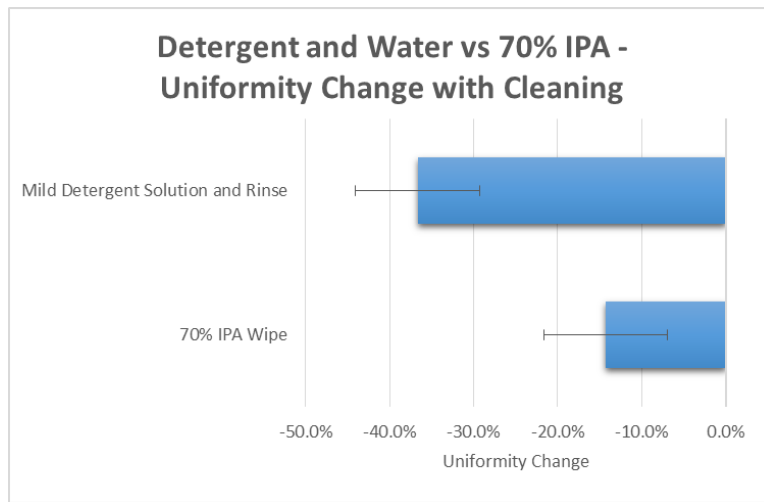
Figure 40. Cleaning method results in terms uniformity change. These are results from the Hampton field study.

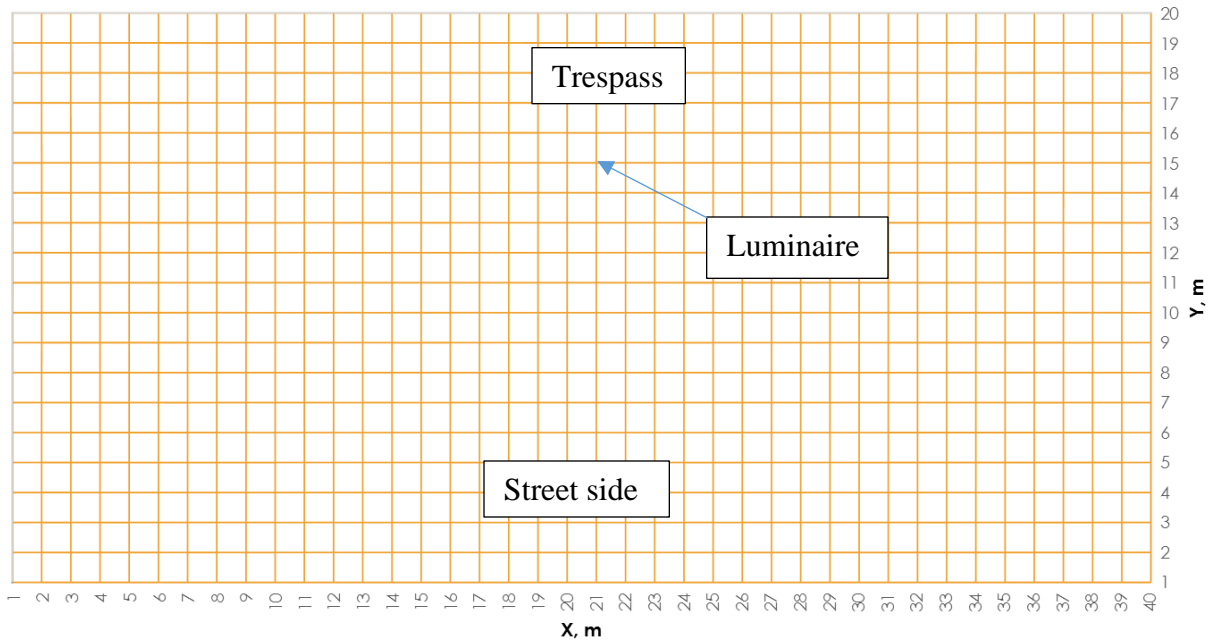
Figure 42. Horizontal and vertical illuminance measurement locations on the laboratory study measurement grid.
