Measure and Report Luminaire Dirt Depreciation (LDD) in LED Luminaires for Street and Roadway Lighting Applications

**Final Report prepared for the
Illuminating Engineering Society of North America**

January 2016

**Center for Infrastructure-Based Safety Systems
Virginia Tech Transportation Institute
3500 Transportation Research Plaza
Blacksburg, Virginia**

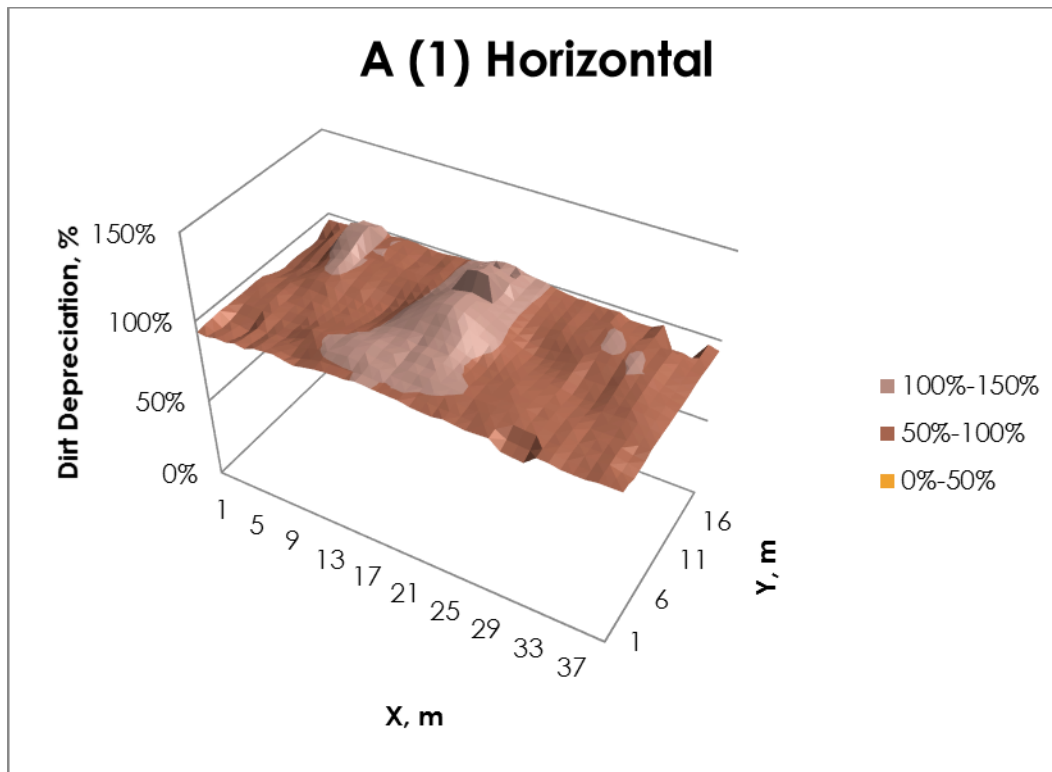
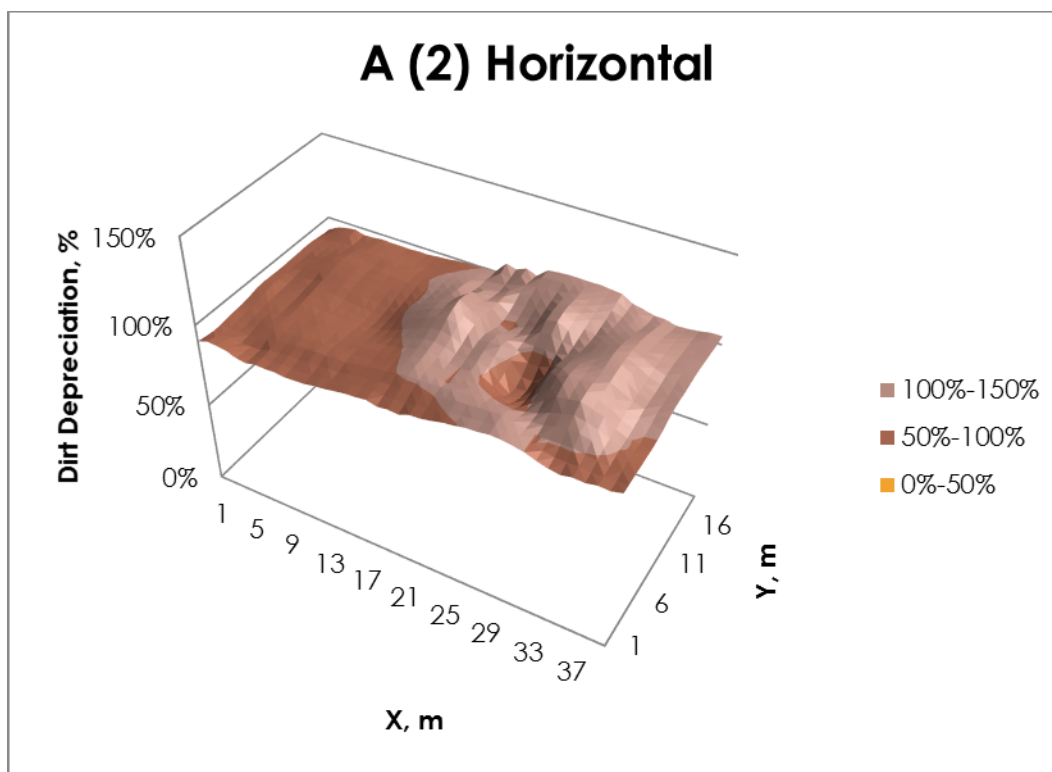
Figure 43. Horizontal dirt depreciation for two Design A luminaires with individual acrylic optical elements.

More interesting is the pattern of light loss. For both luminaires the light was redistributed by the dirt accumulation to increase the lighting approximately 8 m from the centerline and 5 m in front of the luminaire while losing the most light 4 m directly in front of the luminaire. This is likely due to the dirt on the optics reflecting or scattering most of the light back into the luminaire as opposed to absorbing it. This results in a distribution with higher than 100% output in some locations for the dirty luminaire. This was found to be true for nearly all the LED luminaires. Also of note, the dirt accumulation in the park and ride resulted in different light patterns in each pair of identical luminaires. Therefore, the pattern changes may be difficult to predict a priori.

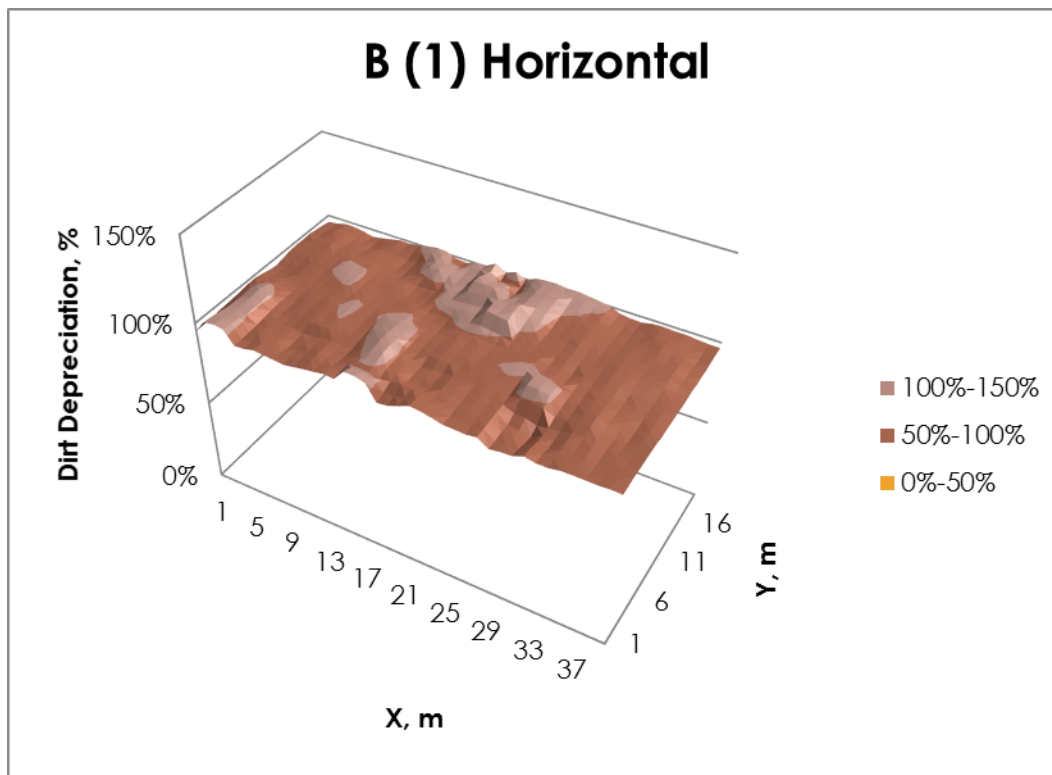
Figure 44. Design B(1) horizontal dirt depreciation in percentage of clean light output.

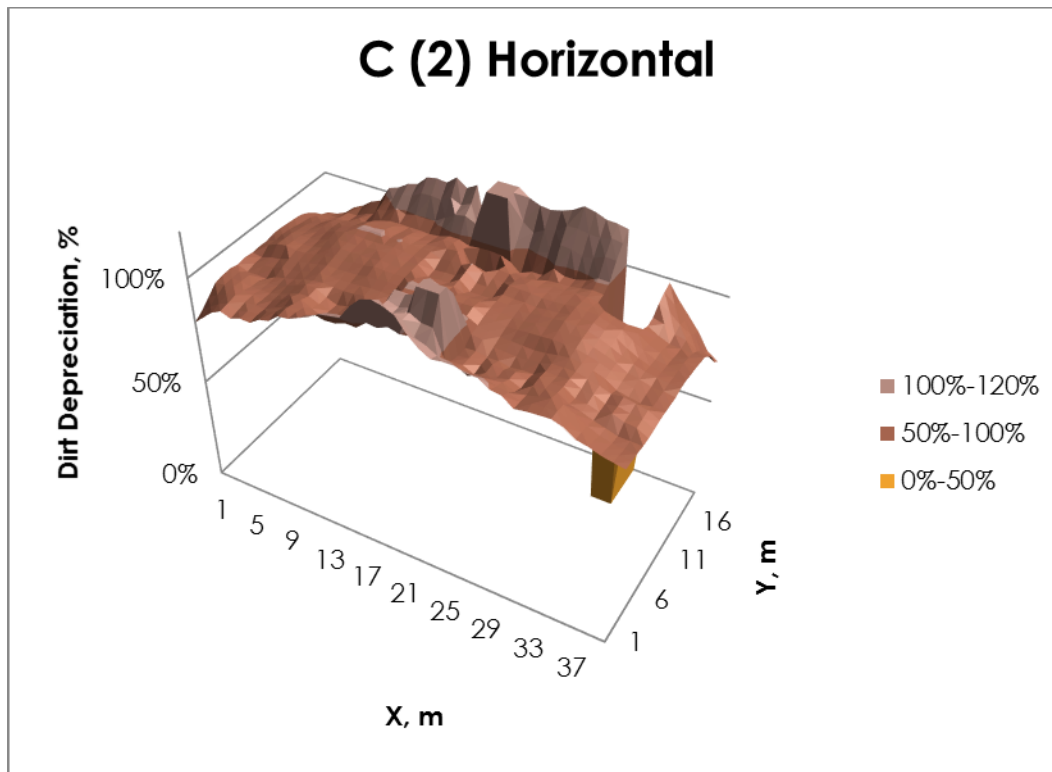
Figure 45. Design C(2) horizontal dirt depreciation in percentage of clean light output.

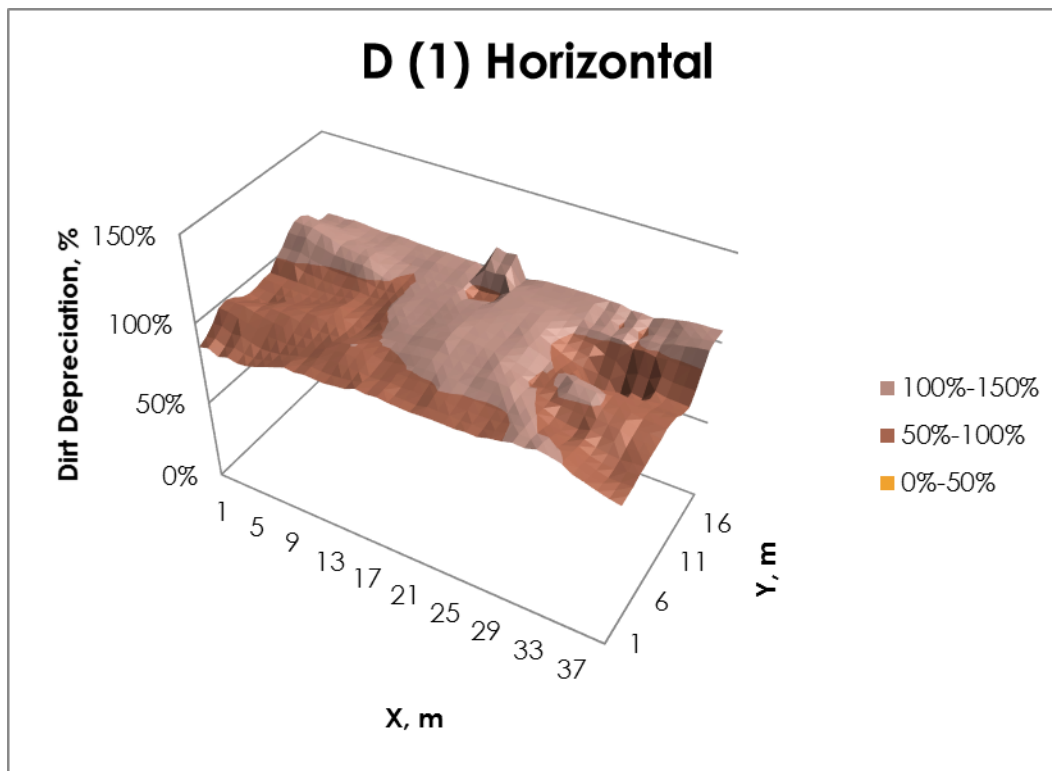
Figure 46. Design D(1) horizontal dirt depreciation in percentage of clean light output.

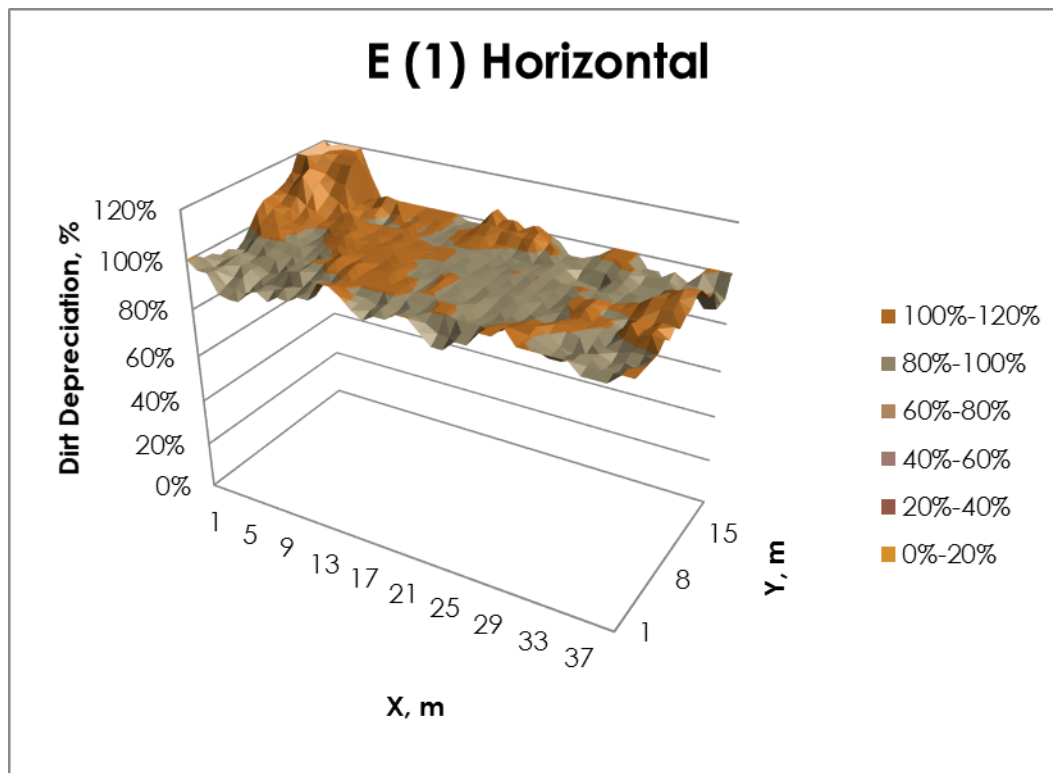
Figure 47. Design E(1) horizontal dirt depreciation in percentage of clean light output.

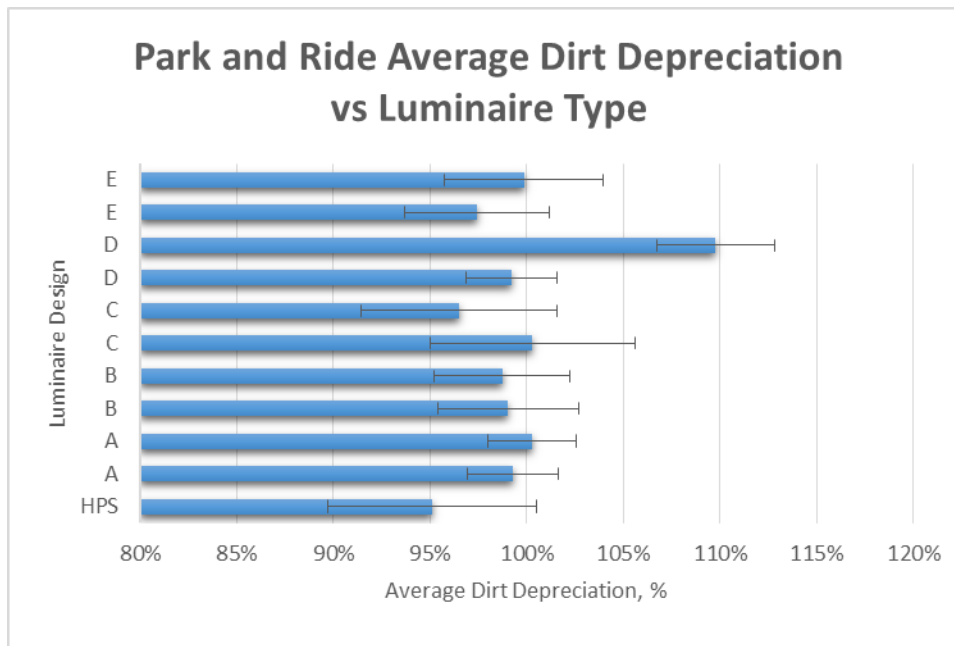
Figure 48. Average dirt depreciation vs. types of optics. HPS light for comparison.

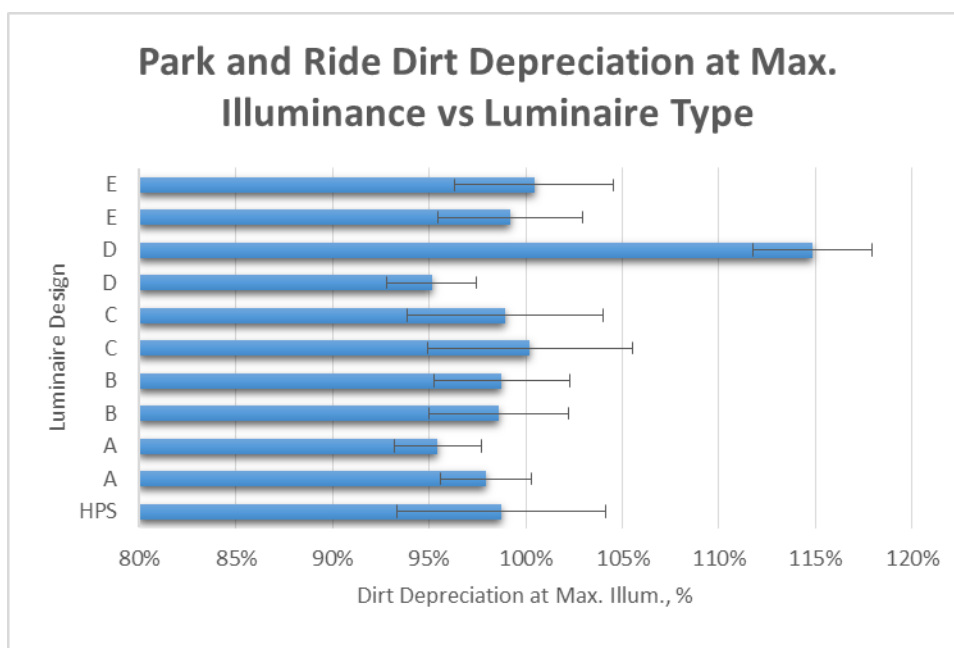
Figure 49. Maximum dirt depreciation vs. type of optics. An HPS light for comparison.

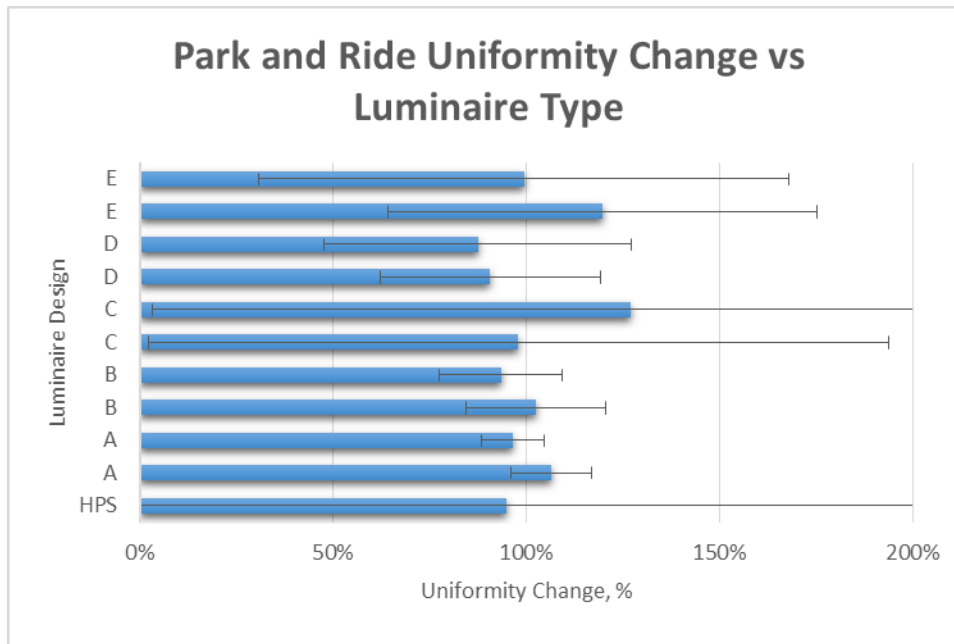
Figure 50. Uniformity change vs. type of optics. An HPS light for comparison.

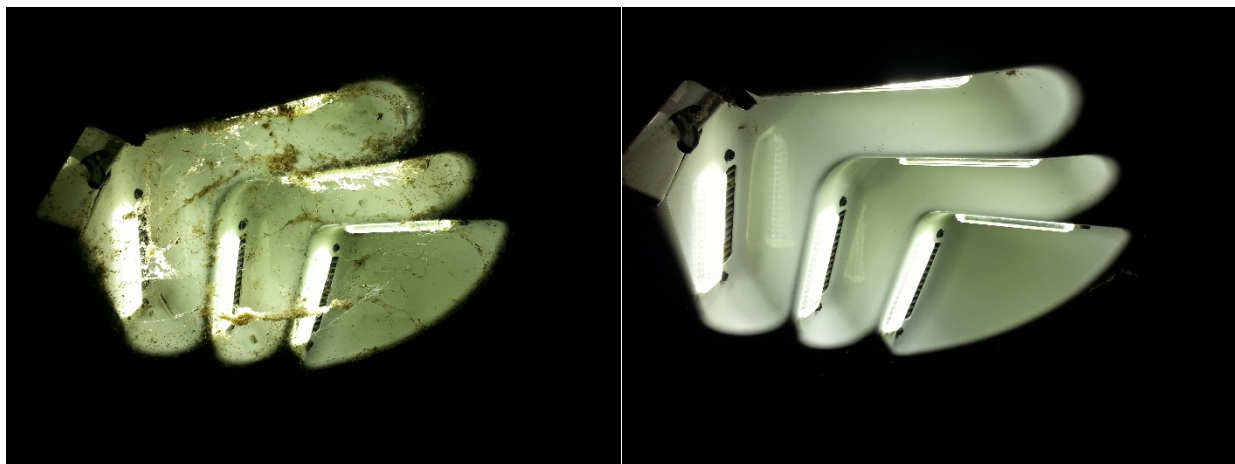
Figure 51. Design F, large molded glass optics and white concave reflector, dirty (left), clean (right)

One of the interesting observations of the Design F luminaire was that many spiders had taken up residence in these luminaires (Figure 51, left) and had built webs across the concave bottom of the luminaire in order to capture food. Presumably, they were able to do this because of the concave nature of the luminaire and due to the temperature of LED luminaire being lower than typical HPS or metal halide luminaires. Proximity to the Kanawha River may have had an influence as there were no spiders observed in the four Design F luminaires installed on I-77.

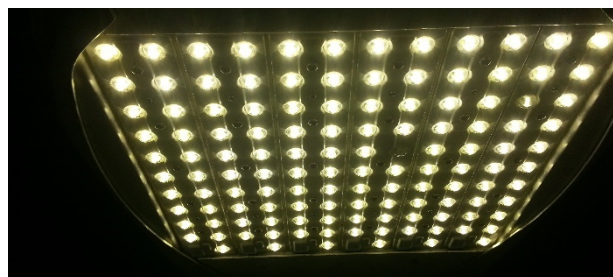
Figure 52. Design G showing failure of one LED unit out of 126.

Other observations included failure of half of one of the Design F luminaires installed on I-77, and failure of one LED out of 126 in one of the two Design G luminaires cleaned (Figure 52).

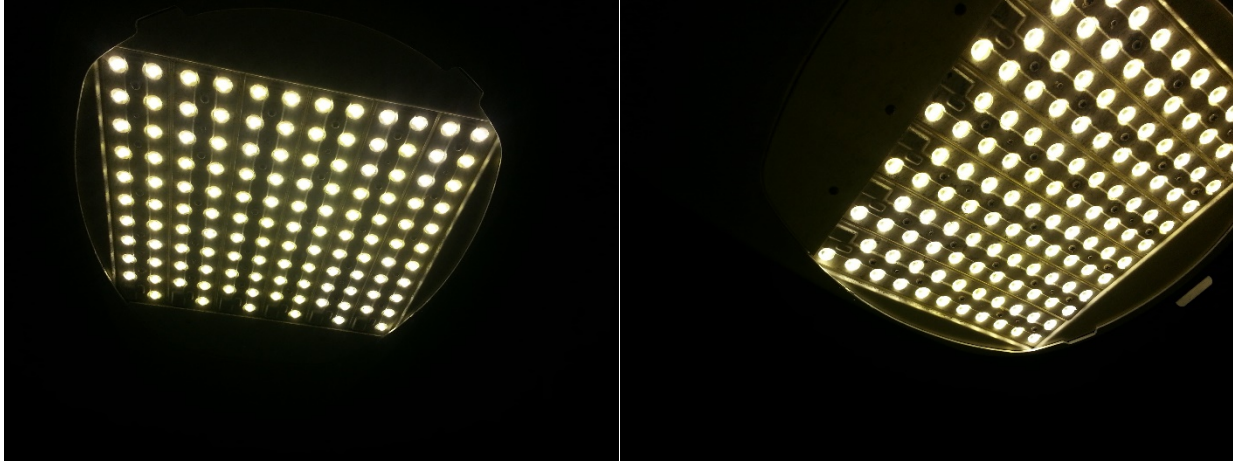
Figure 53. Design G, individual molded plastic optics, dirty (left), clean (right). The photographs do not capture the difference between the dirty and clean very well.

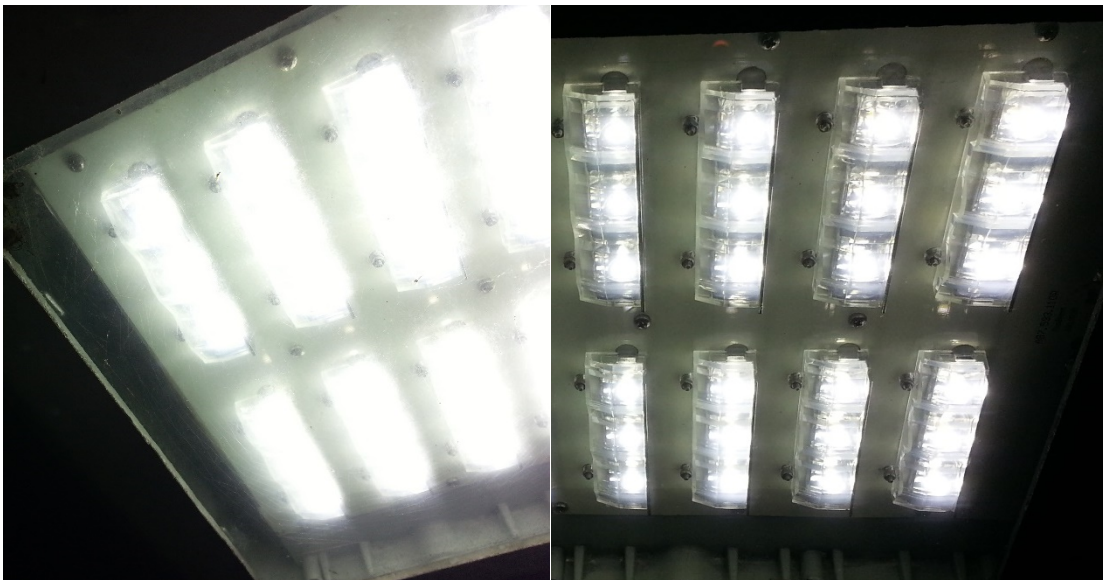
Figure 54. Design J, flat glass over large molded optics, dirty (left), clean (right).

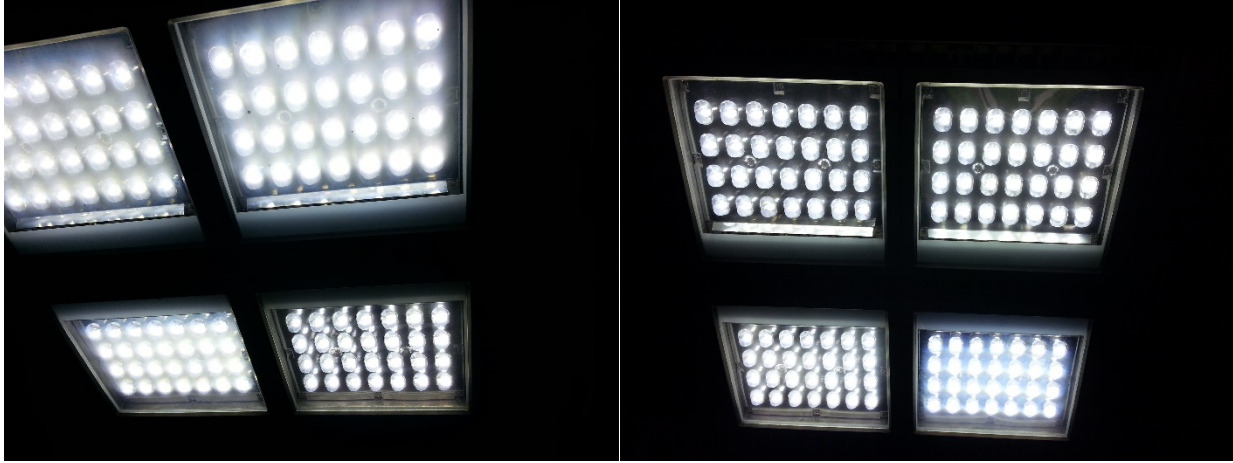
Figure 55. Design K, flat glass optics over individually molded optics, dirty (left), clean (right).

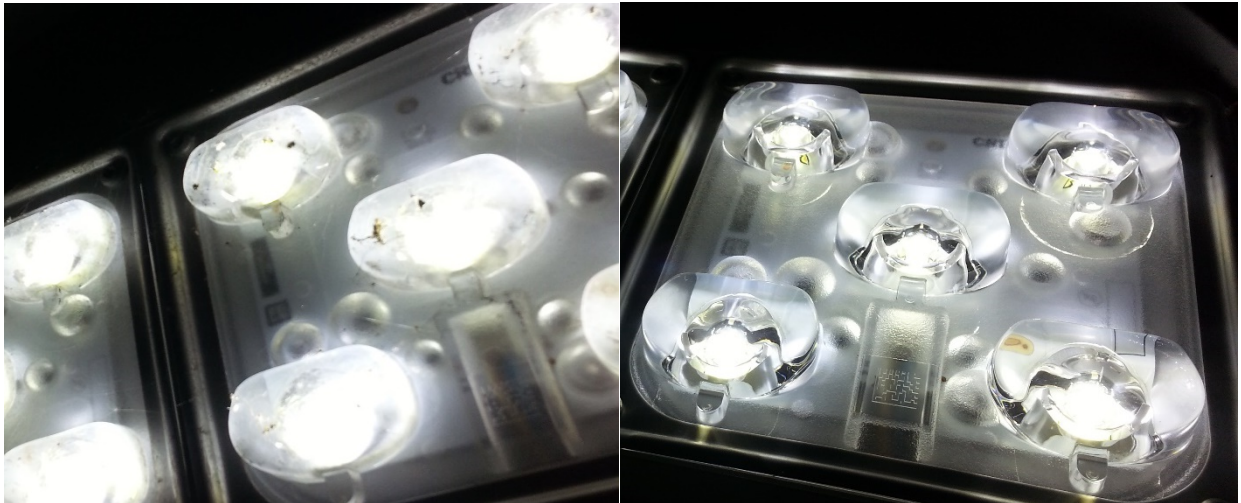
Figure 56: Design L, large individual molded plastic optics: dirty (left) and clean (right).

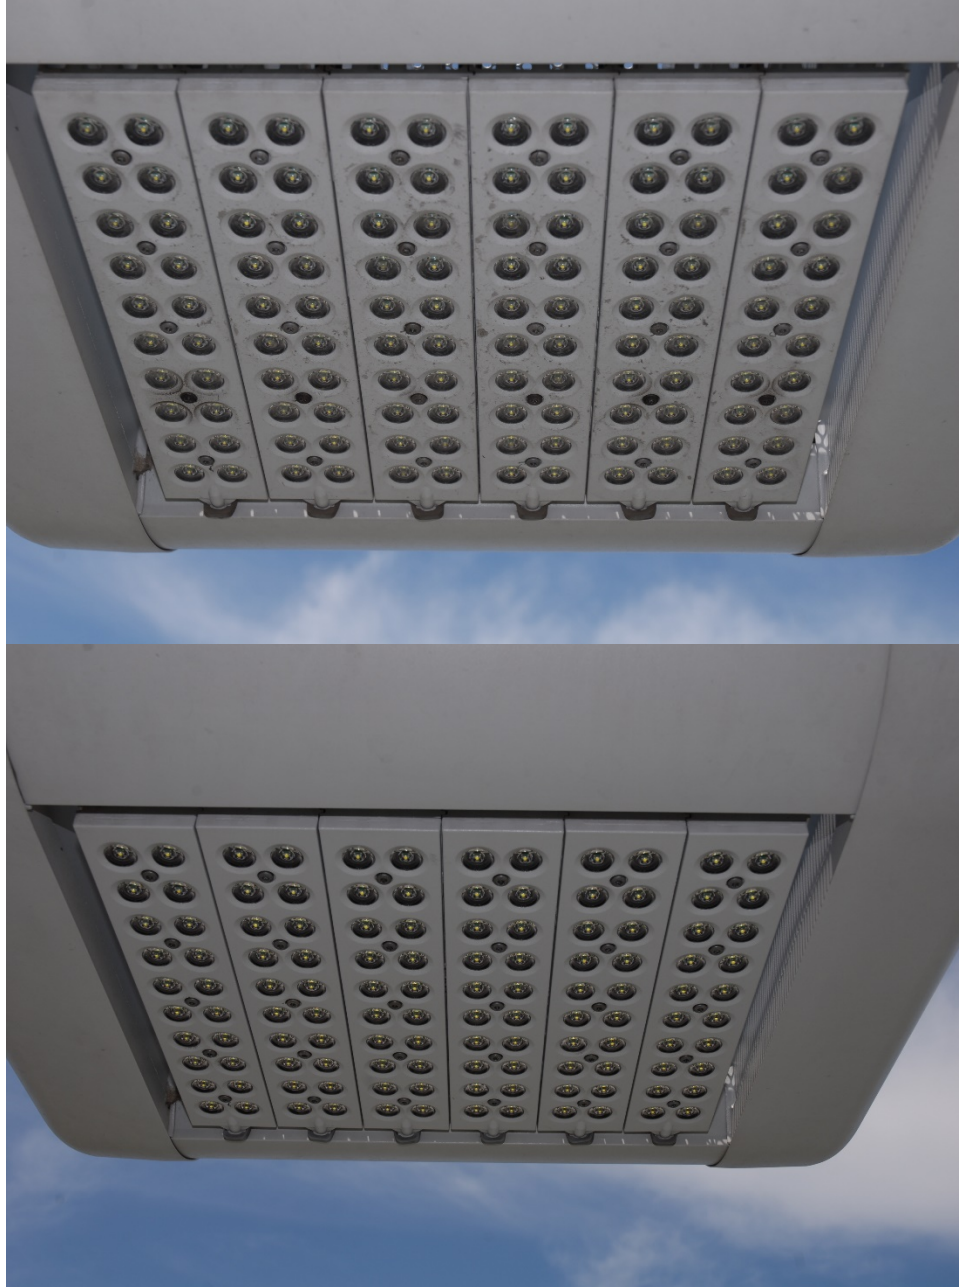
Figure 59. I-35W luminaire before cleaning (top) and after (bottom). The dirt is difficult to see on the optics.

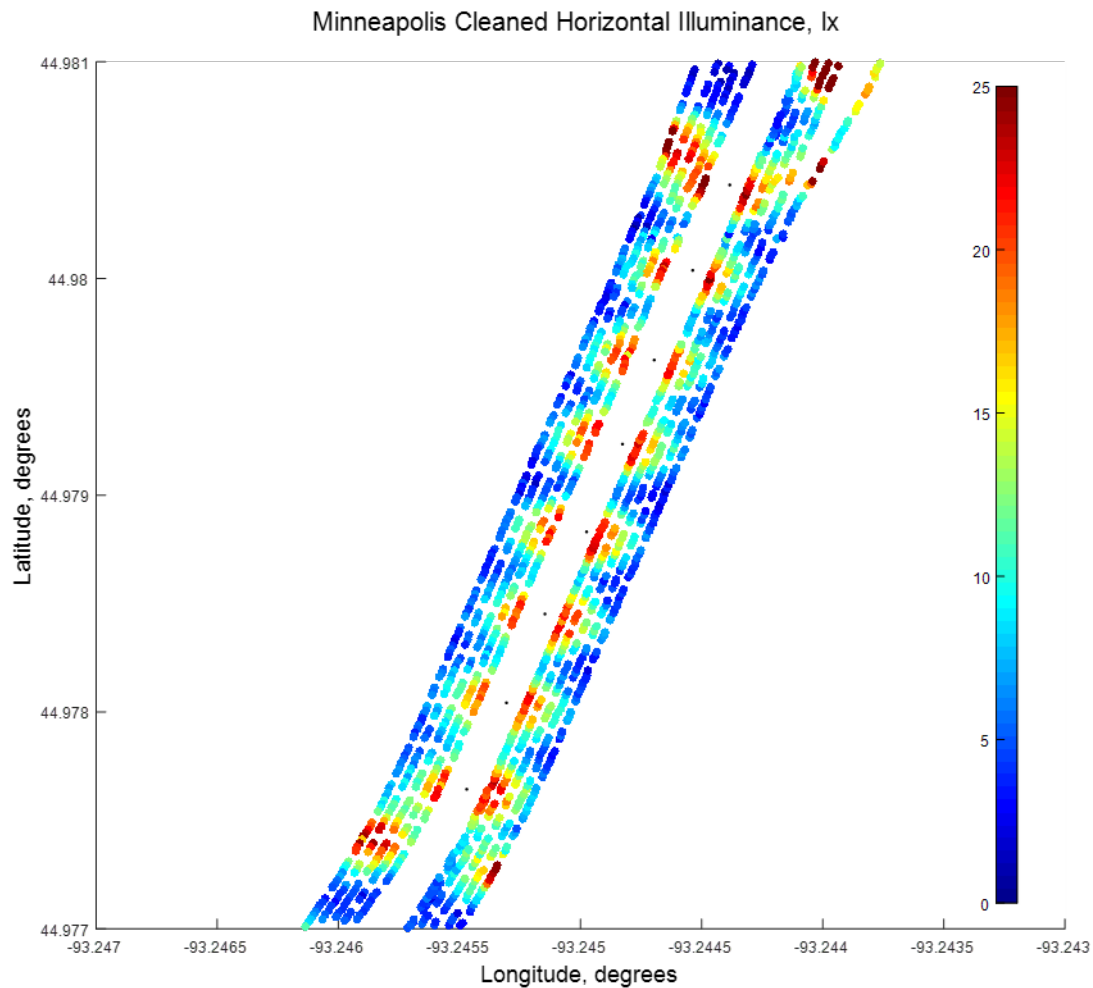
Figure 60. Minneapolis I-35W cleaned horizontal illuminance preliminary data.

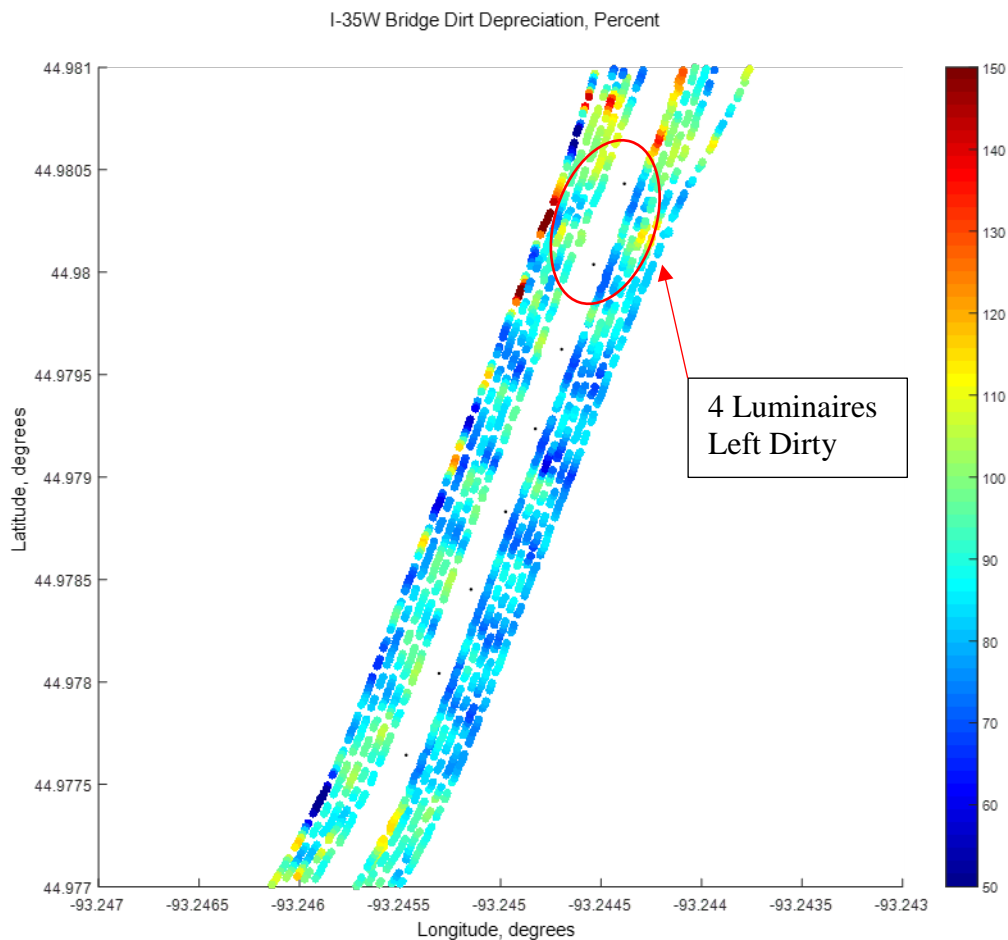
Figure 61. I-35W bridge dirt depreciation results in percentage of original illuminance value.

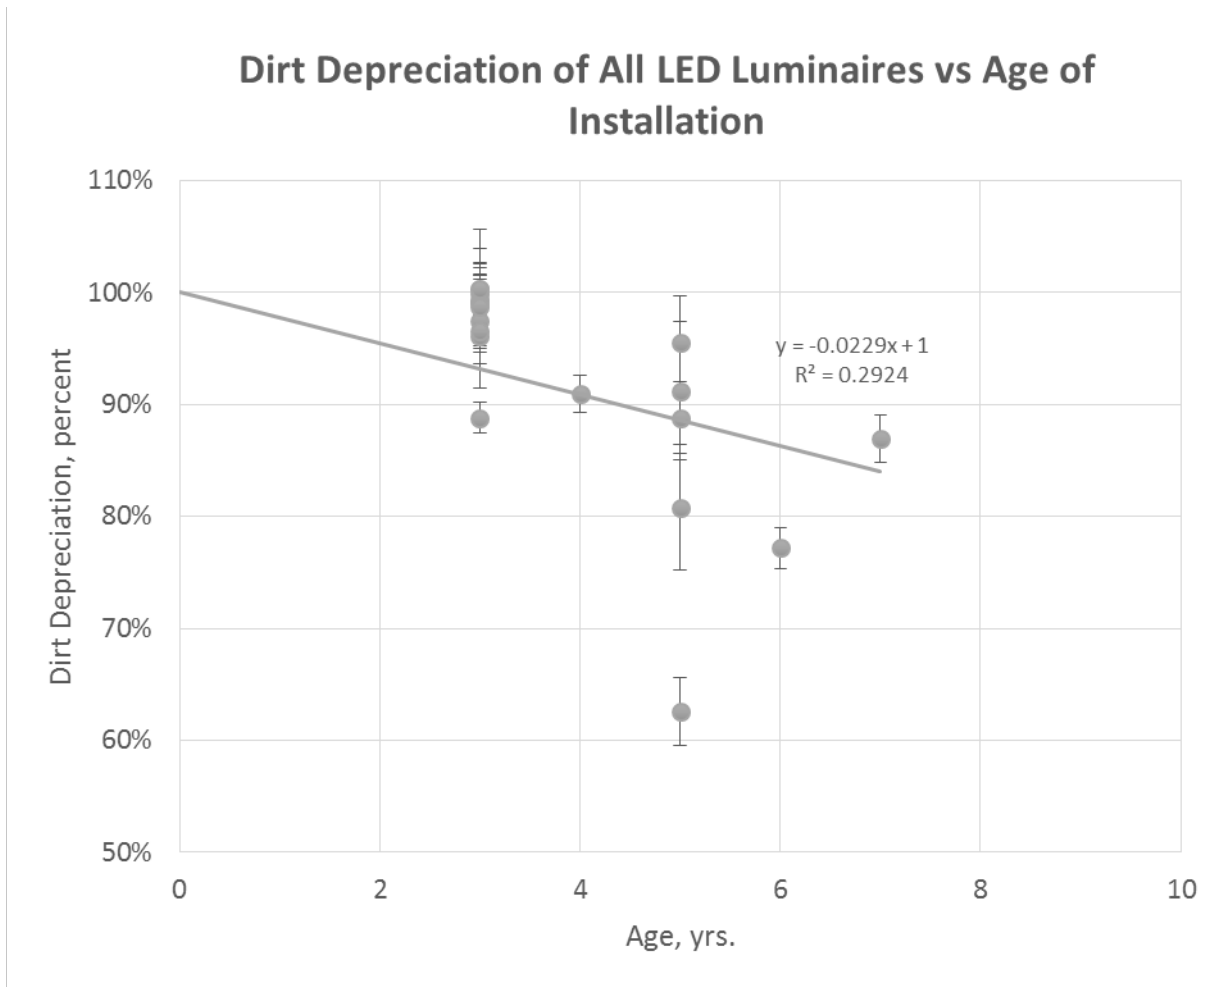
Figure 62. Average dirt depreciation vs. age for all LED luminaires sampled.

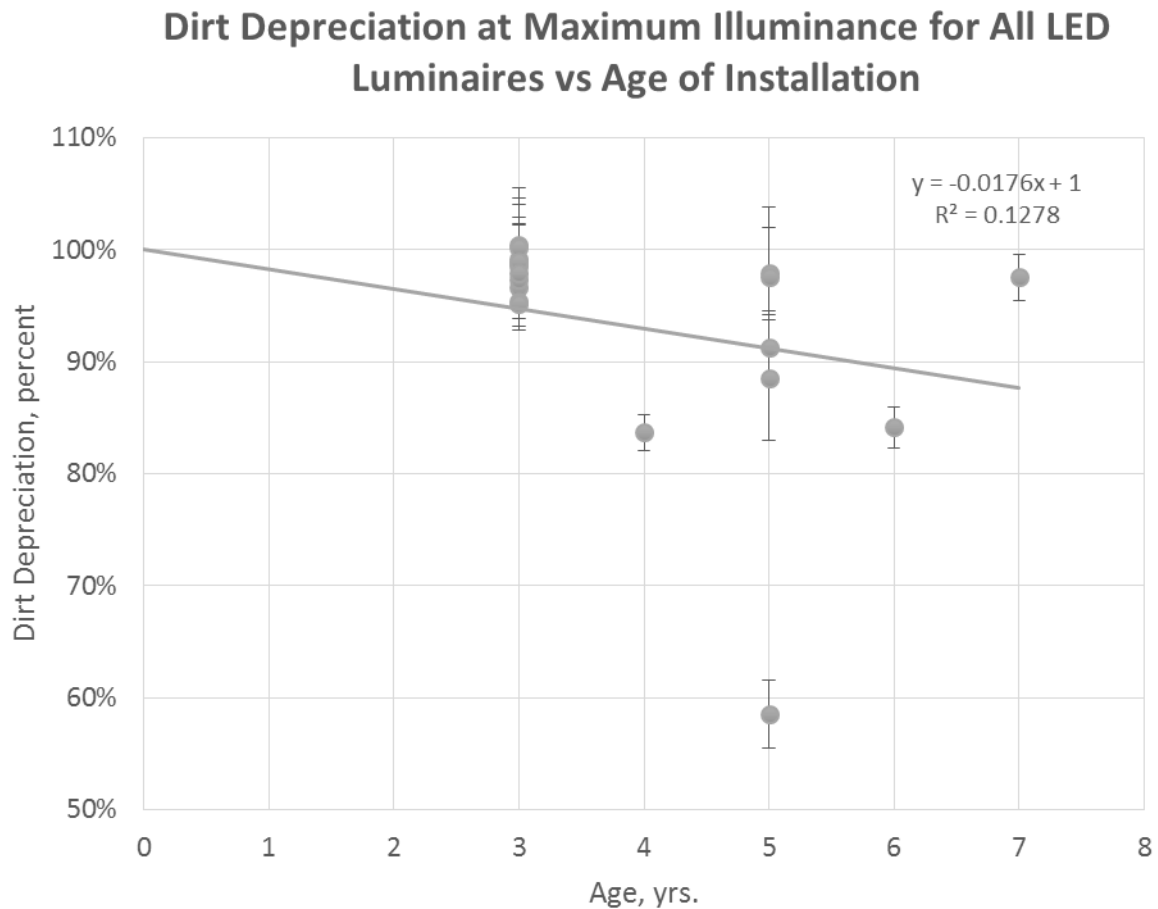
Figure 63. Dirt depreciation at maximum illuminance vs. age for all LED luminaires sampled.

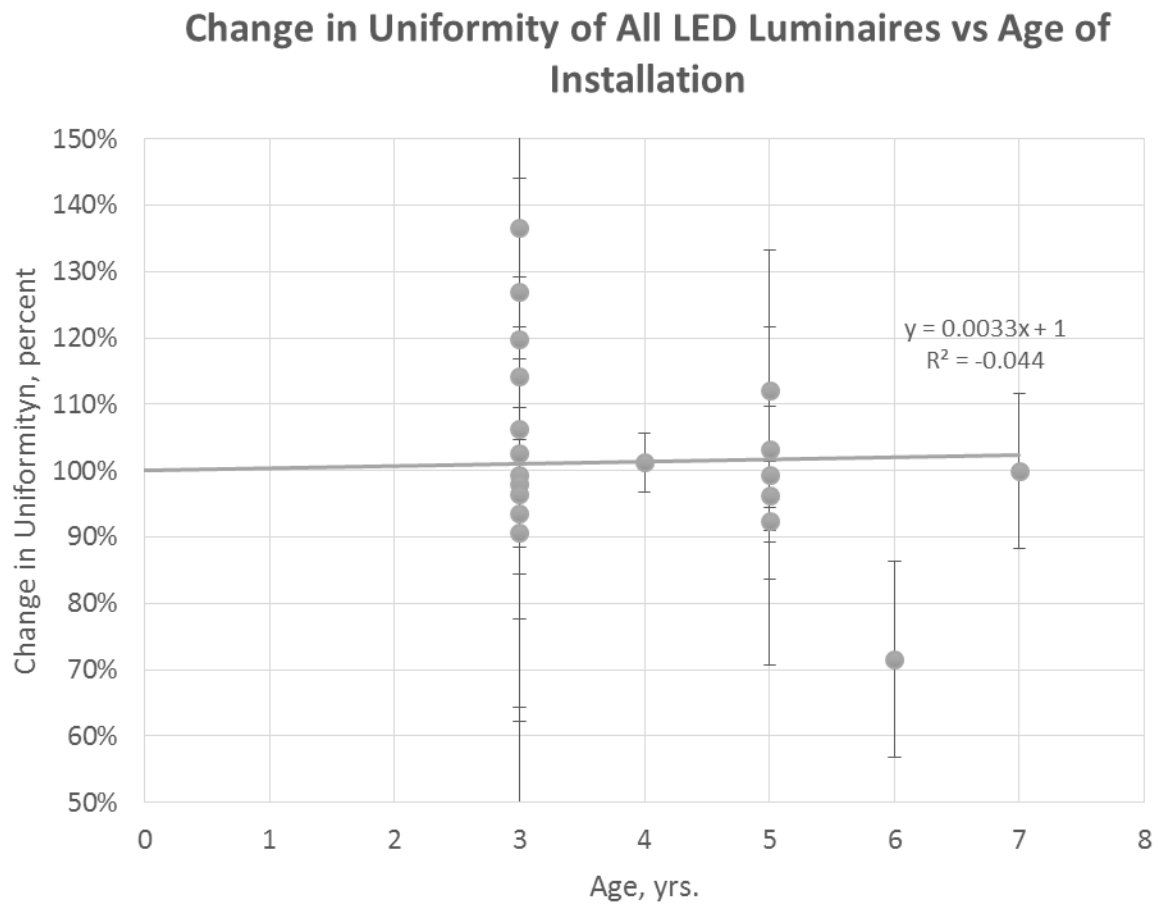
Figure 64. Change in uniformity vs. age for all LED luminaires sampled.

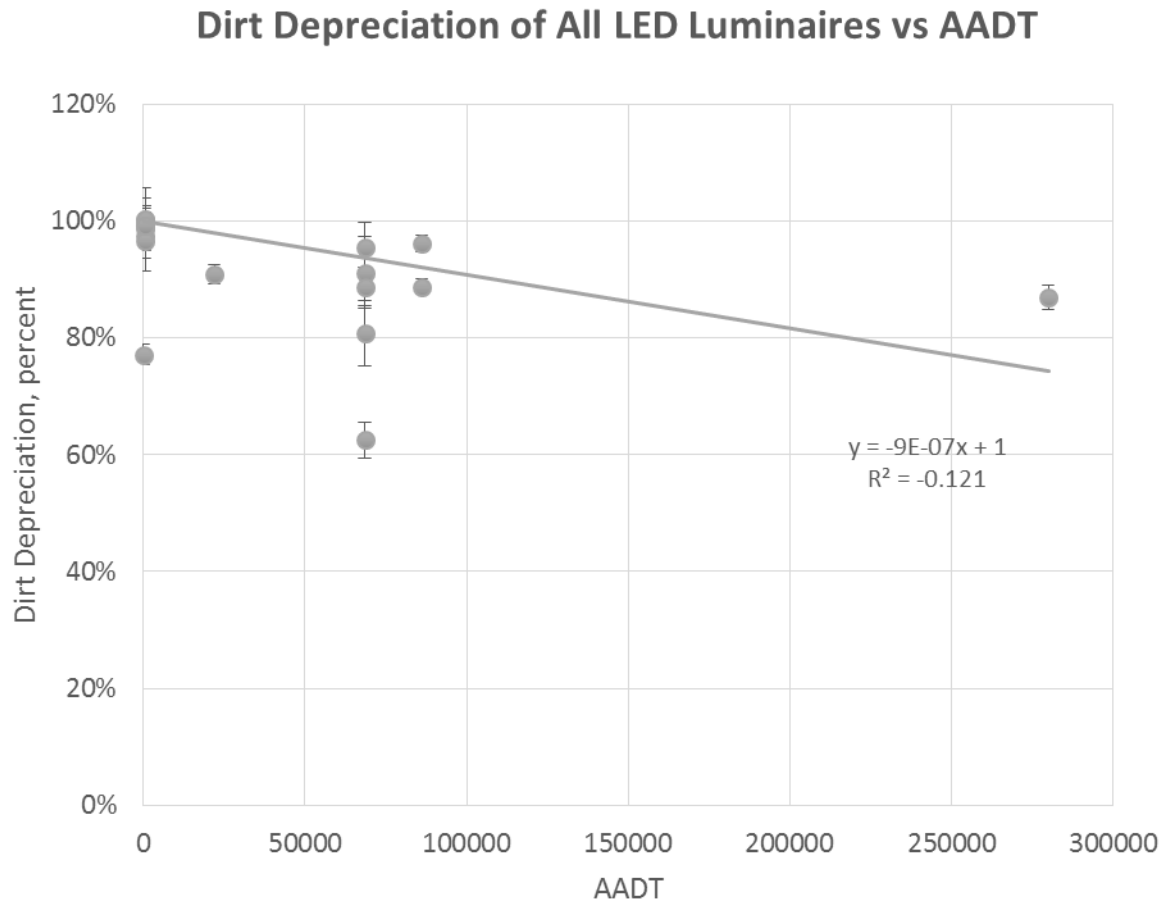
Figure 65. Average dirt depreciation vs. AADT for all LED luminaires sampled.

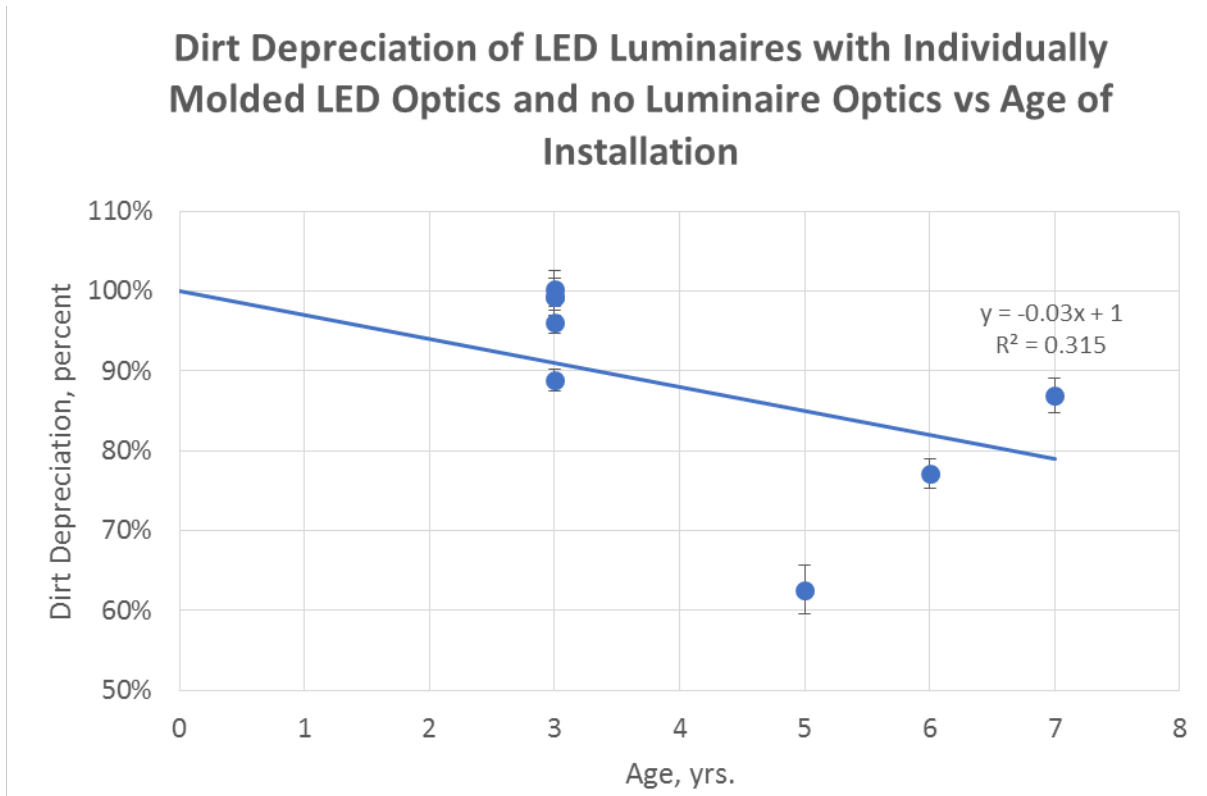
Figure 66. Dirt depreciation for individual molded acrylic optics and no luminaire optics (i.e., Designs A, D, and G).

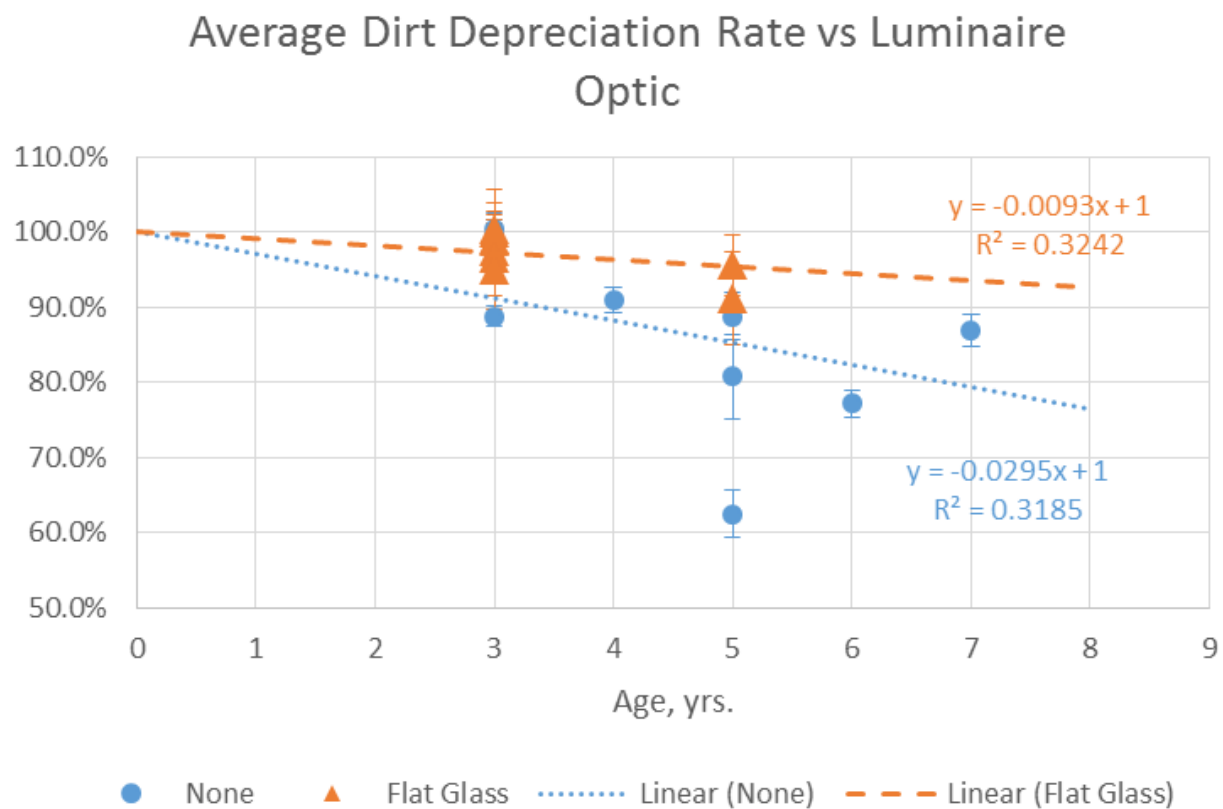
Figure 67. Average dirt depreciation rate vs. age for all samples versus the outer optic, categorized into flat glass or none.

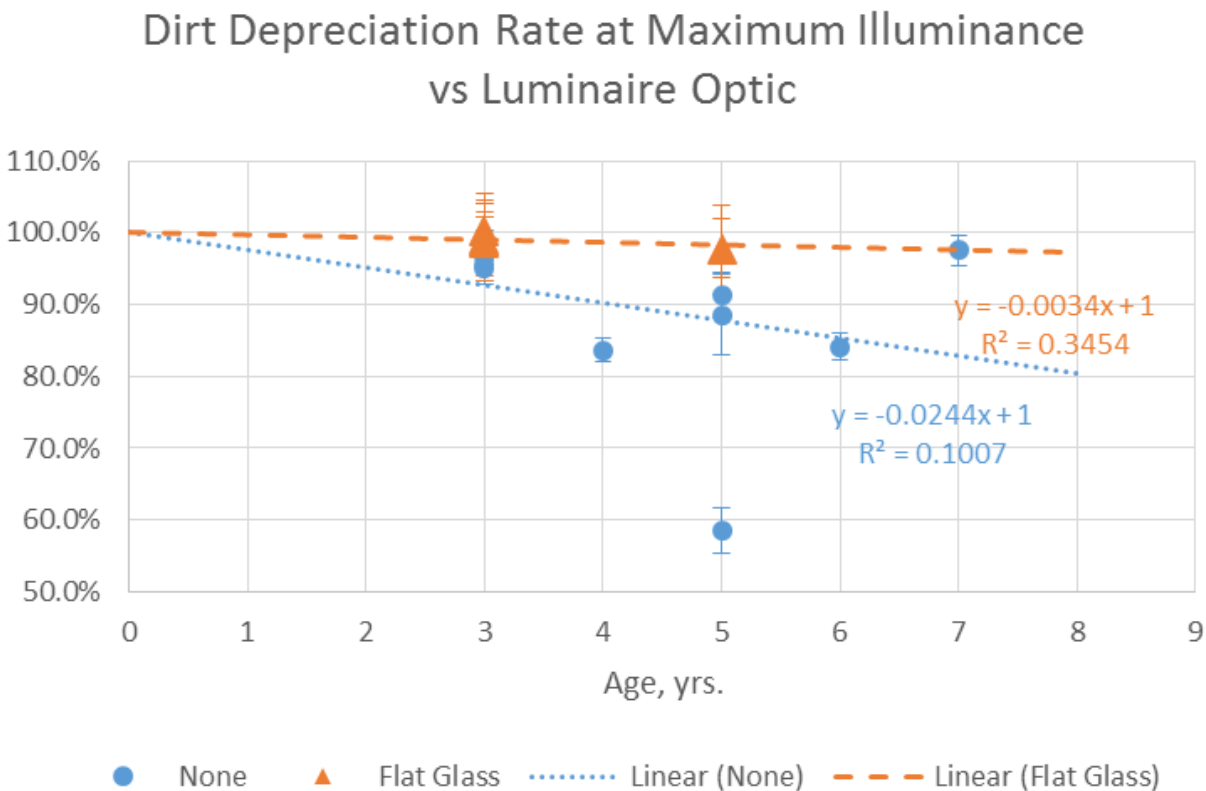
Figure 68. Maximum illuminance location dirt depreciation rate vs. age for all samples vs. the outer optic, categorized into flat glass or none.

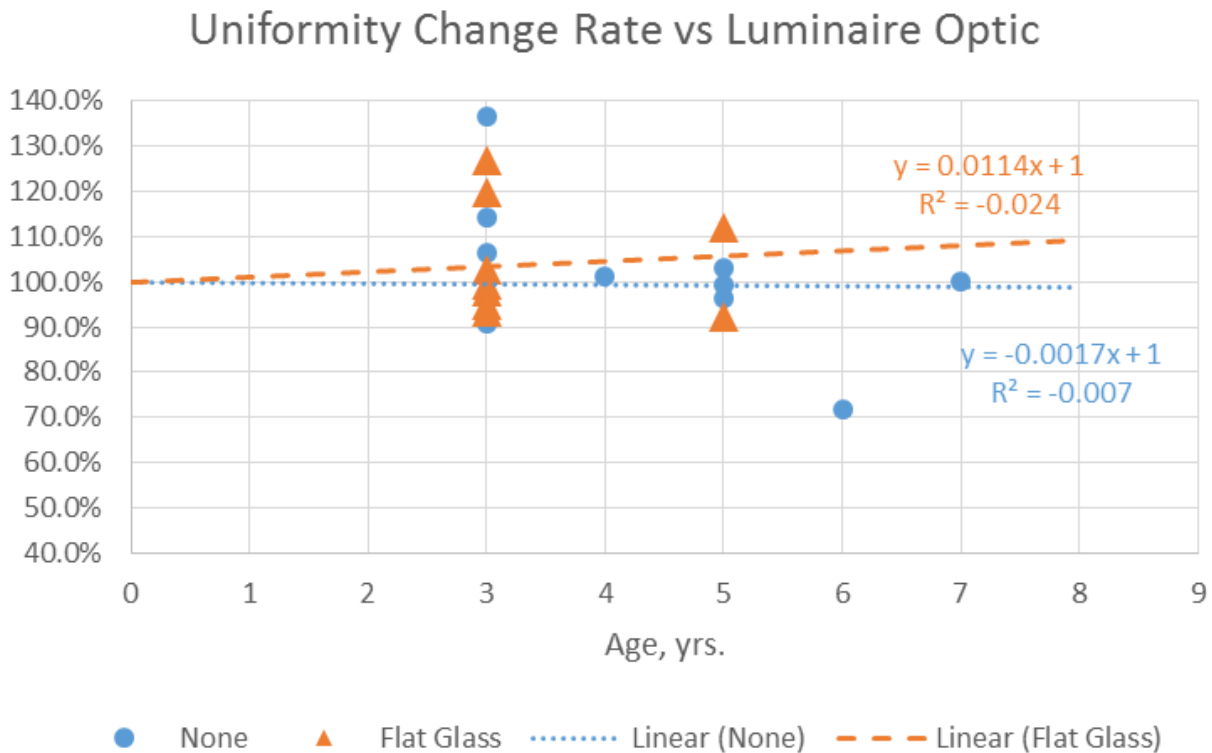
Figure 69. Uniformity change rate vs. age for all samples vs. the outer optic, categorized into flat glass or none.
