Measure and Report Luminaire Dirt Depreciation (LDD) in LED Luminaires for Street and Roadway Lighting Applications

**Final Report prepared for the
Illuminating Engineering Society of North America**

January 2016

**Center for Infrastructure-Based Safety Systems
Virginia Tech Transportation Institute
3500 Transportation Research Plaza
Blacksburg, Virginia**

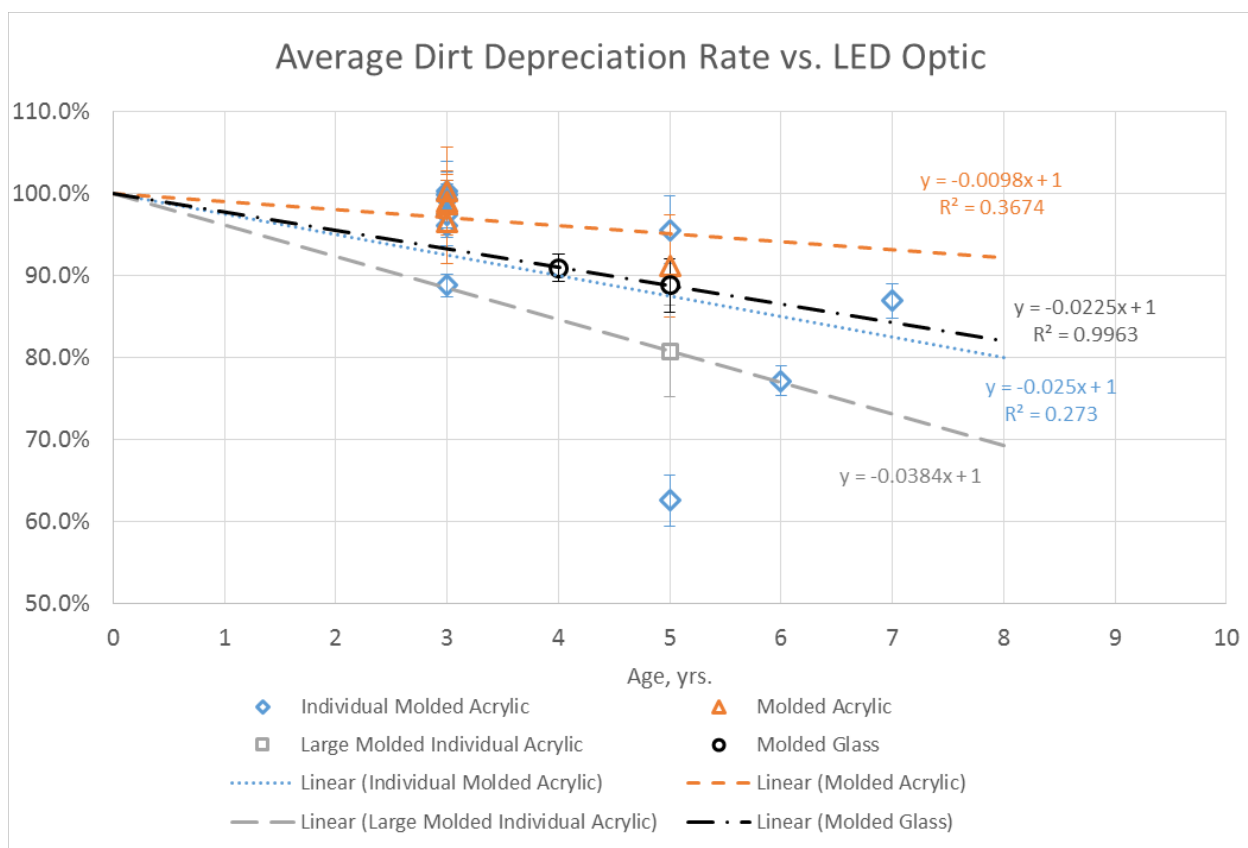
Figure 70. Average dirt depreciation rate vs. age for all samples vs. the inner optic.

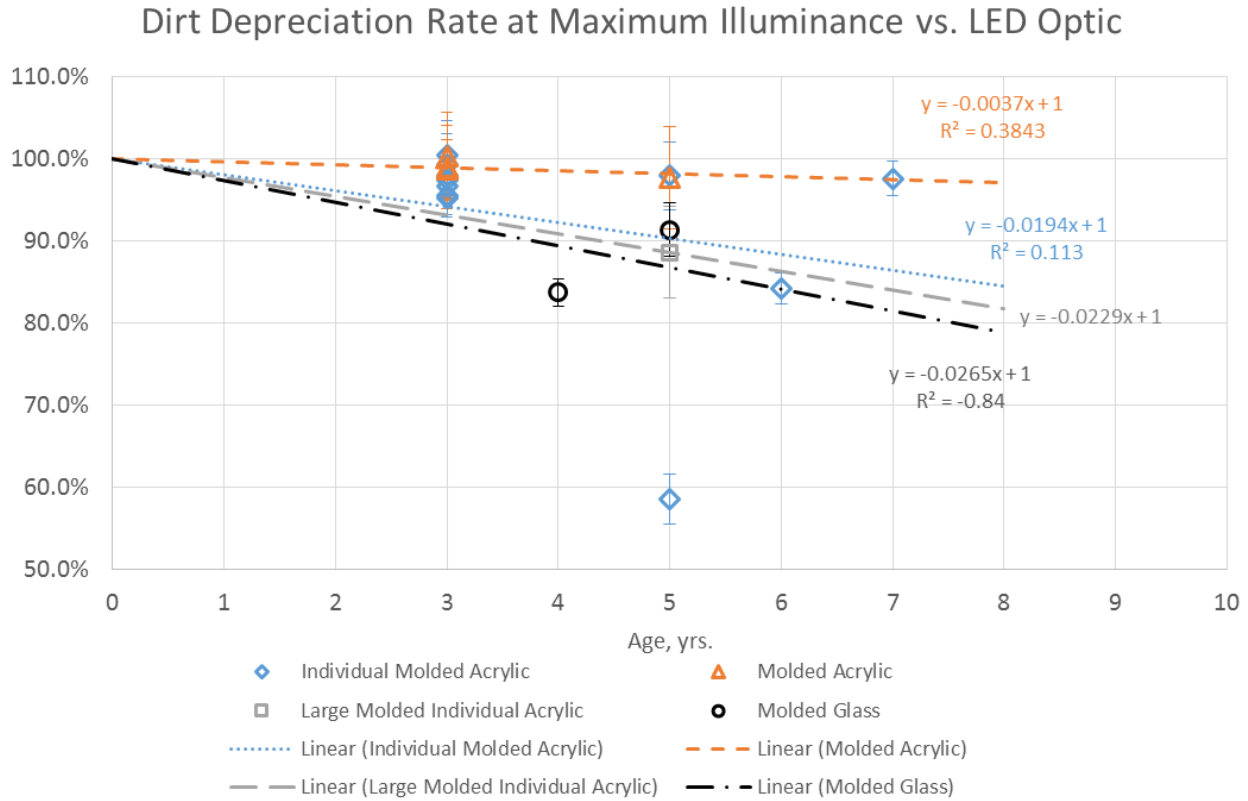
Figure 71. Maximum dirt depreciation rate vs. age for all samples vs. the inner optic.

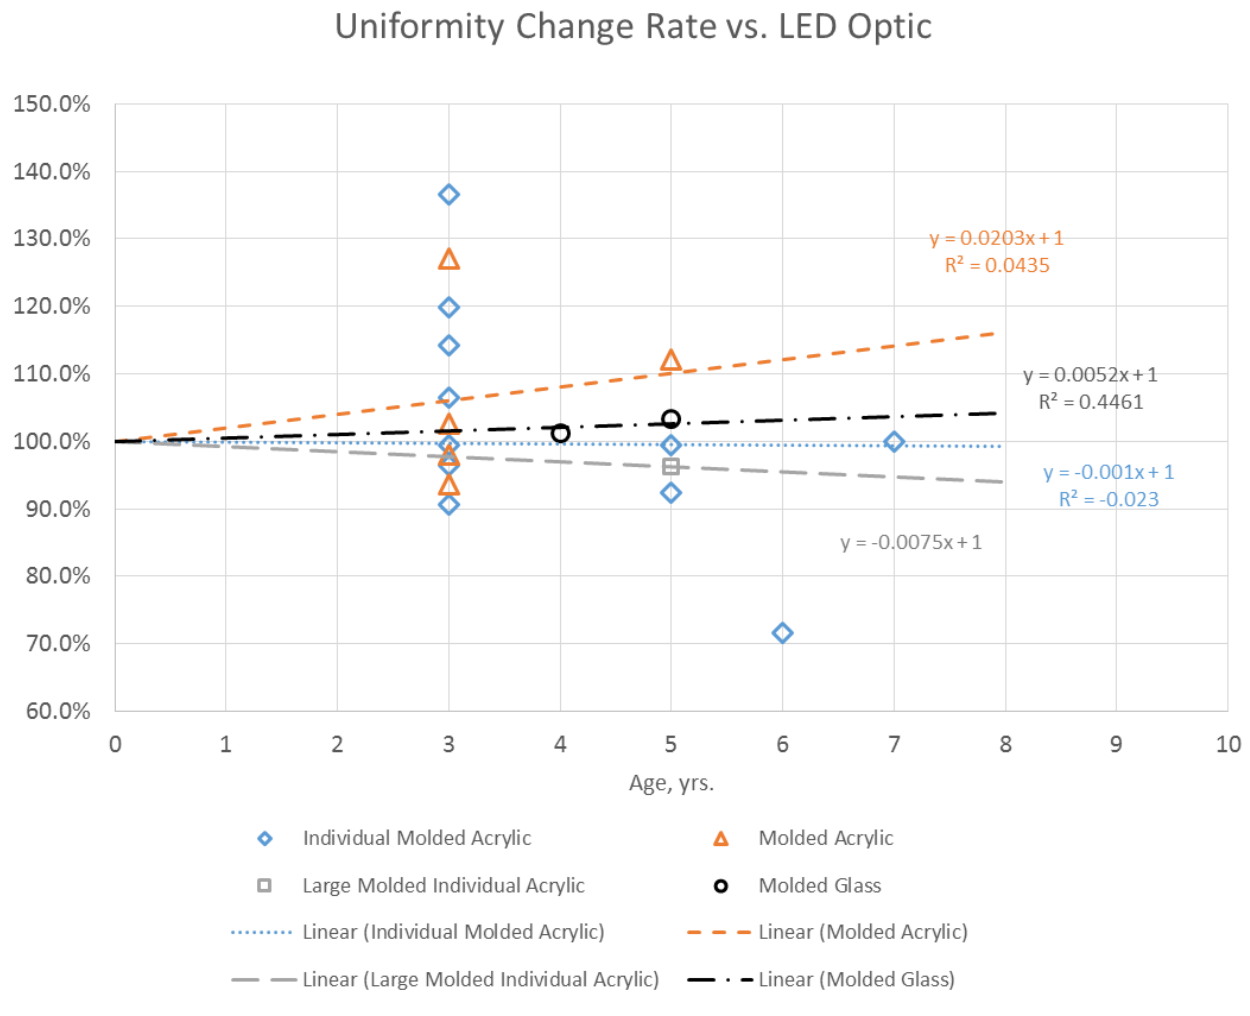
Figure 72. Average uniformity change rate vs. inner optics.
