Gareth Francis – Opus  
International Consultants  
The Tides of Change – Tauranga Inner  
Harbour Coastal Erosion Study

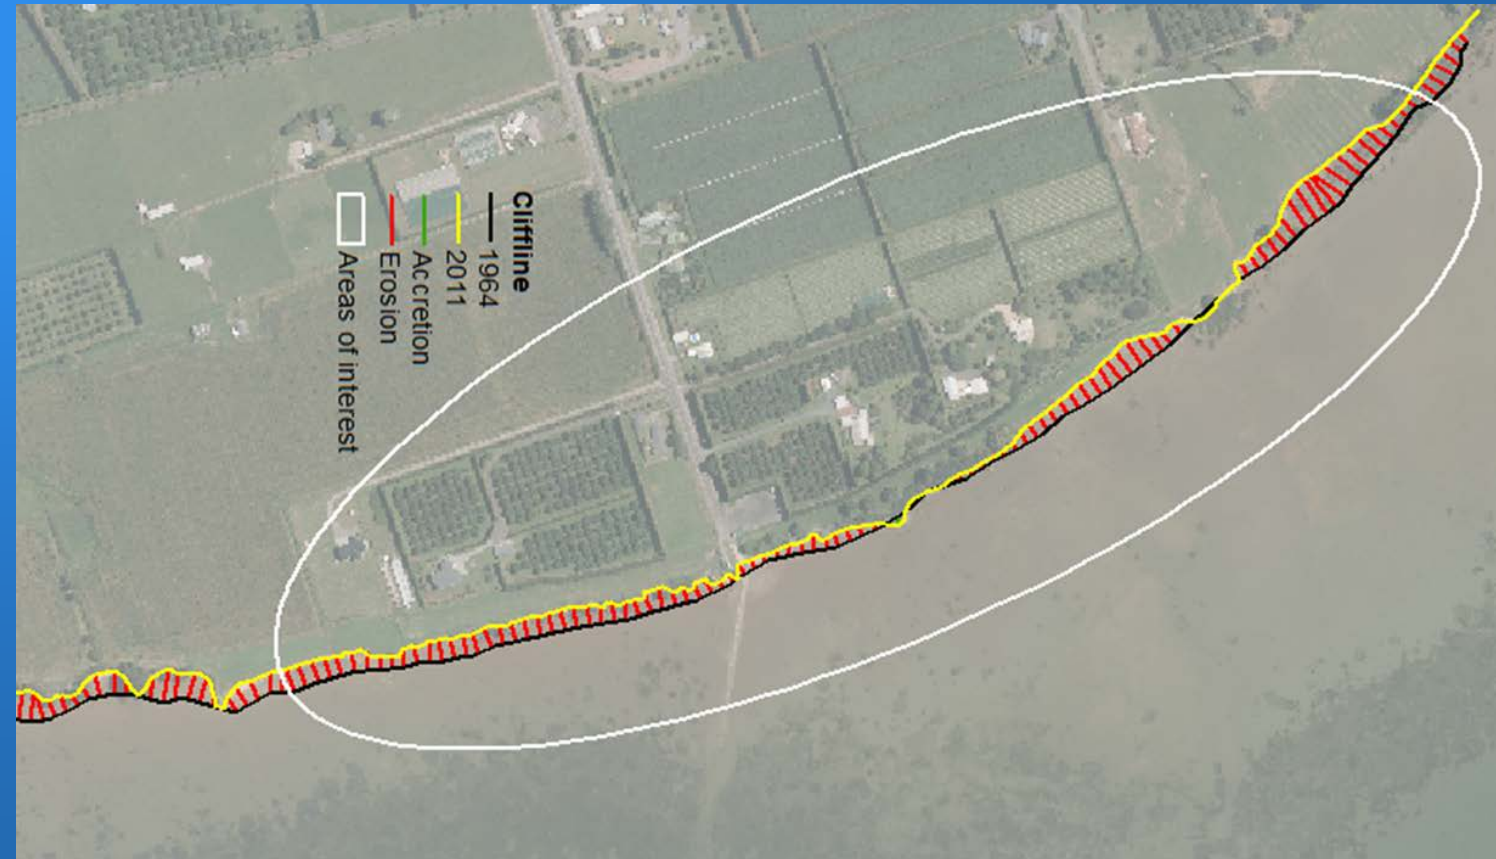
- McMillan Park

- Use of aerial photography
- Measured differences based on longest time scale
- Adjustments
- Rate of erosion per year

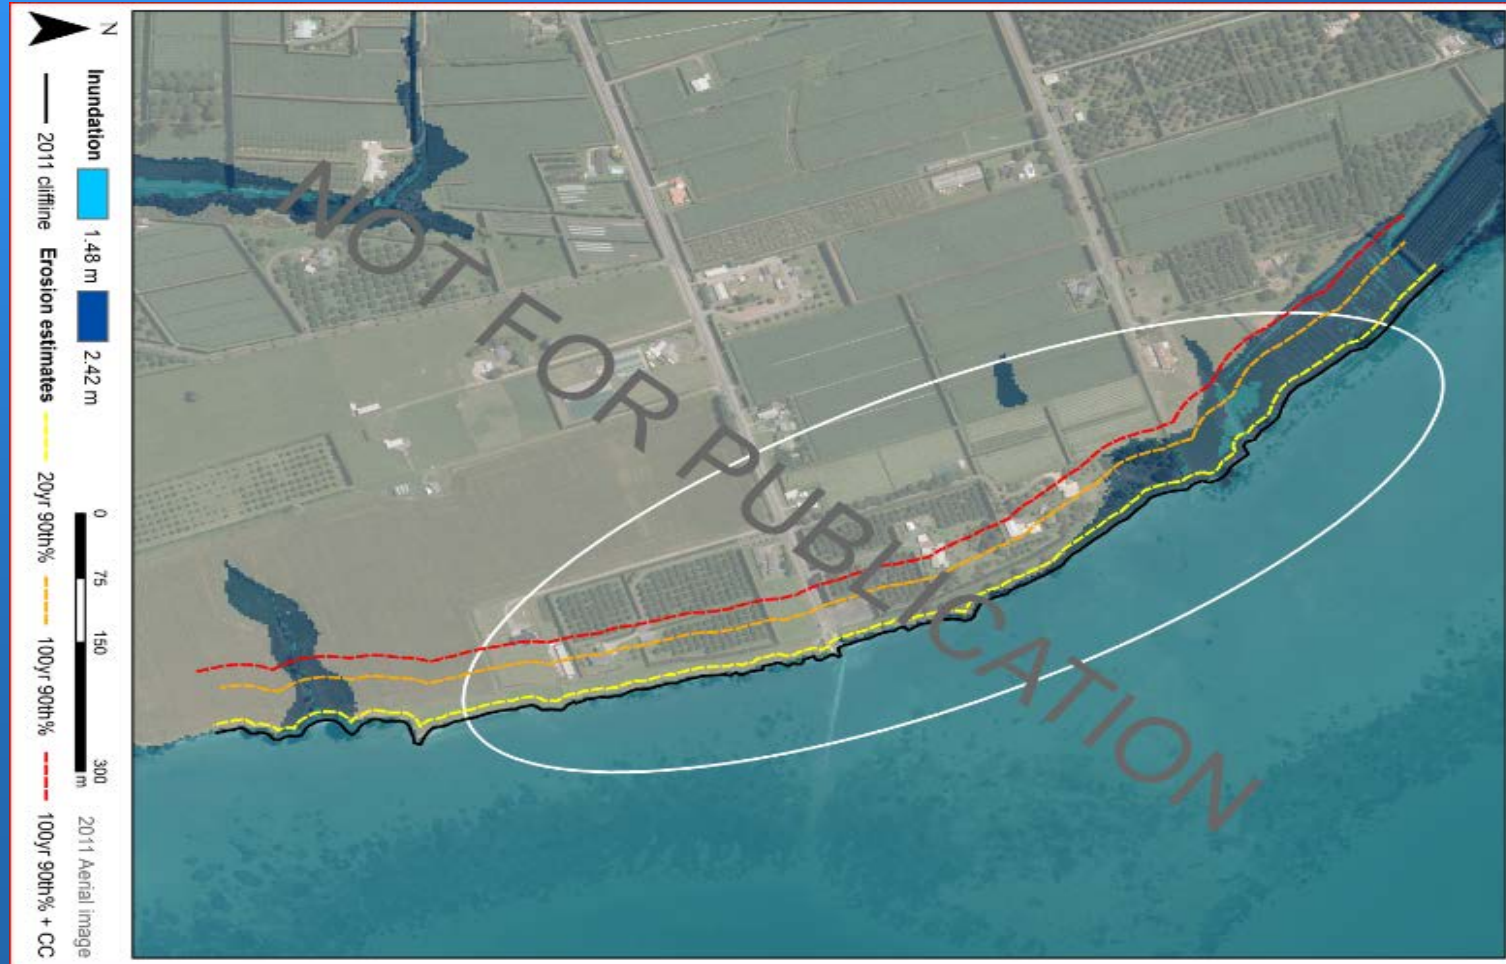
## Erosion Extent Forecasts – McMillan Park

- Short term 20 year period – current erosion rate
- Long term 100 year period – current erosion rate
- Long term 100 year with climate change
  - Based on current understanding climate change equates to rise in sea level of approximately 1m.

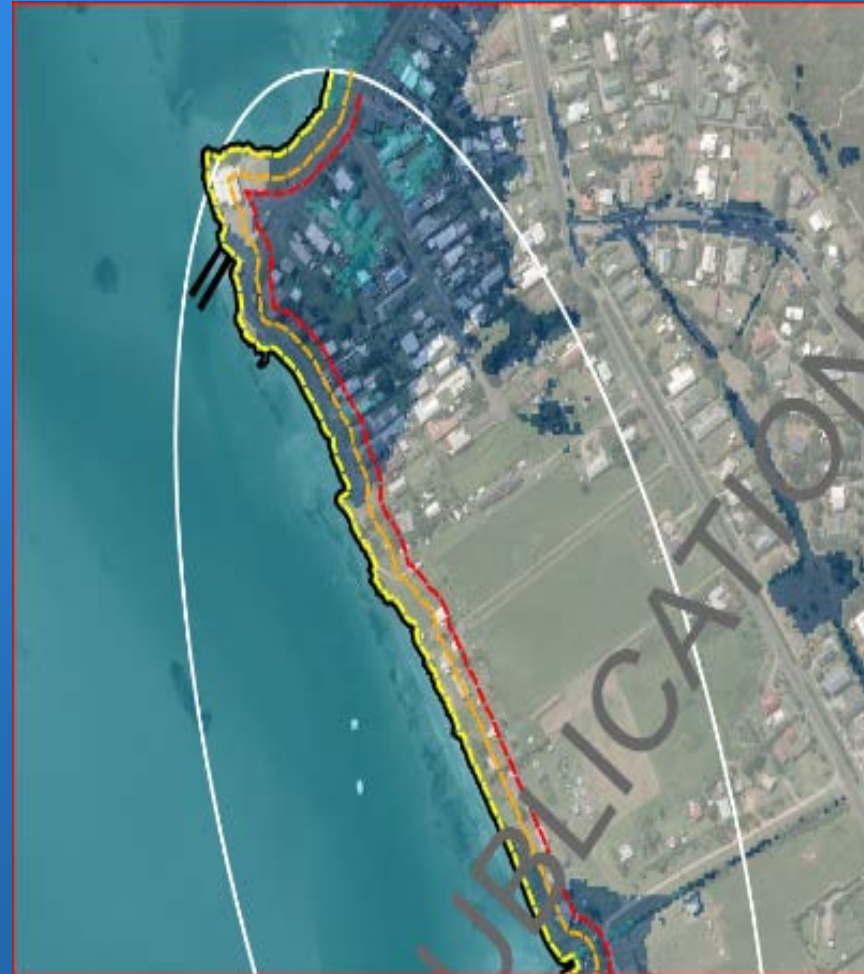
## Inundation Risk

- Sea level rise of 1m will cause significant flooding
- Dominant in some areas

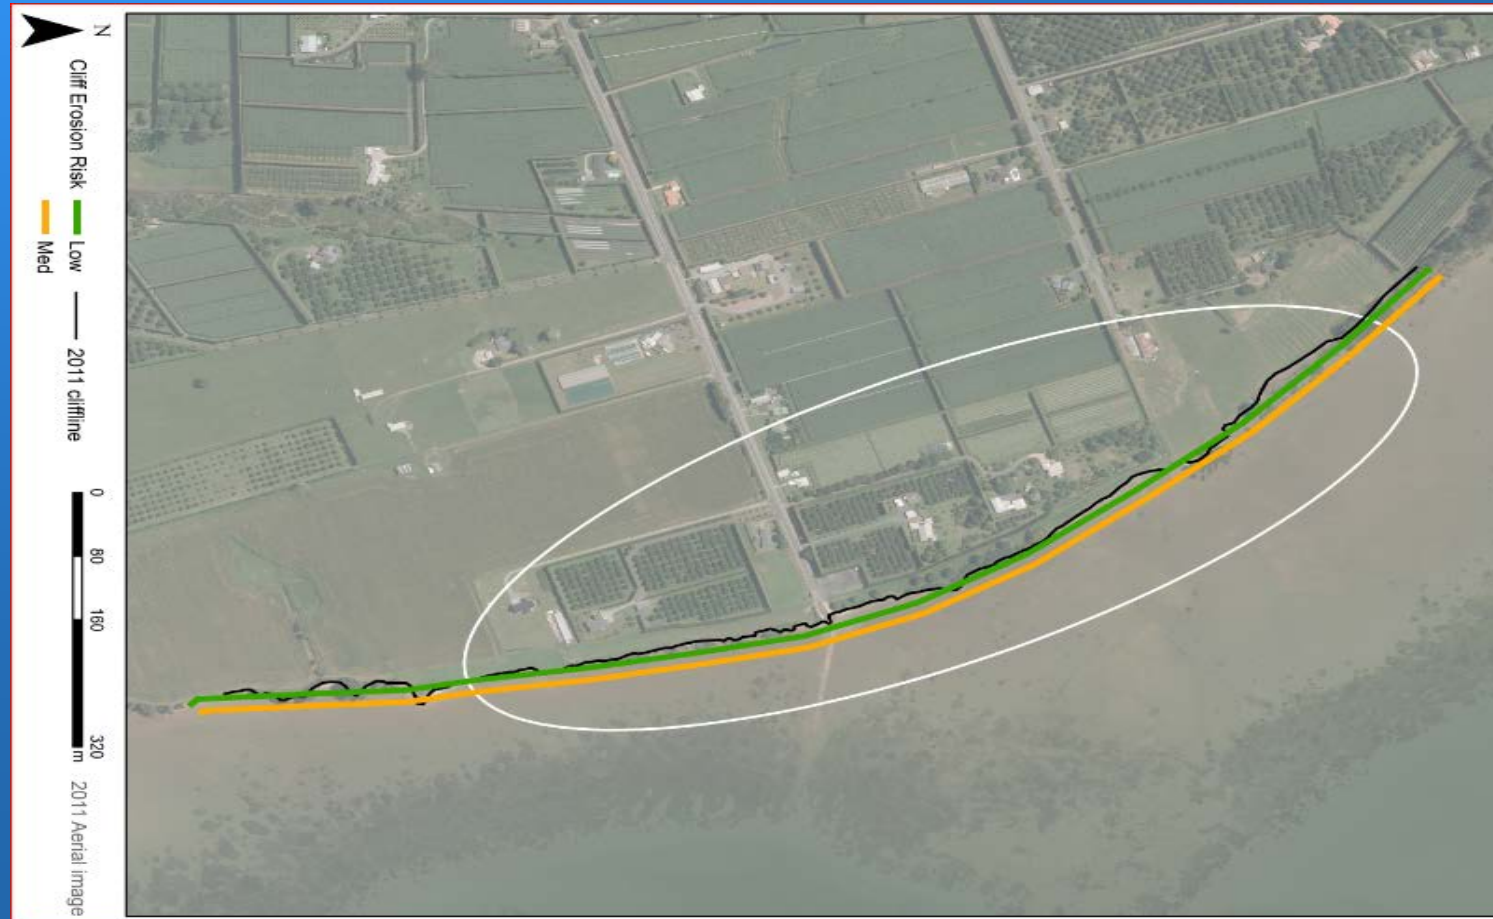
## Risk Mapping – McMillan Park

- 3 categories (H,M,L)
- Based on financial loss within erosion zone
- Does not consider:
  - Flood risk
  - Cultural values
  - Environmental values
  - Heritage values
