# Temuka Water Event

DECEMBER 2017 – MARCH 2018

Ashley Harper, CPEng; FIPENZ  
*Infrastructure Group Manager*  
*Timaru District Council*

In early December 2017 the Temuka Water Supply was found to contain millions of Asbestos Fibres from an unknown source.

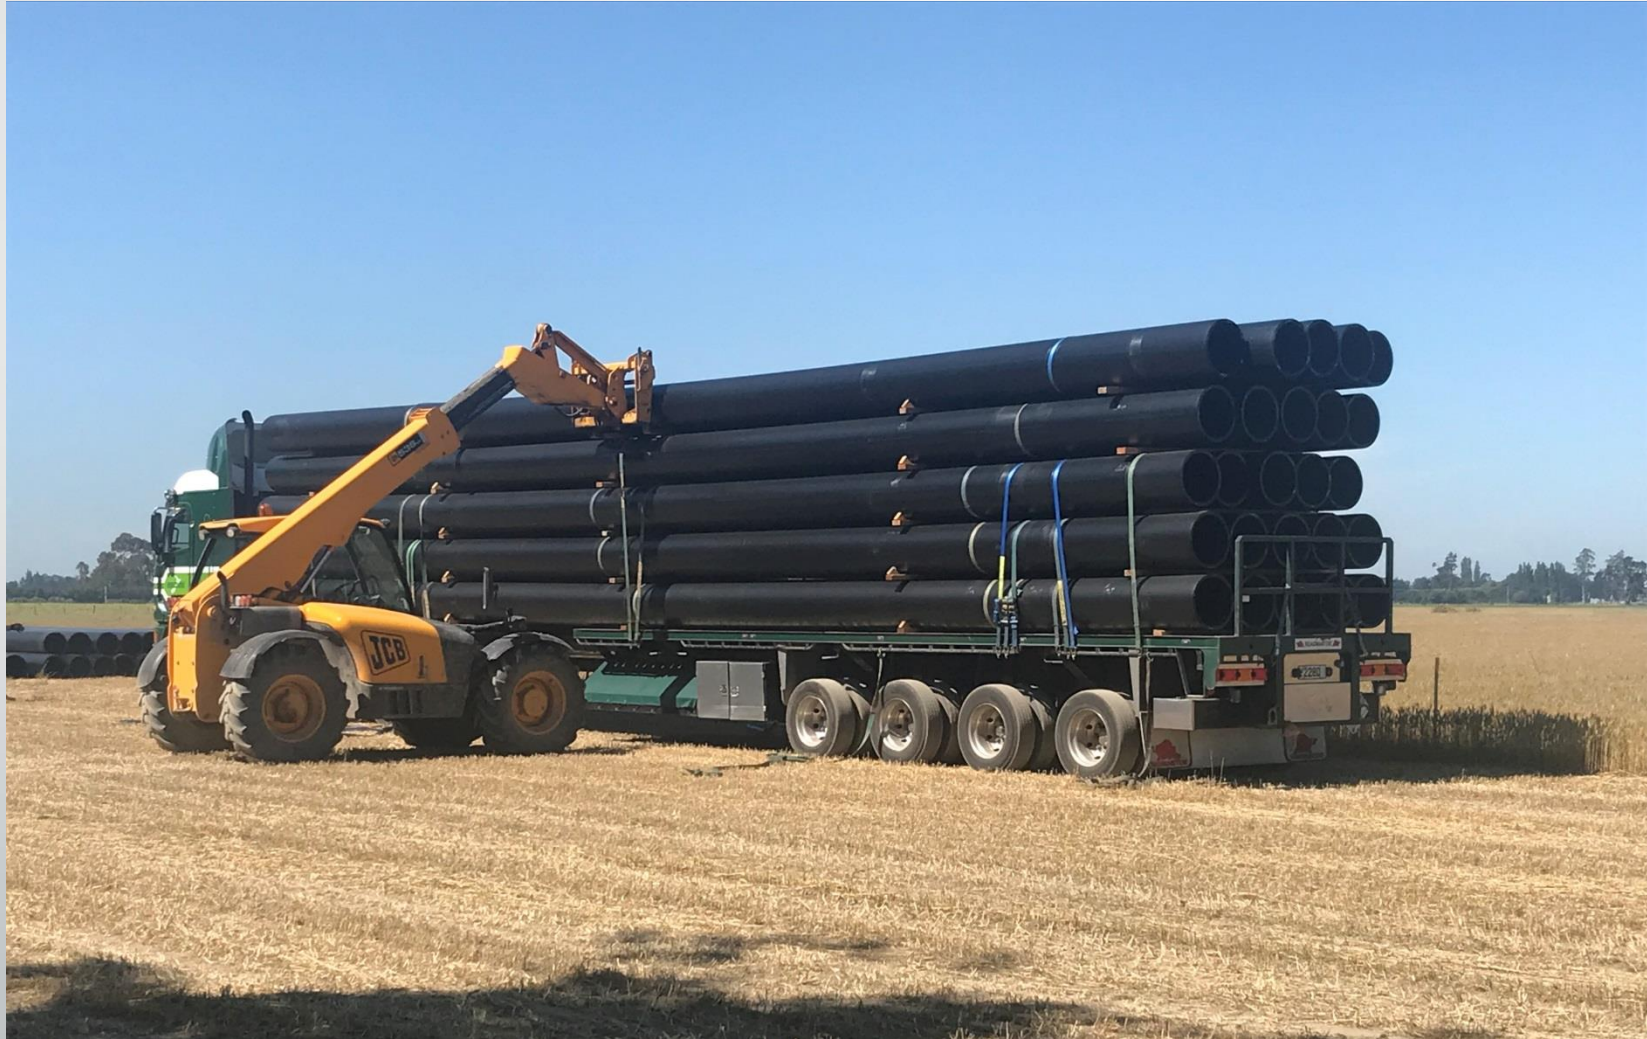
# 450mm HDPE Pipes 29.01.2018

- Current Trunk Main
  - 3km 2015 300mm PVC
  - 9km 1964 300mm AC 'Fibrolite' brand
- Options
  - 9km 1 x 300mm PVC
  - 9km 2 x 300mm PVC
  - 9km 1 x 450mm HDPE
- Features
  - 'In Line' valves @ 1.5km
  - Air valves
  - Sluice valves
  - Metering
  - PRV
  - PSV

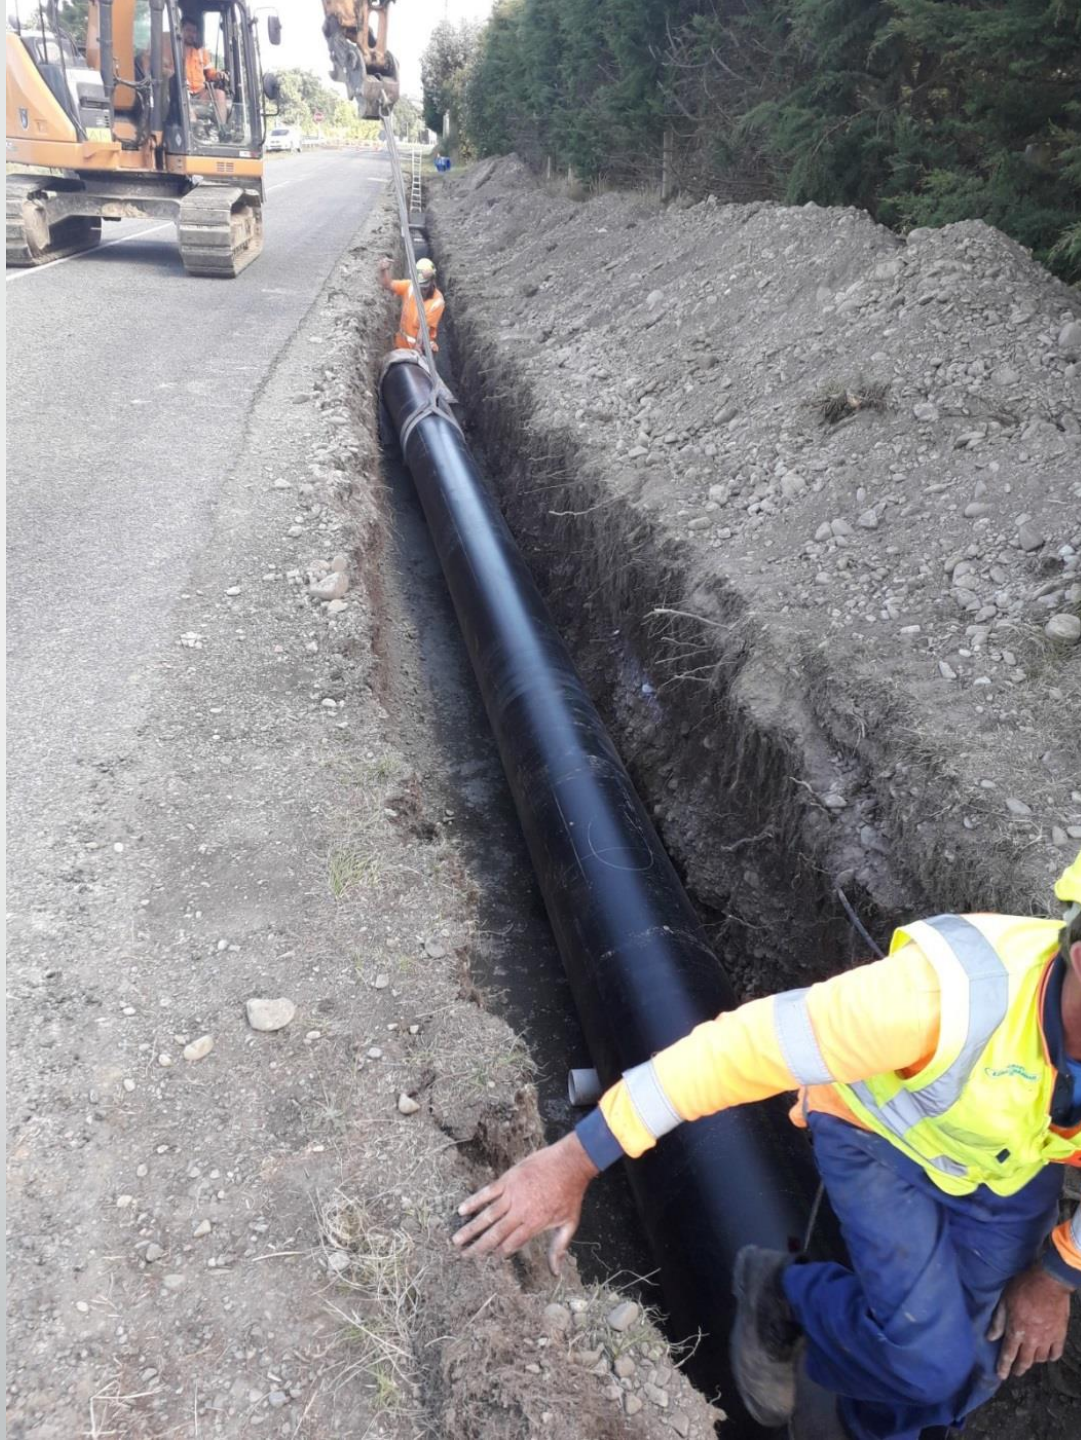
# Zone 1: Pipe Install

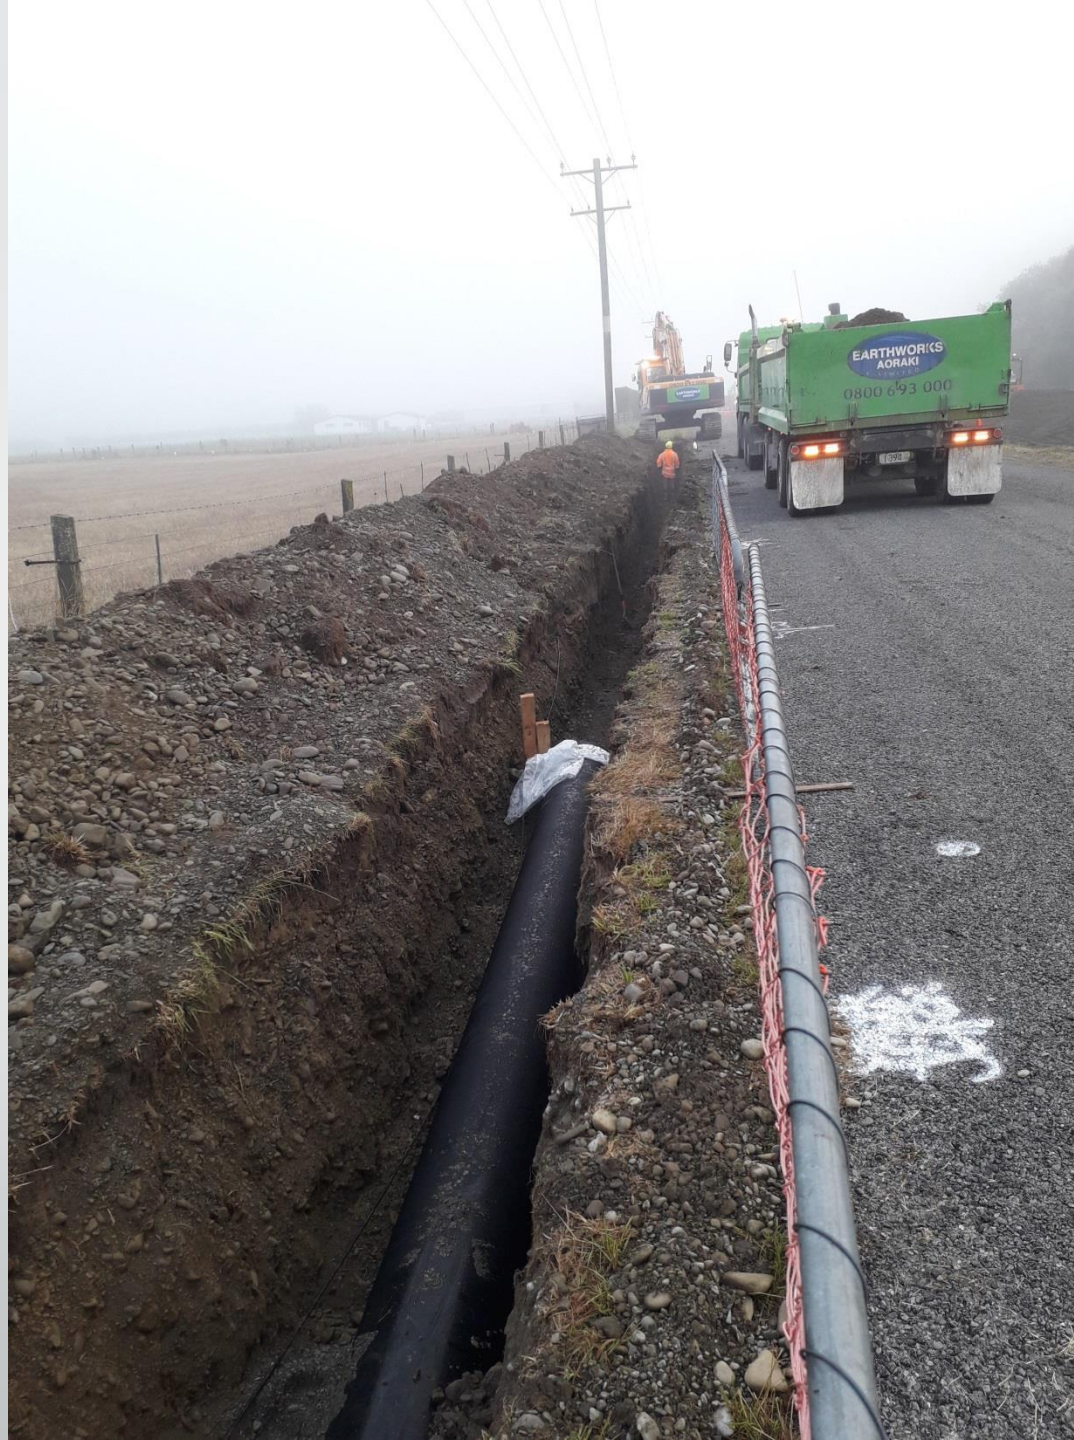
# Zone 1: Pipe Install

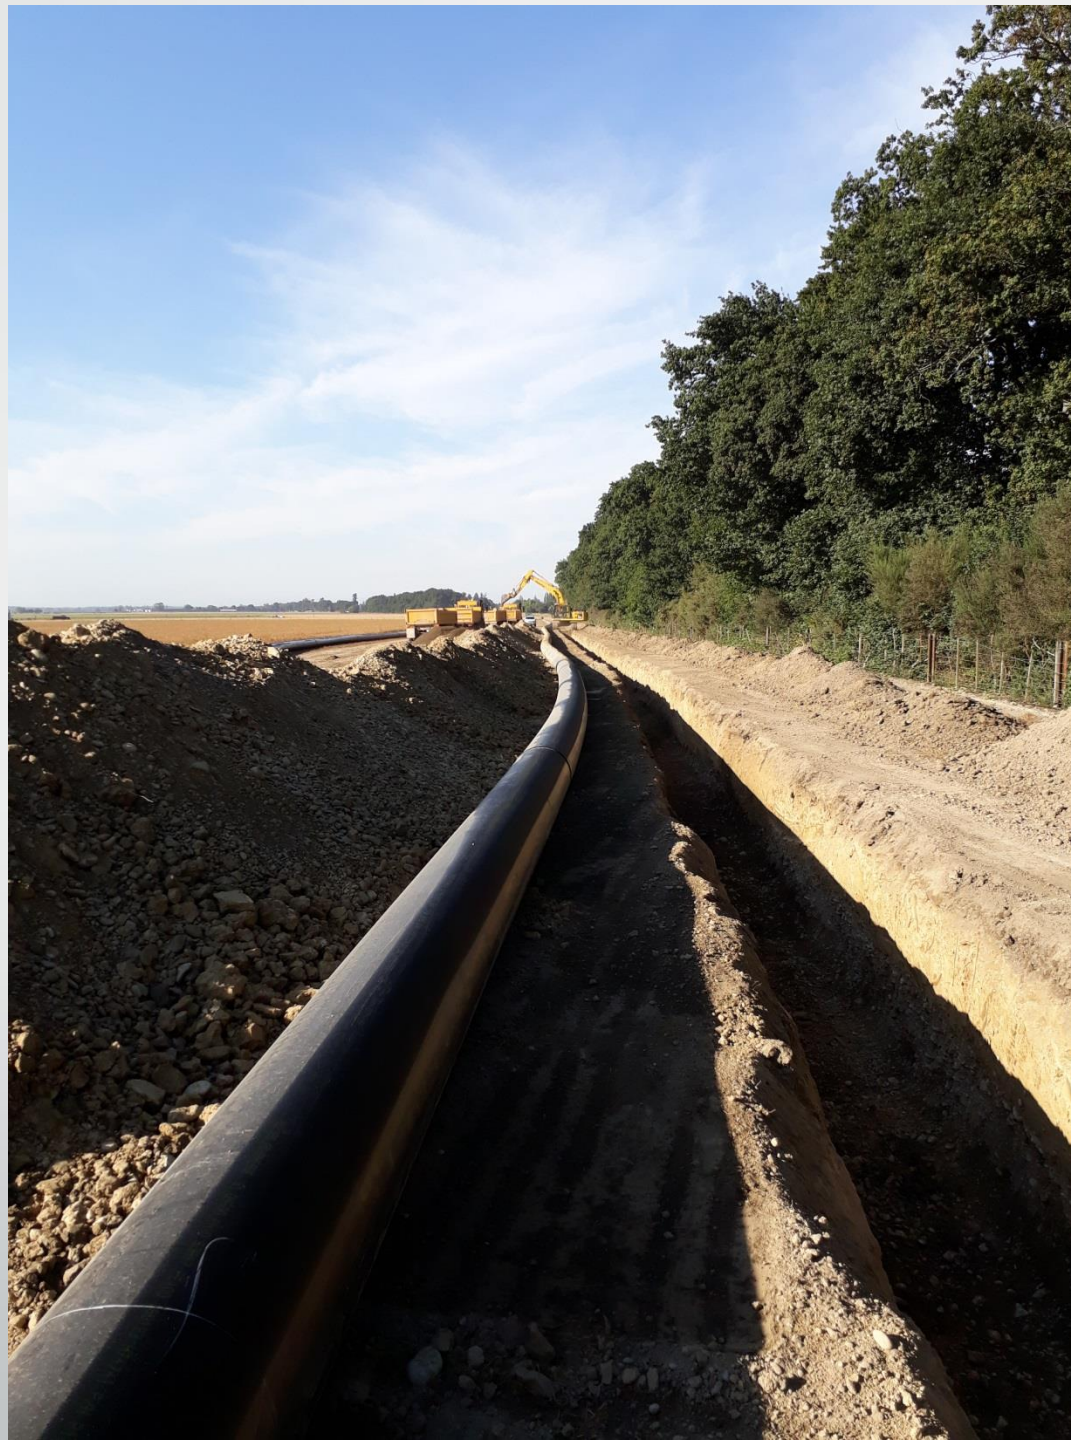
## Zone 2: Pipe Install

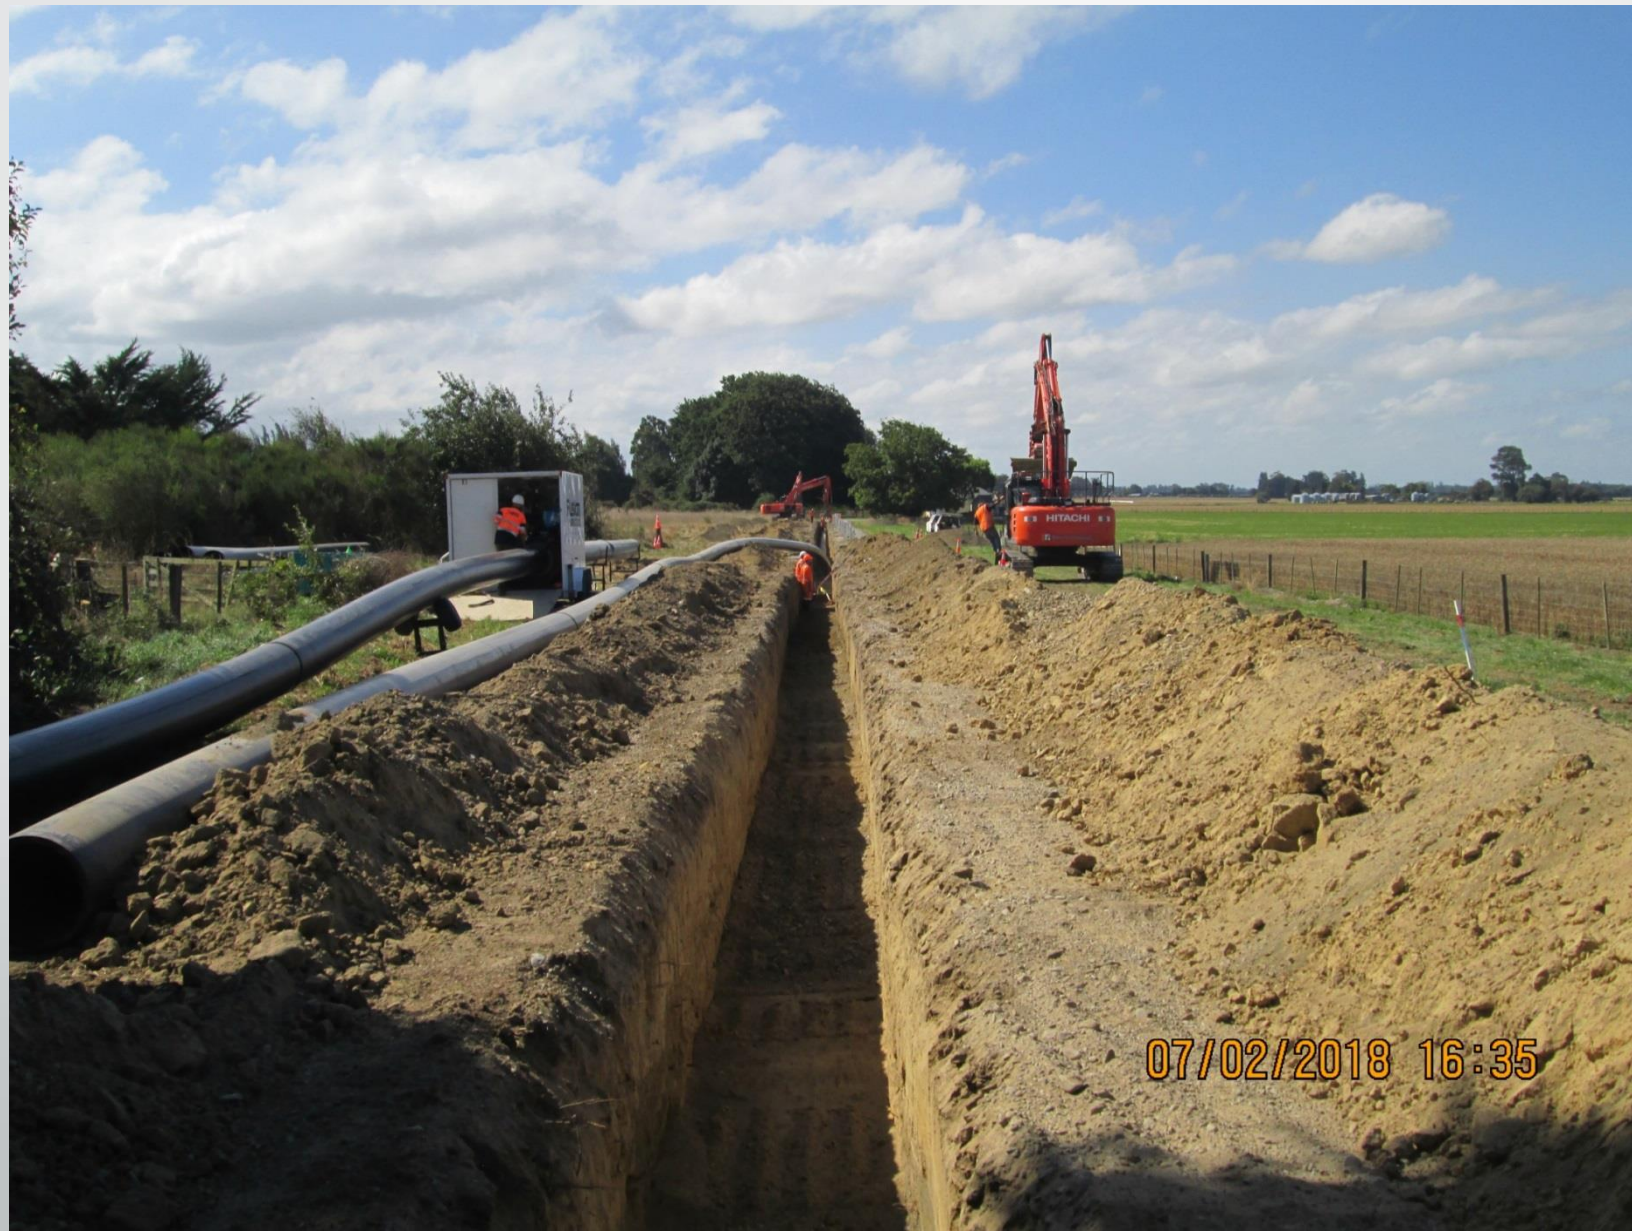
# Zone 3: Pipe Install

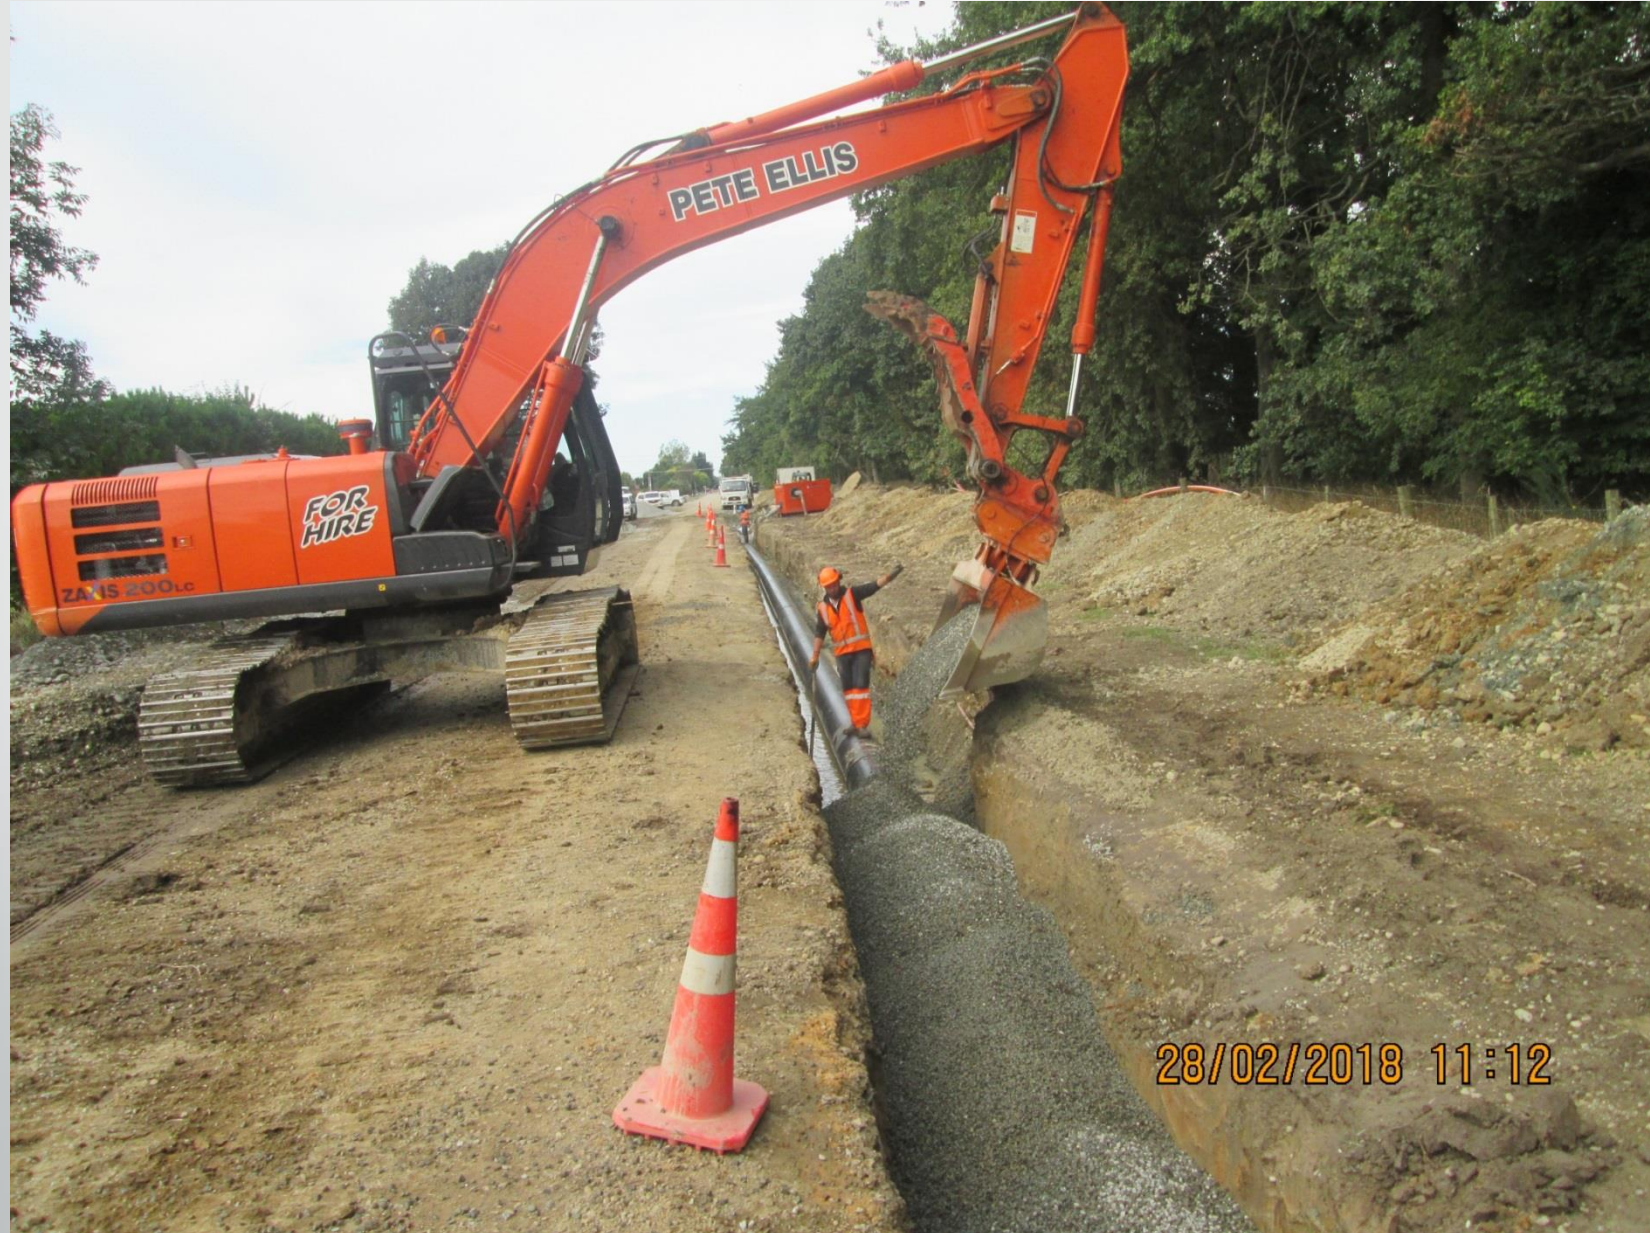
## Zone 3: Backfilling

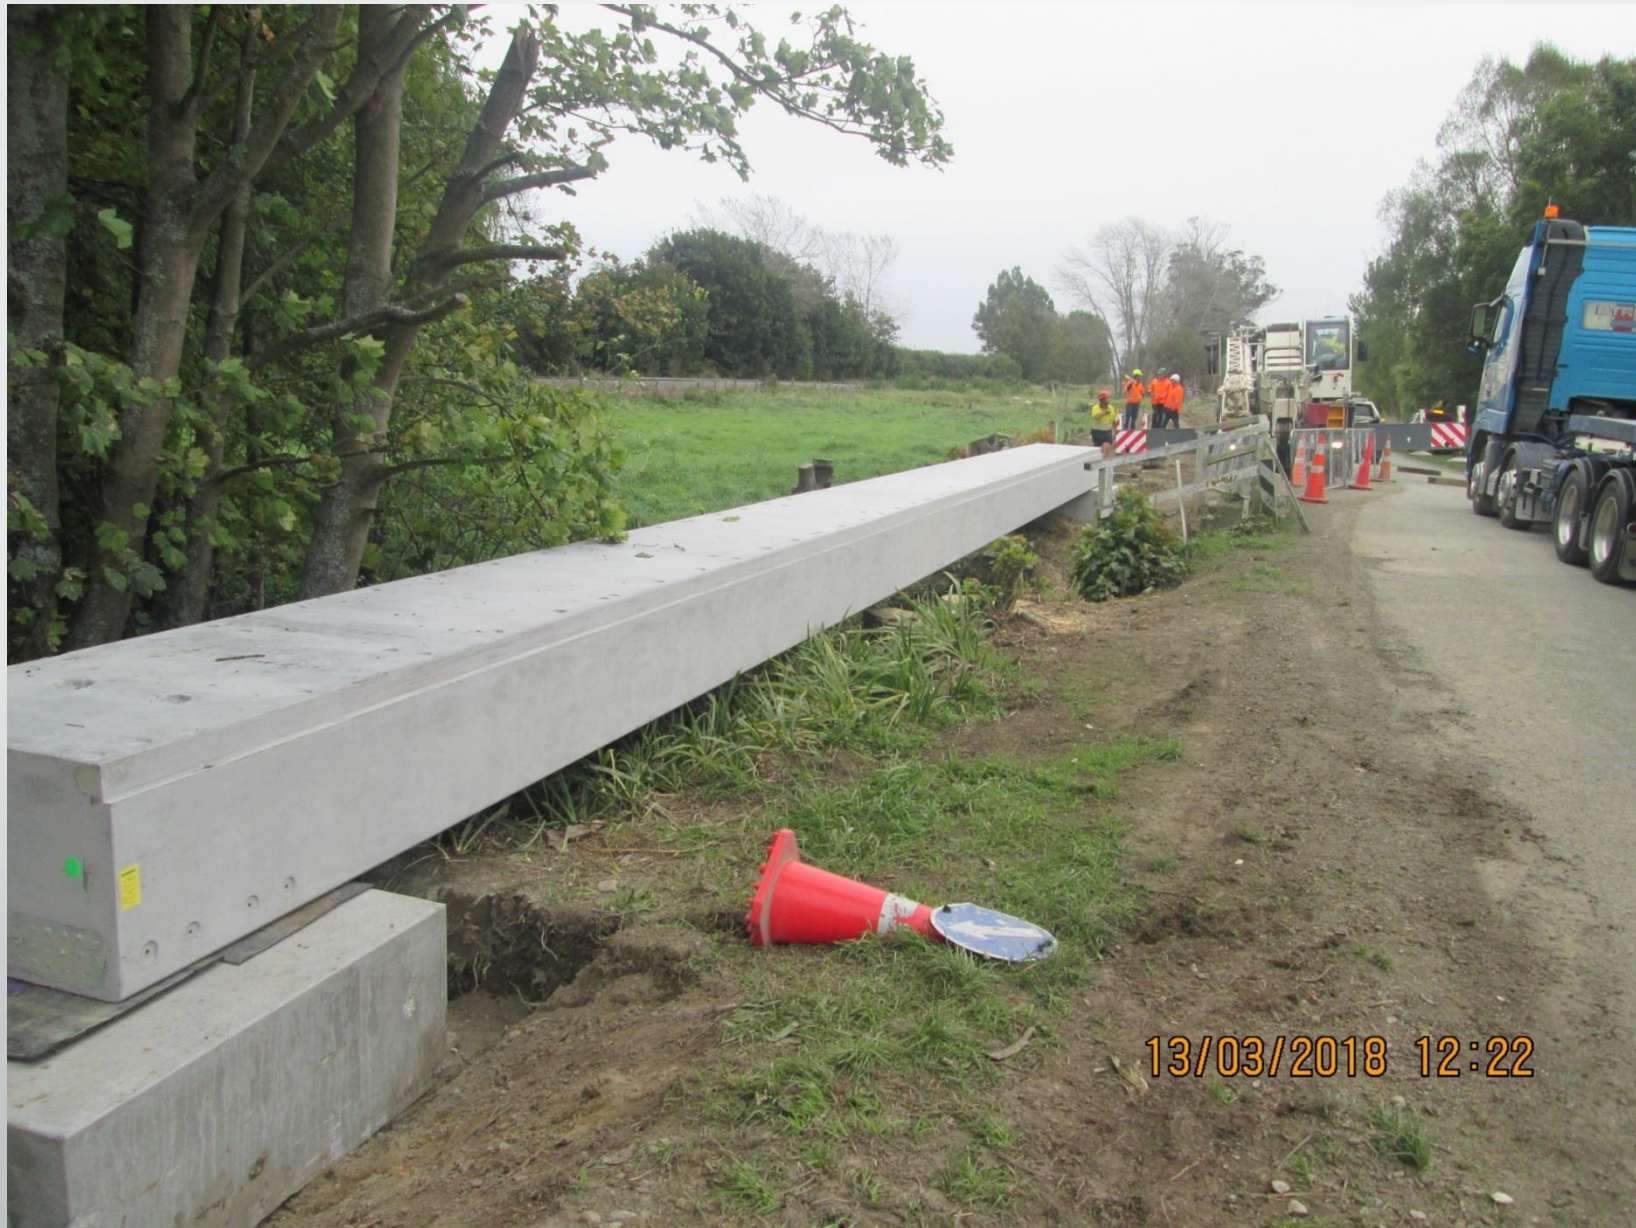
## Zone 4: Bridge for Pipe

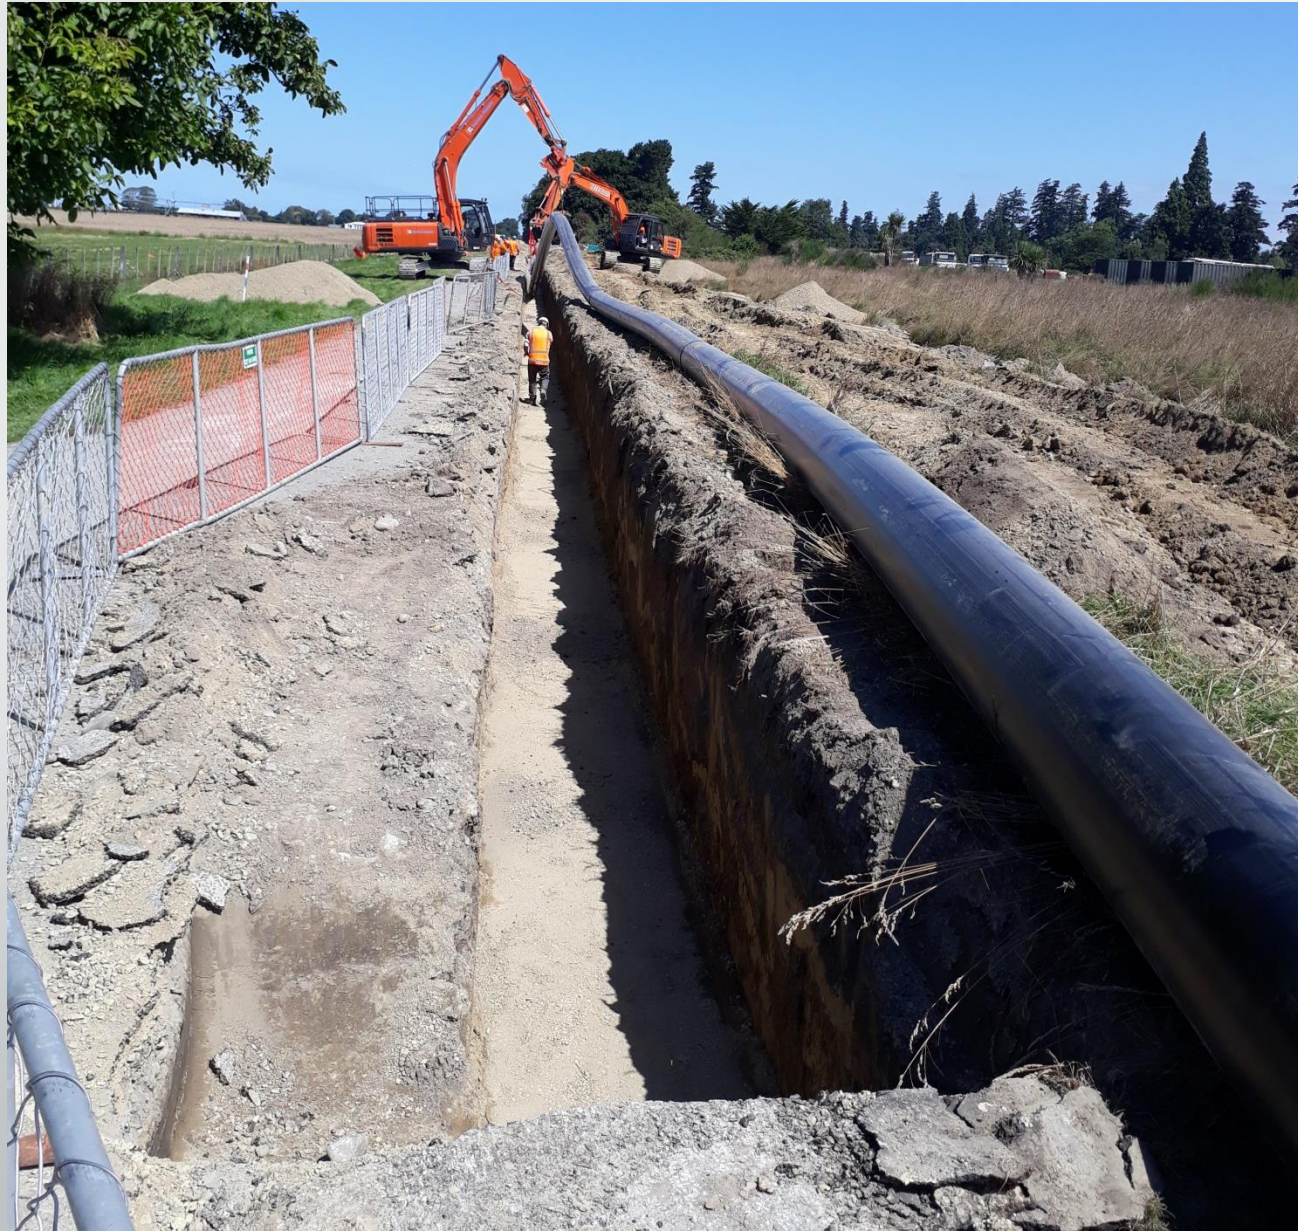
# Zone 4: Pipe Install

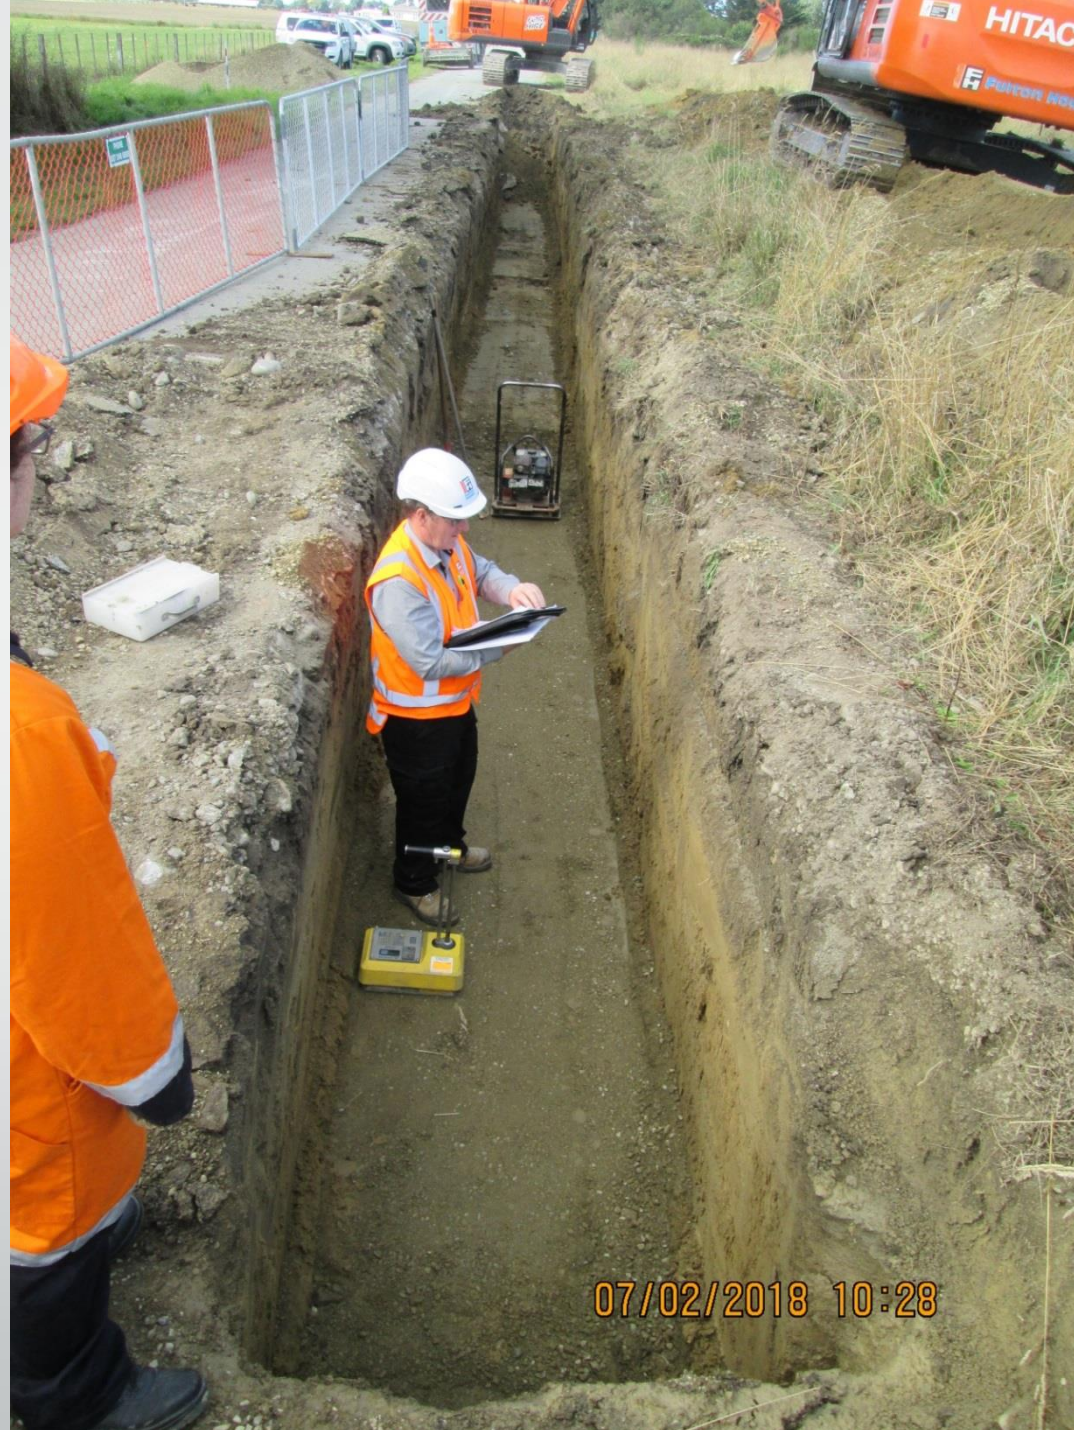
# Zone 4: Trench Testing

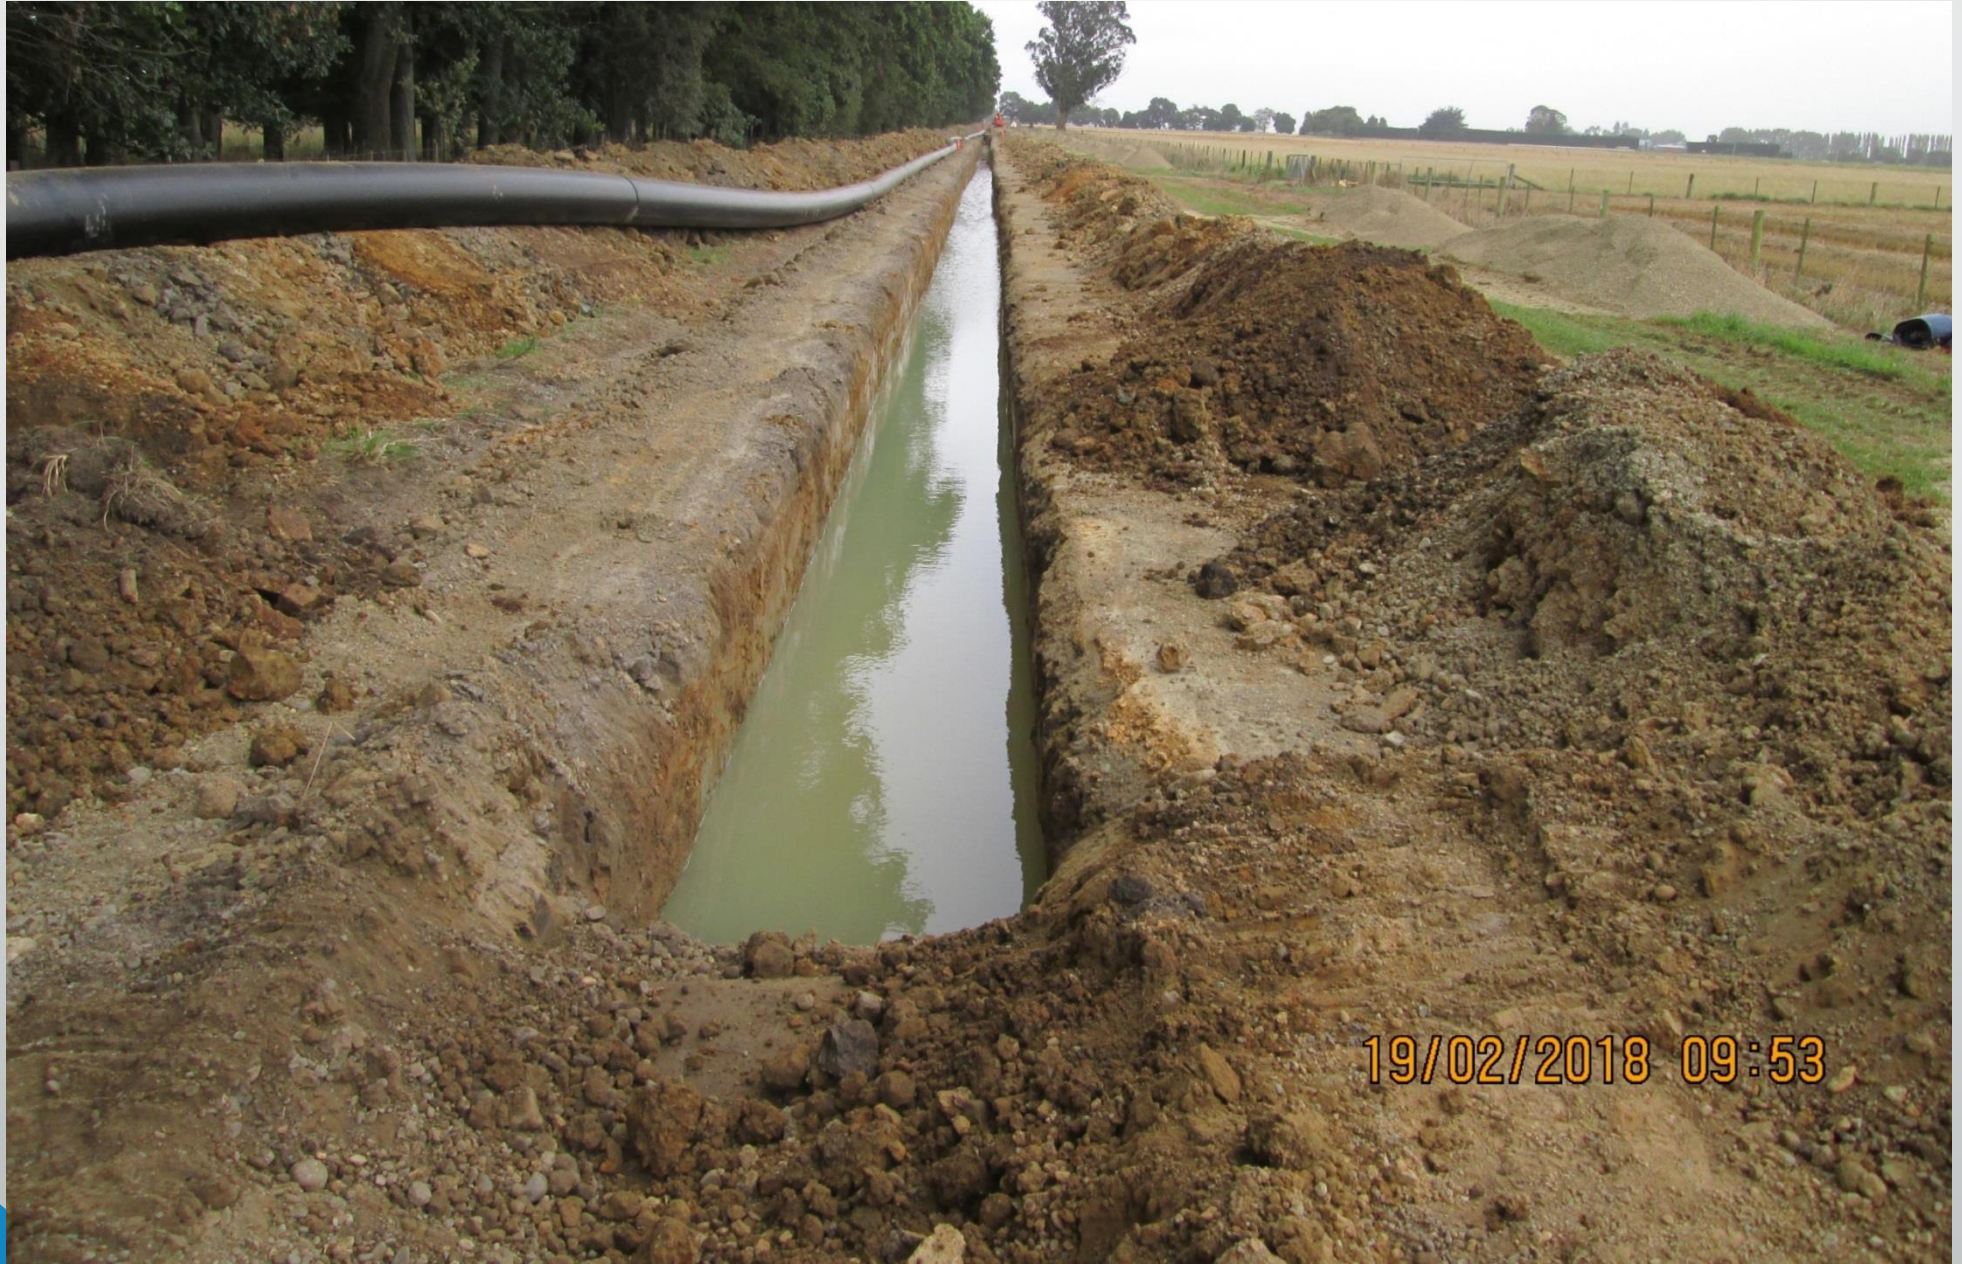
# Zone 4: Ground Water

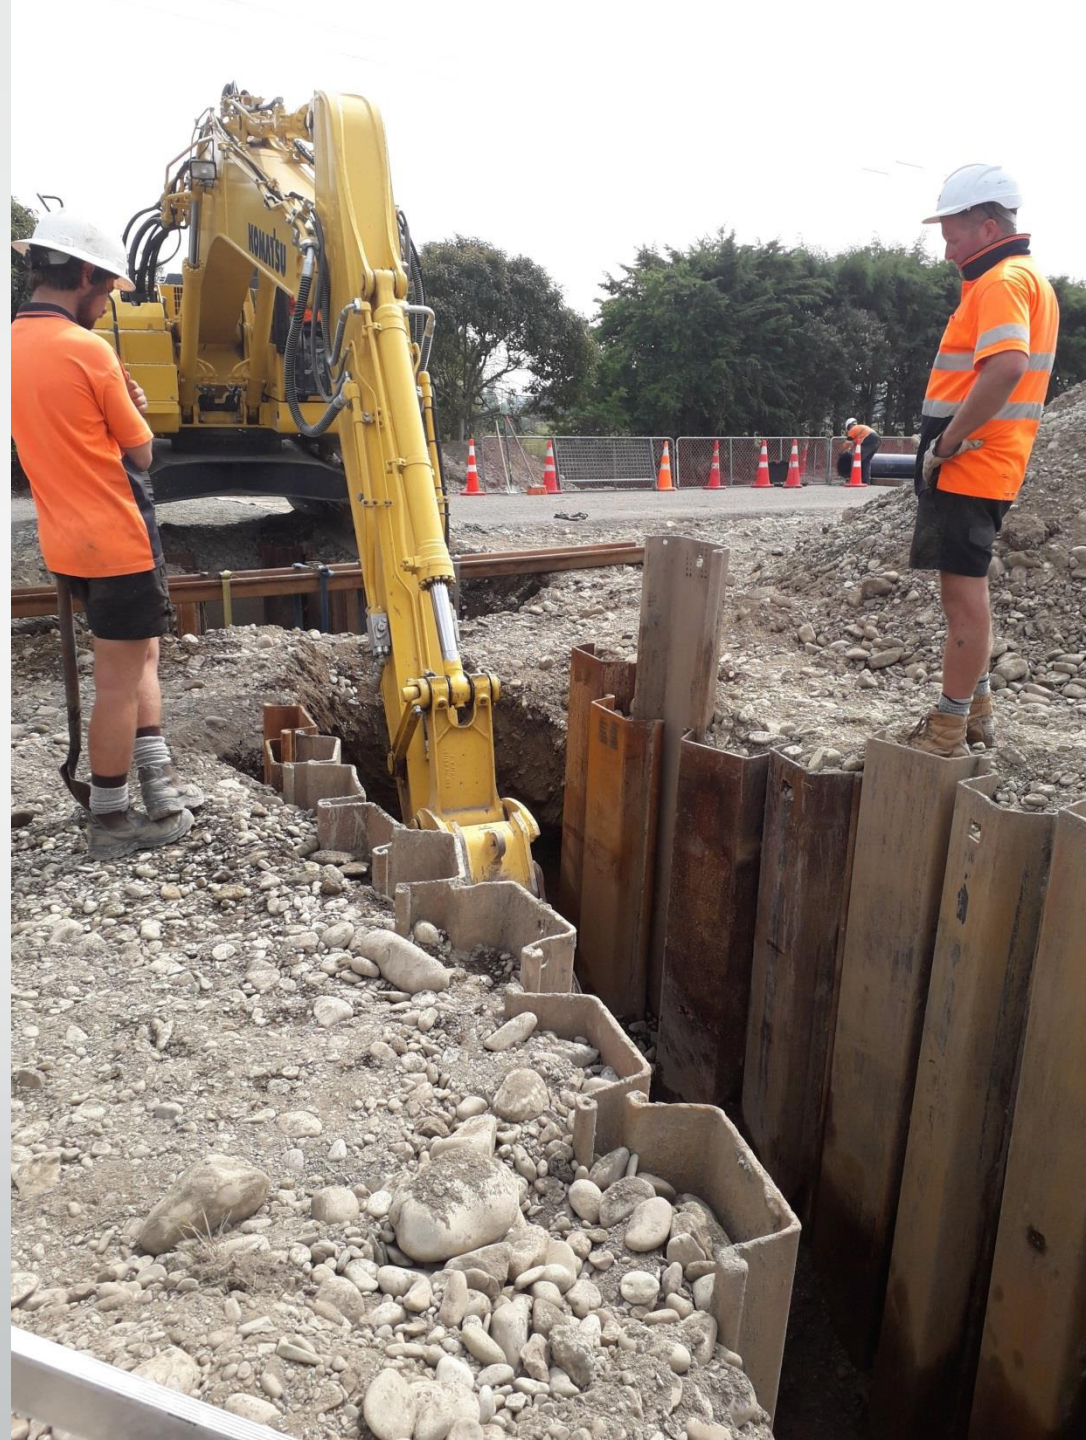
# State H-Way 1 / Railway Crossing: Sheet Piling

- 4 Zones/4 Contractors
- 4 Connections
- 1.5m max depth
- Avoid
  - Fibre Optics x3
  - Existing 300mm AC
  - Trunk Sewer – 300mm HDPE
  - State Highway 1

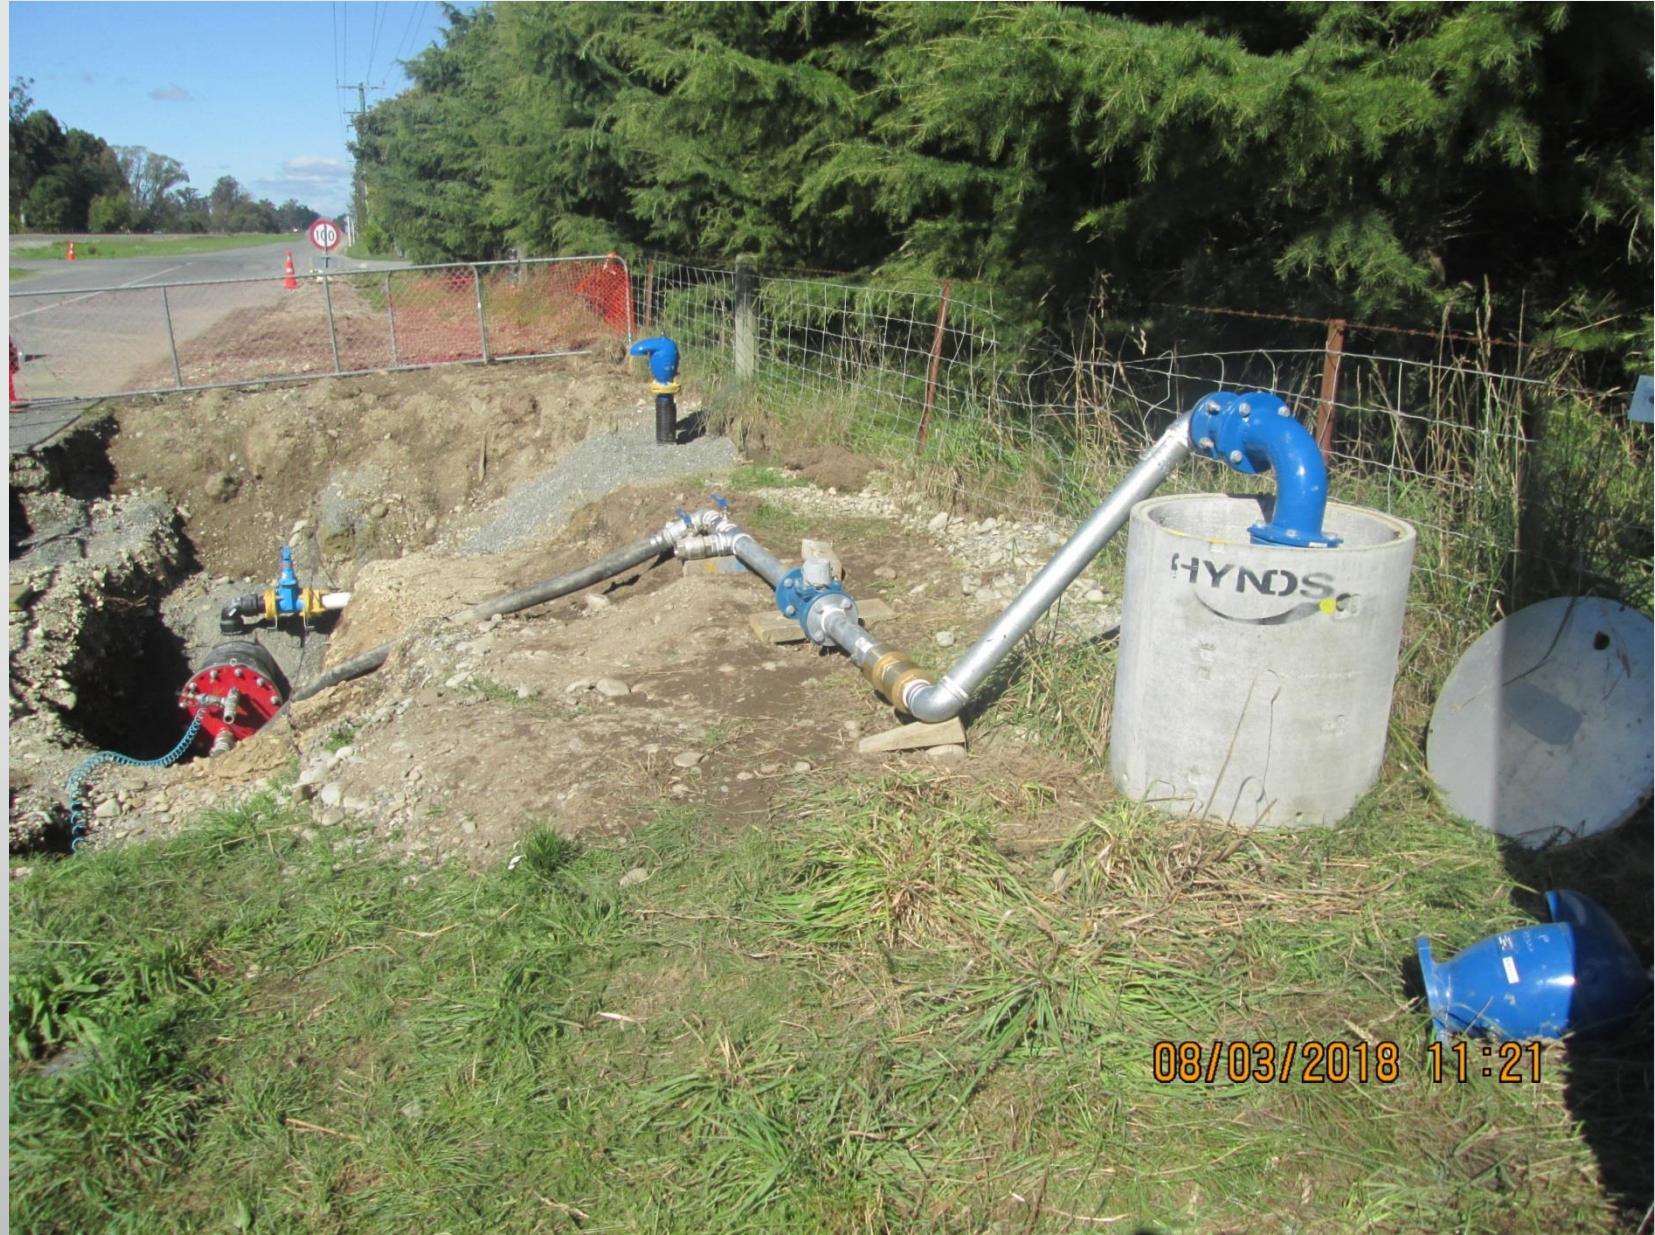
# Zone 1: Pipe Filling

- Testing
- Swabbing
- Sterilisation – Chlorination
- De-chlorination
- Cut Over
