# Temuka Water Event

DECEMBER 2017 – MARCH 2018

Ashley Harper, CPEng; FIPENZ  
*Infrastructure Group Manager*  
*Timaru District Council*

In early December 2017 the Temuka Water Supply was found to contain millions of Asbestos Fibres from an unknown source.

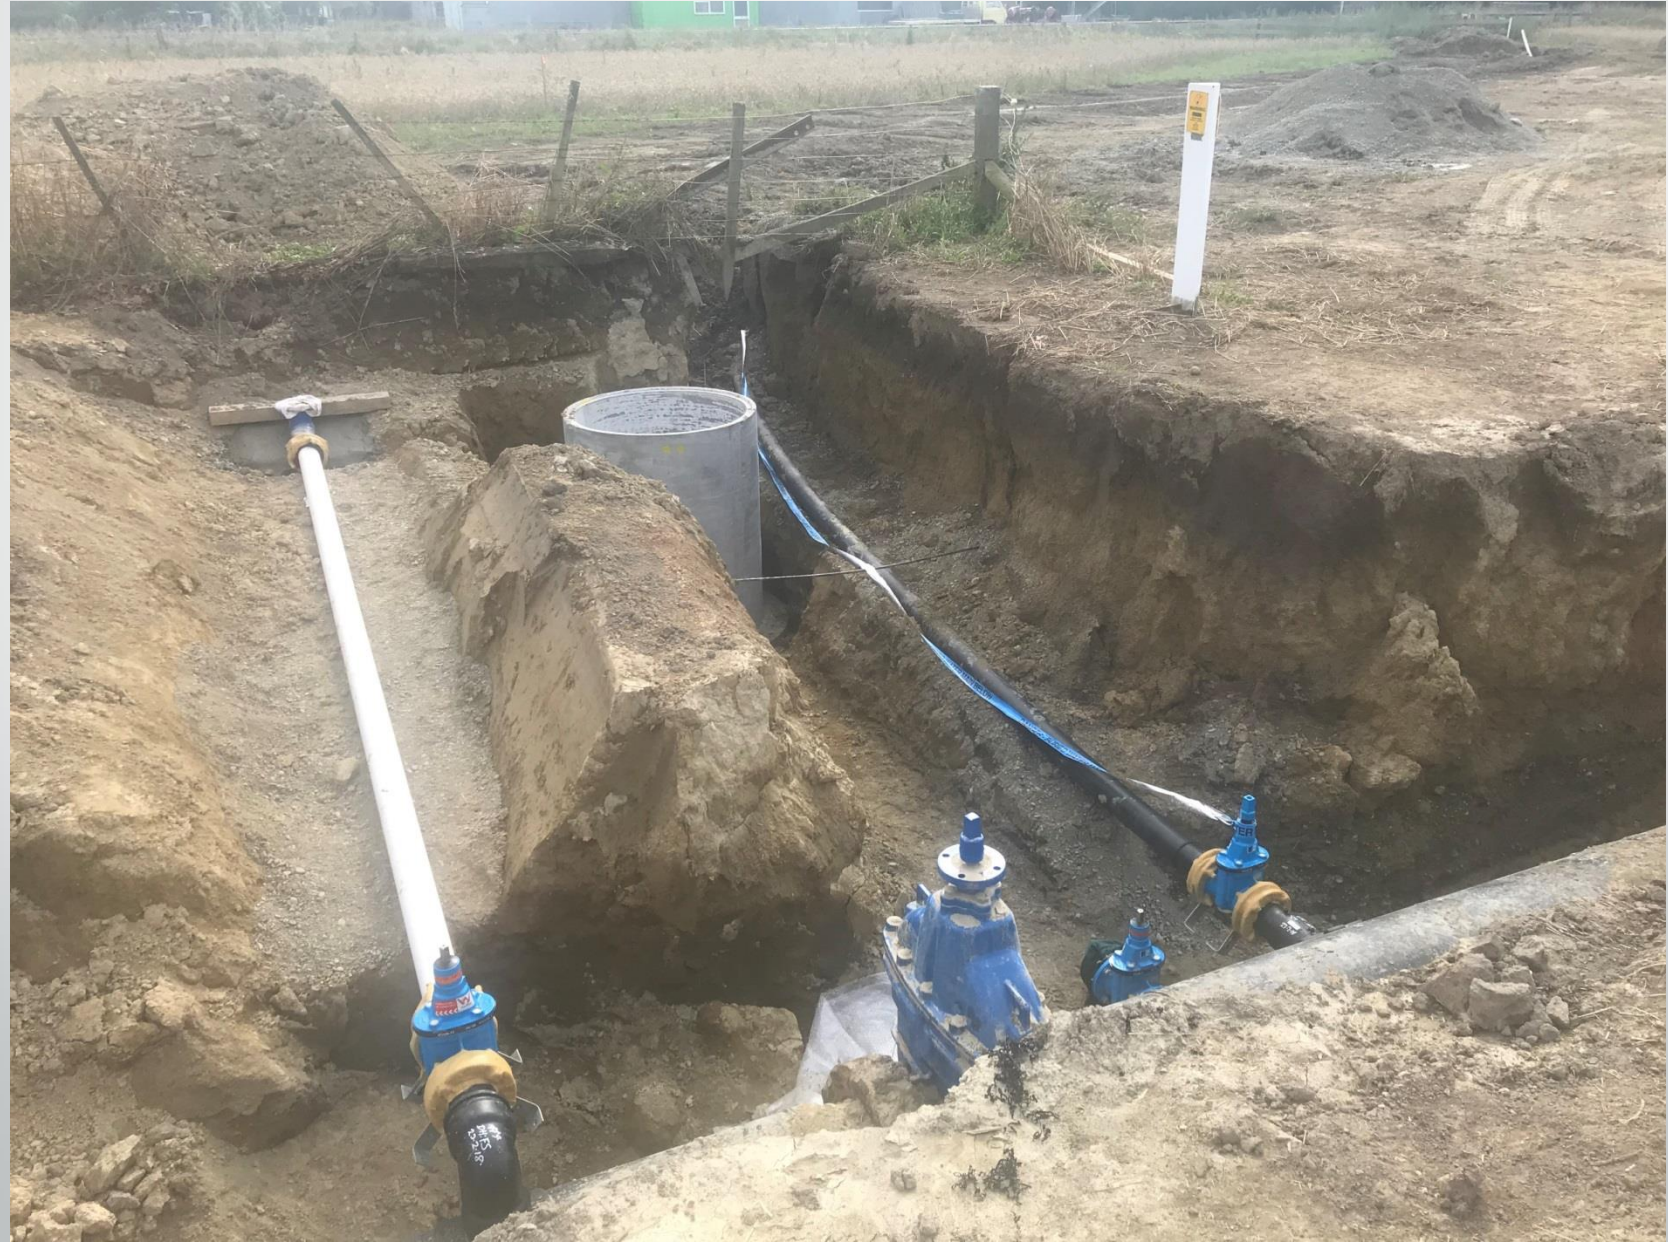
## Zone 2: Winchester Connection

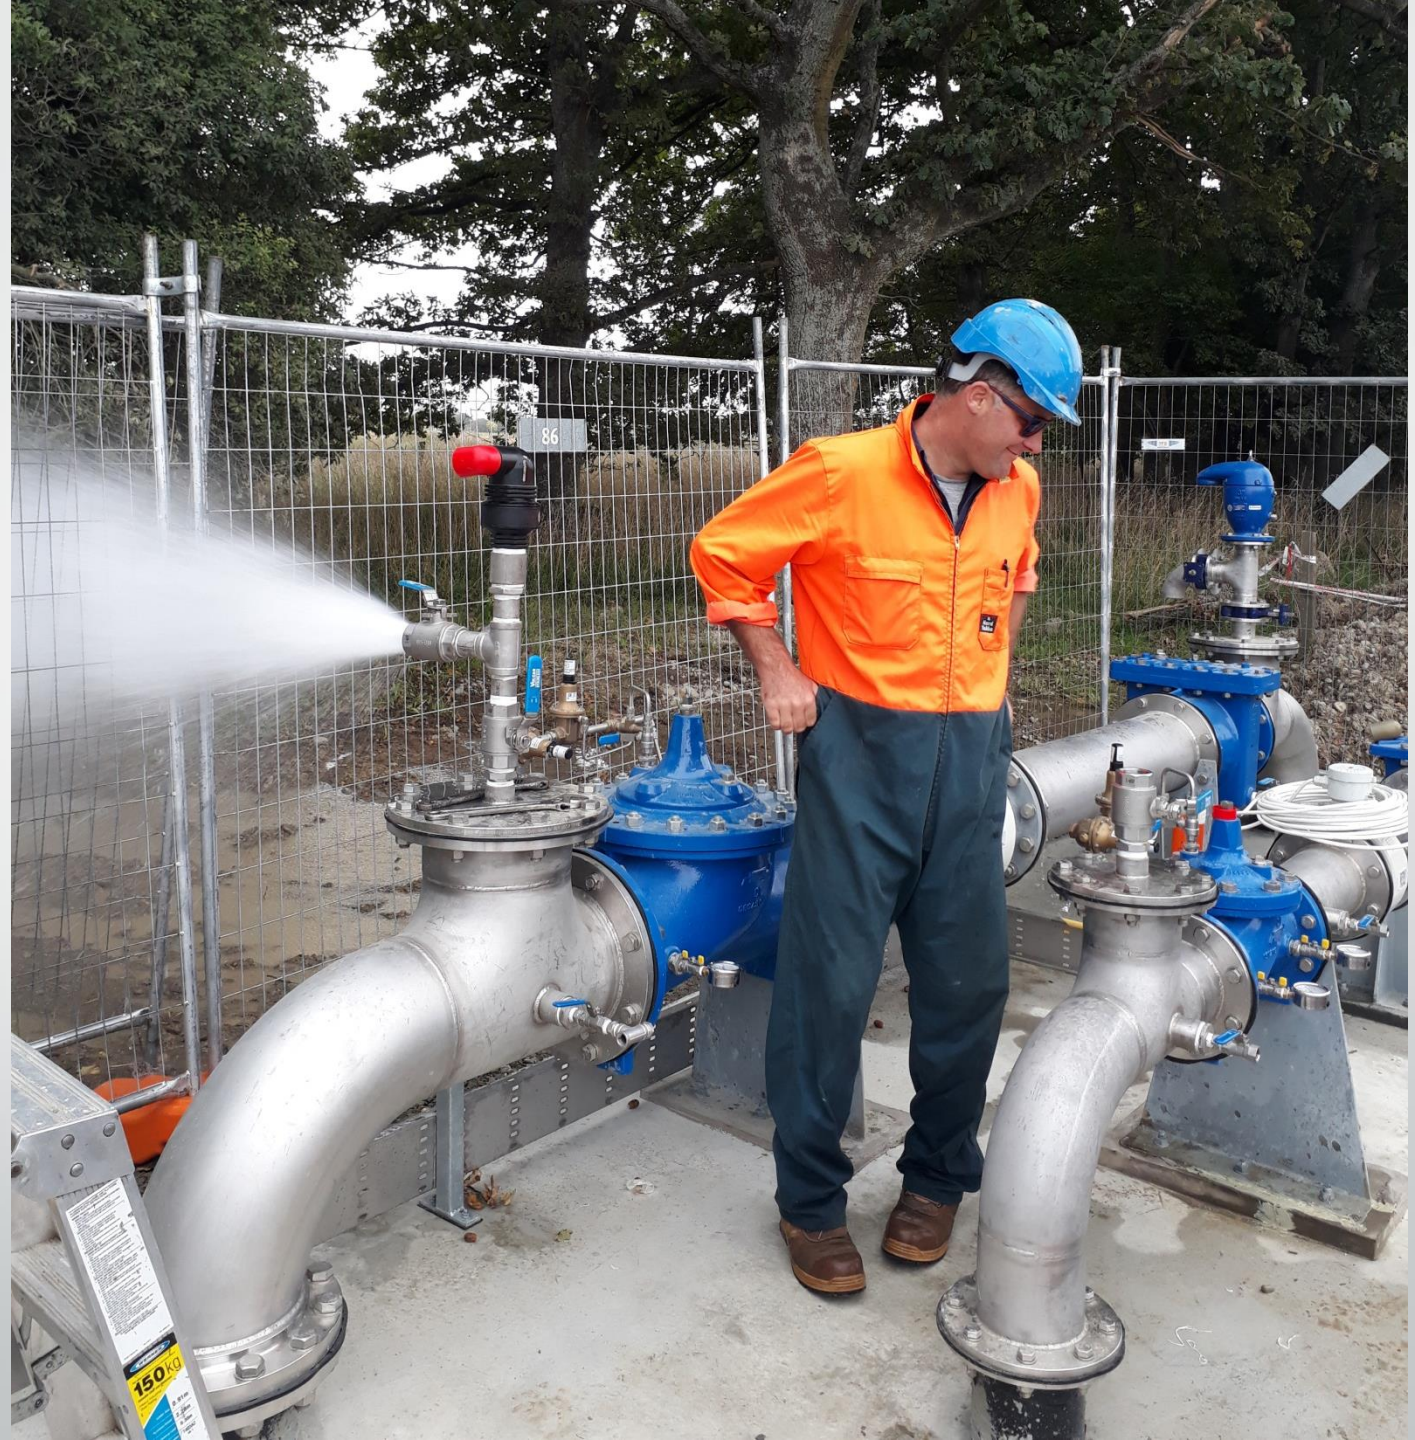
20.03.2018

# PRV Testing

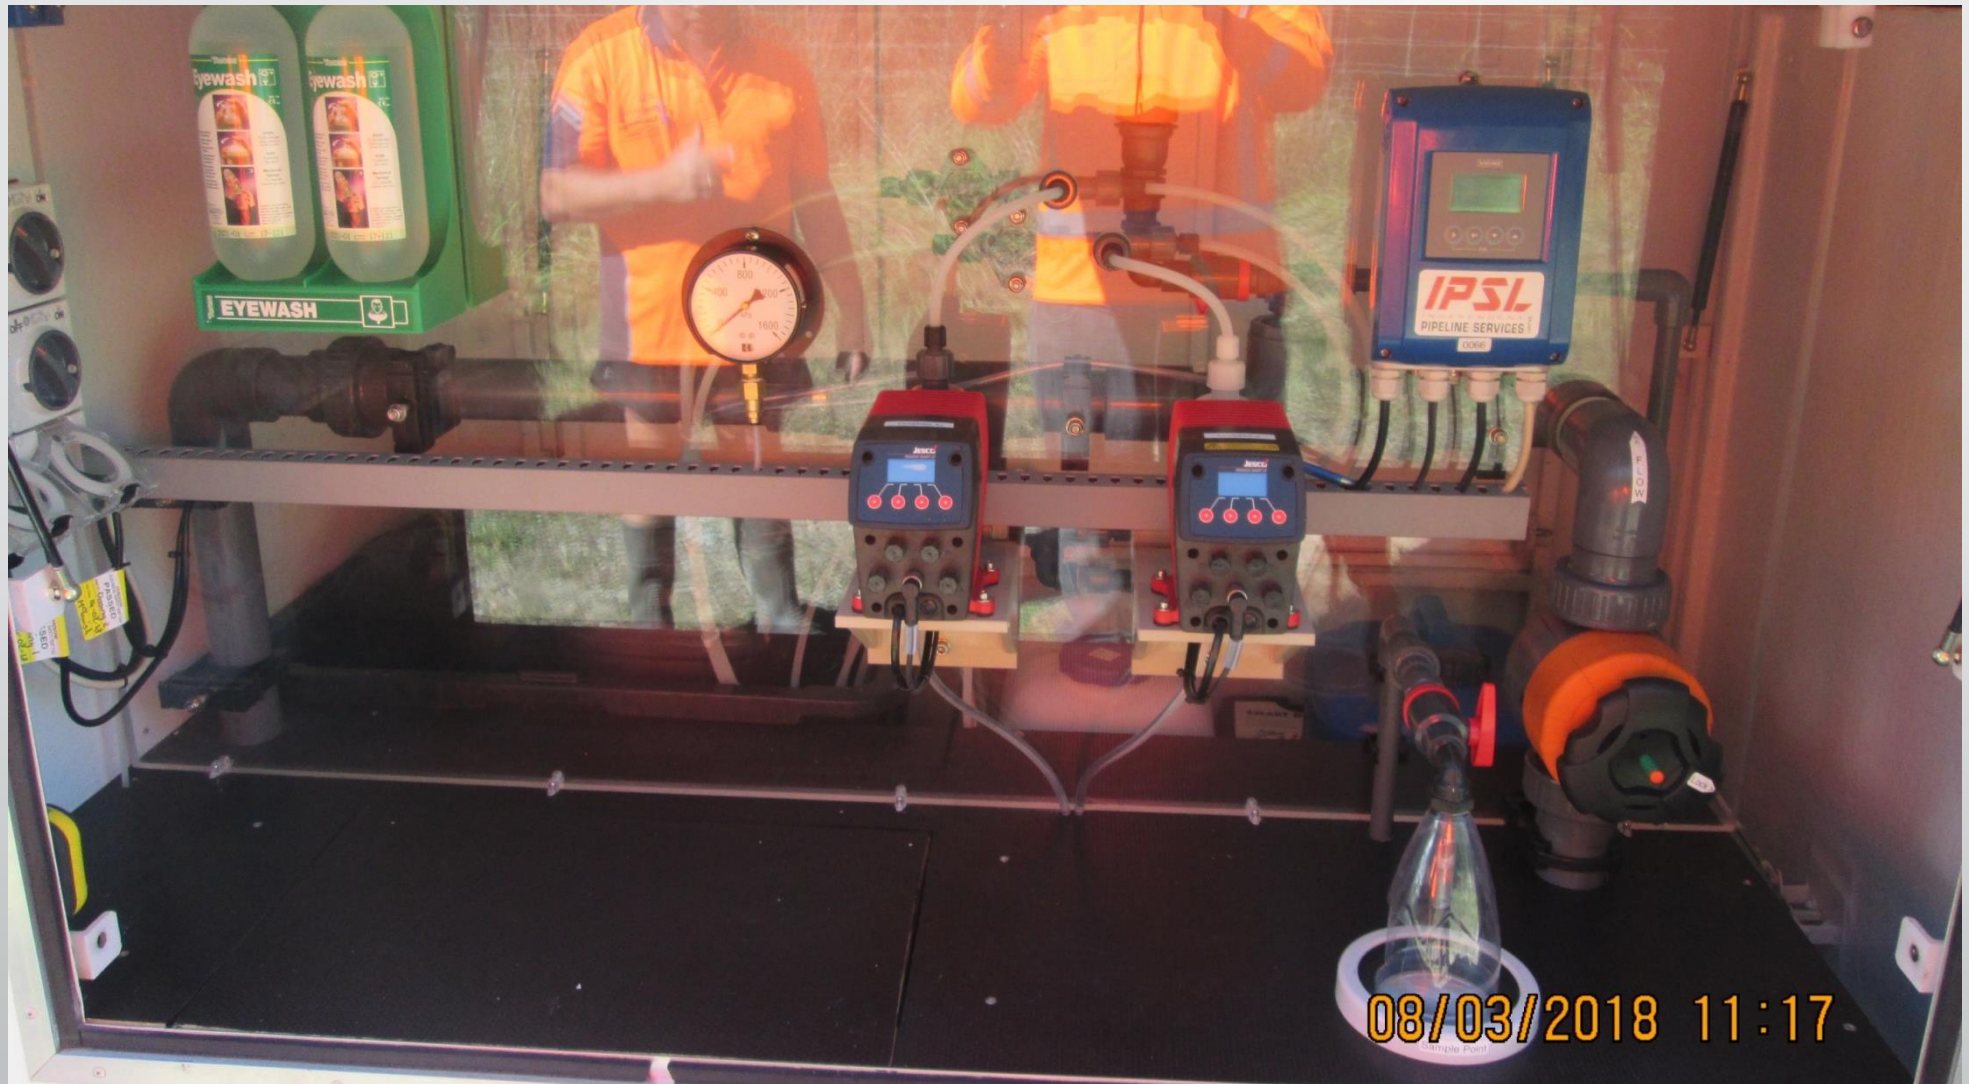
# All Zones: Chlorination

- Testing
- Swabbing
- Sterilisation – Chlorination
- De-chlorination
- Cut Over
