# **INNOVATIONS IN PUBLIC LIGHTING INSPECTION AND ASSET MANAGEMENT**

**Spencer, N<sup>1</sup>**

<sup>1</sup>Revo Group Pty Ltd, Newcastle, NSW

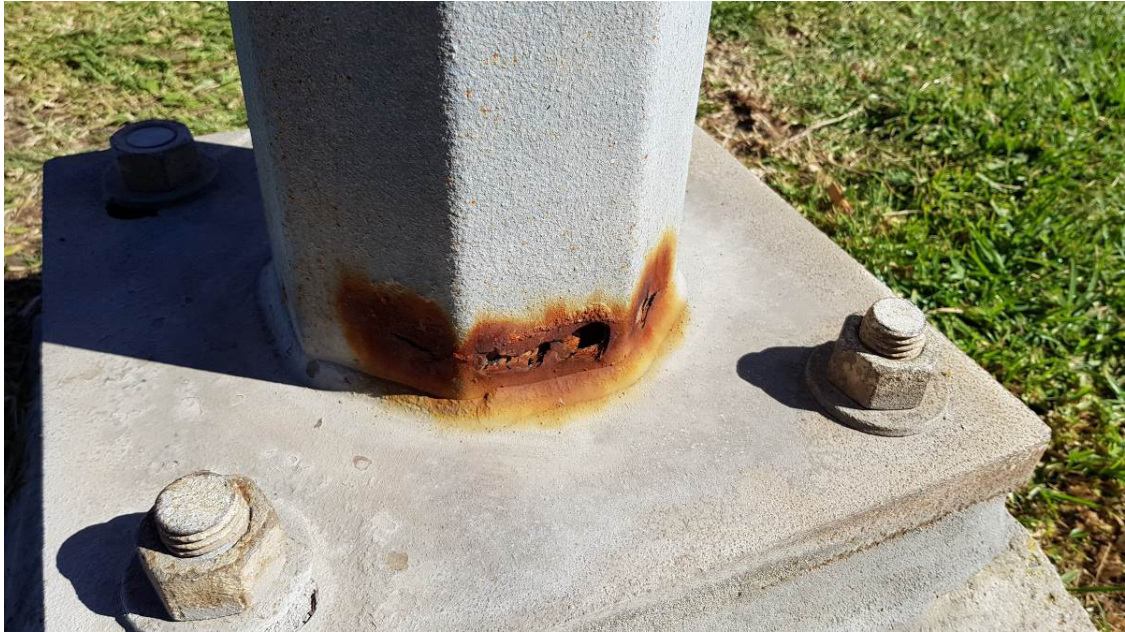
**Figure 1: Typical location and result of corrosion for base plate mounted poles.**

UT thickness tools are the most commonly used tools for steel pole inspection. This is likely to continue for flange-based poles on concrete footings. For Flange based poles the corrosion typically occurs at or just above the base plate due to a build-up of moisture on the inside of the pole (Figure 1).

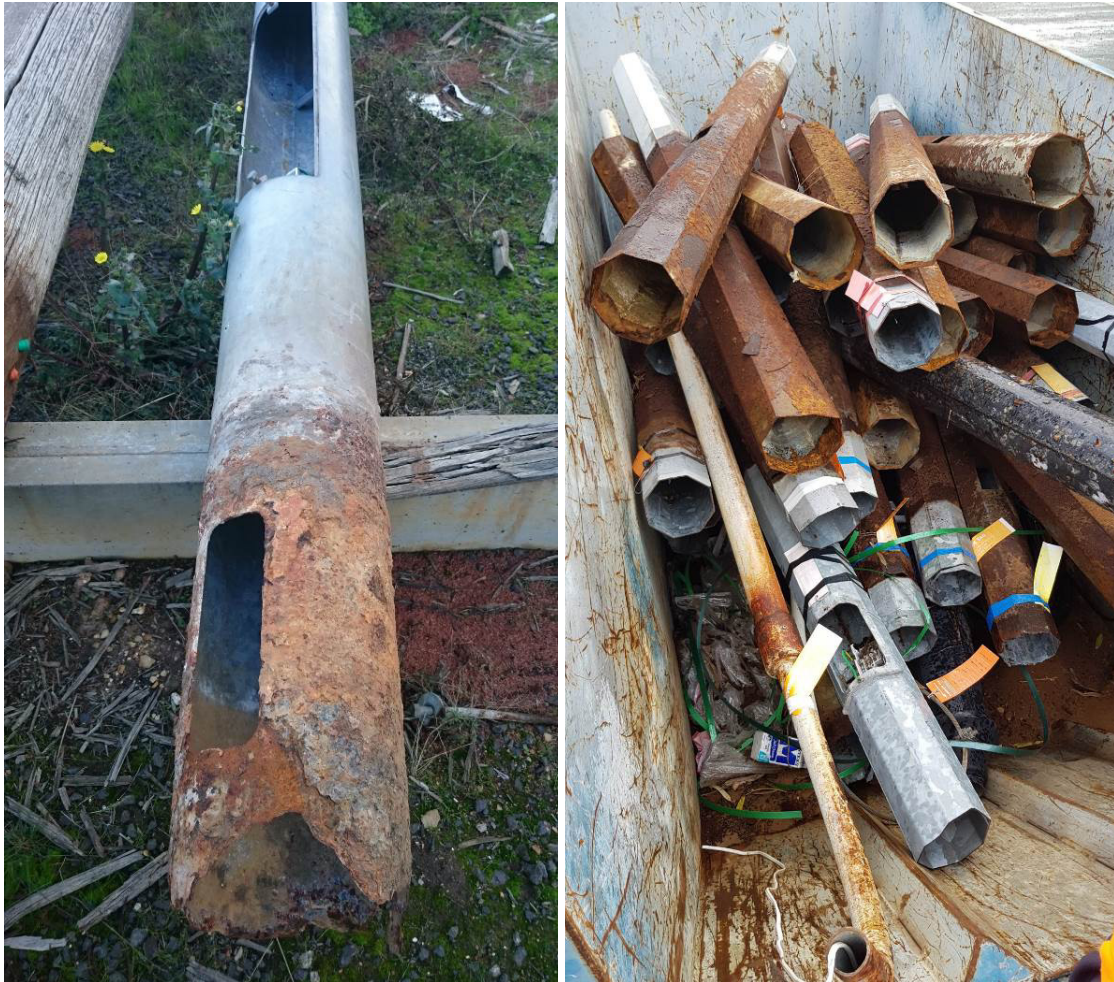
Figure 2: Examples showing corrosion of steel poles can occur anywhere below ground.

However, the primary concern for direct-buried steel poles is the below ground region. Unlike wood poles where the majority of decay and insect attack occurs above 400mm below ground line, steel can deteriorate anywhere below or above ground line, and in our experience there is an increasing instance of corrosion failures more than 400mm below ground (typical depth an inspector may dig to inspect a pole). Figure 2 shows some examples of the extent that corrosion can occur below ground. In this case the UT thickness methods become cumbersome, time consuming and inaccurate (depending on whether there is access to the worst location or not).

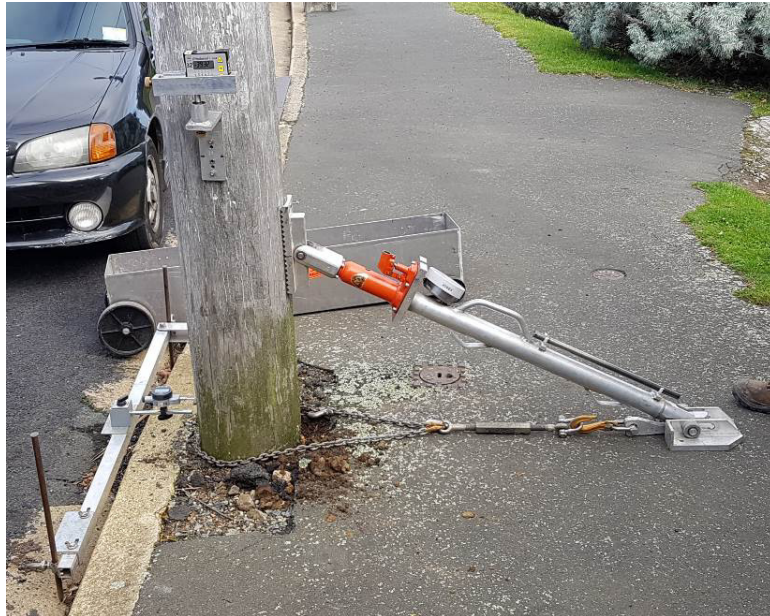
Figure 6: The Deuar MPT device set up for a test.

Proof loading is a technique that has found favour with some utilities in Australia and New Zealand in particular. The two main technologies in this space are the Deuar MPT, and the Rei-Lux device. The Rei-lux device is probably more suited to steel poles, but it is simpler to group it in this area for the purposes of this discussion.

The technology normally performs well in comparative tests, as it gives an “almost” direct measurement of residual strength. In reality, it is determining the stiffness of the pole with a bias towards the ground line, and comparing that to an assumed stiffness vs. strength relationship. The technique is one of the more time consuming techniques and can be very sensitive to small errors in setup/operator input. One of the issues to be aware of, is that the determination of load on the pole can be a downfall of this method, and it has been known to turn an otherwise good measurement of residual strength, into an incorrect result for serviceability index (strength divided by design load). There have been concerns raised around repeatability and reproducibility from some users as well. There is also concern over the techniques causing failure of the pole due to the exerted loads.
