Temuka water event (asbestos)

Ashley Harper

Group Manager Infrastructure, Timaru District Council, New Zealand

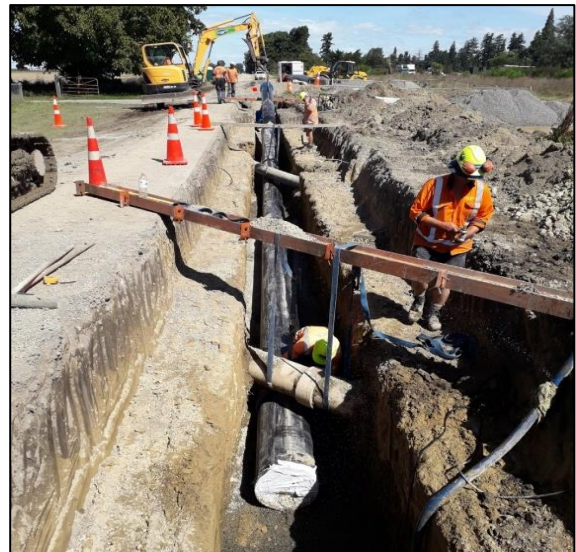
Crossing existing 300mm AC pipe

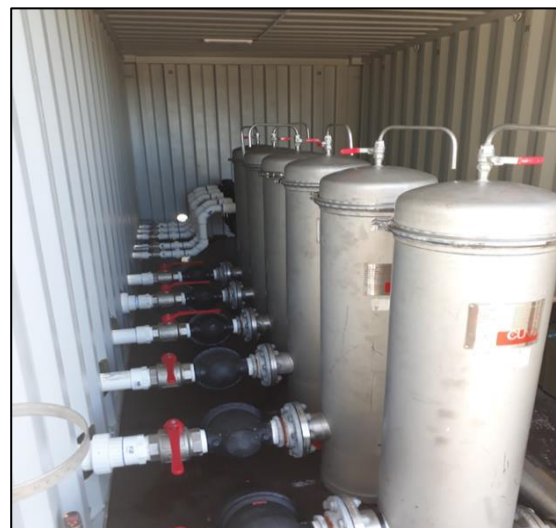
The filtration plant had been sitting in Christchurch in-case it was required for an emergency deployment during the major infrastructural repairs following the earthquake. Our Development and Renewals Engineer was aware of the plant and suggested that we may be able to use it as a stop gap measure while the replacement work was underway.

The plant was sourced, modified and installed within 3 weeks of the problem being discovered.
