# Townsville City Council, From Condition Data to Informed Decisions Using PARMMS-Horizons Management Tool

Ernesto Urbaez  
([eurbaez@pavement.com.au](mailto:eurbaez@pavement.com.au))  
PMS-QLD

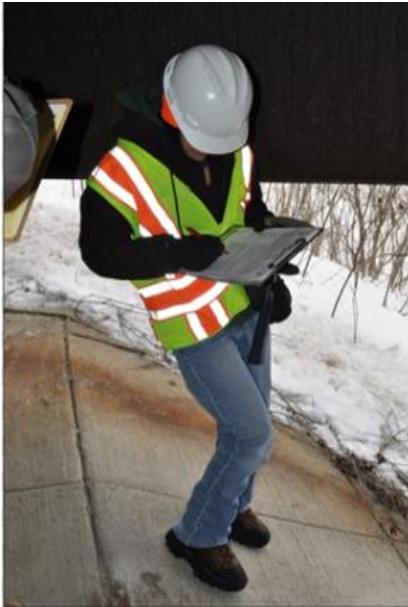
## Traditional (Qualitative)

MICHIGAN DEPARTMENT OF TRANSPORTATION									
SAFETY INSPECTION REPORT - CURB ELEMENTS									
SITE INFO		MILEPOST		STRUCTURE ID		STRUCTURE CONDITION		MILE CODE	
Project	Latitude / Longitude	MILEPOST	Structure ID	Structure Condition					
File No	42.62172 / -85.42328	0000000000000000	0000000000000000	Not Available					
Feature	Length / Width	Owner							
CONCRETE BRIDGE	150' / 14.0'	Region (Interstate)							
Location	State / Route / Post-Mile	TRC	Operational Status						
111 MI S OF I-75, I-75	1178 / 1 / 2008 / 2008	CONCRETE	2 State (in operation)						
Region / County	Material / Design	Last MI Inspection	Scale Evaluation						
Westland / Washtenaw	1.5 Slab / 48 Stringer/Slab	08/01/2013 / 08/01	1.00 / 1000000						
INSPECTION TEAM									
Inspector Name	Agency / Company Name	Emp. Photo	Emp. Date						
James DeWitt	MS&T INSPECTOR	JA	03/07/2013						
CURB ELEMENTS									
Element	Element Name	Total Quantity	Dist. 1	Dist. 2	Dist. 3	Dist. 4	Dist. 5	Dist. 6	Dist. 7

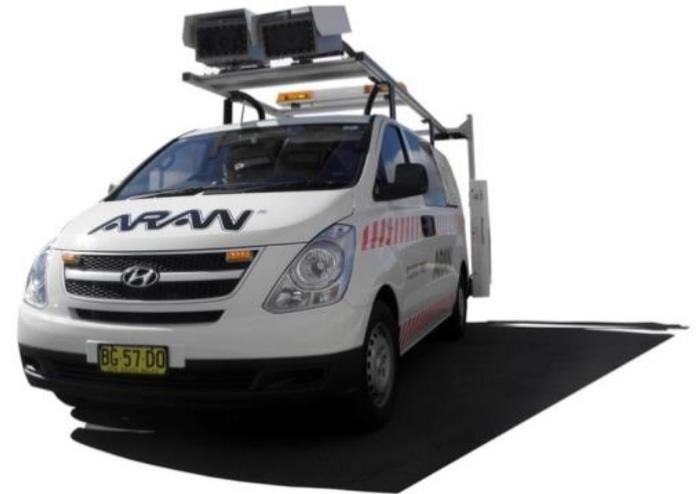
# Collected by PMS using the ARAN System

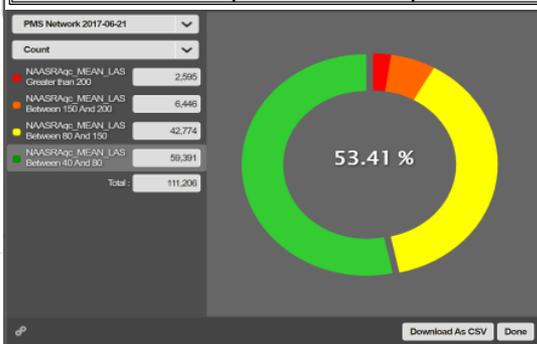
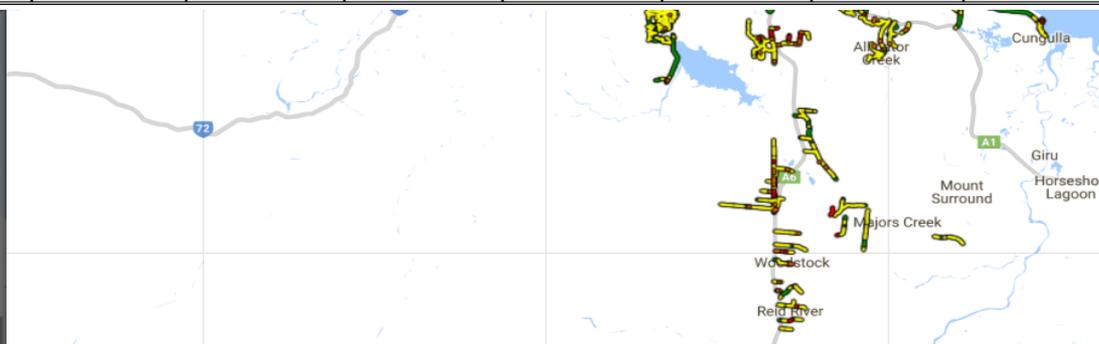
# Distribution of Roughness (NRM) Across the Network

Roughness (NRM) Bins	Network	Seal				Asphalt			
		Class 1&2	Class 3&4	Class 5	Class 6, 7&8	Class 1&2	Class 3&4	Class 5	Class 6, 7&8
40 – 80	53.41%	57.76%	52.80%	41.08%	-	67.10%	61.76%	57.85%	-
80 – 150	38.46%	30.42%	37.91%	46.13%	-	28.04%	33.09%	36.58%	33.33%
150 – 200	5.80%	7.70%	6.73%	8.83%	50.00%	3.42%	3.90%	4.16%	-
> 200	2.33%	4.12%	2.57%	3.97%	50.00%	1.44%	1.24%	1.41%	66.67%

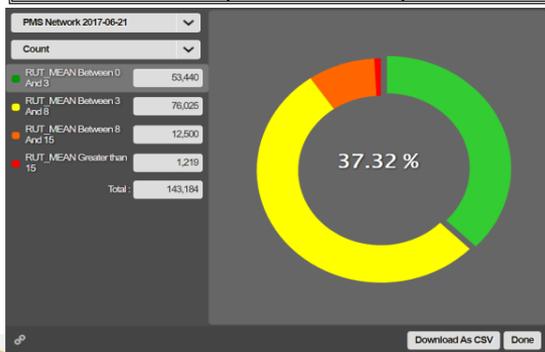
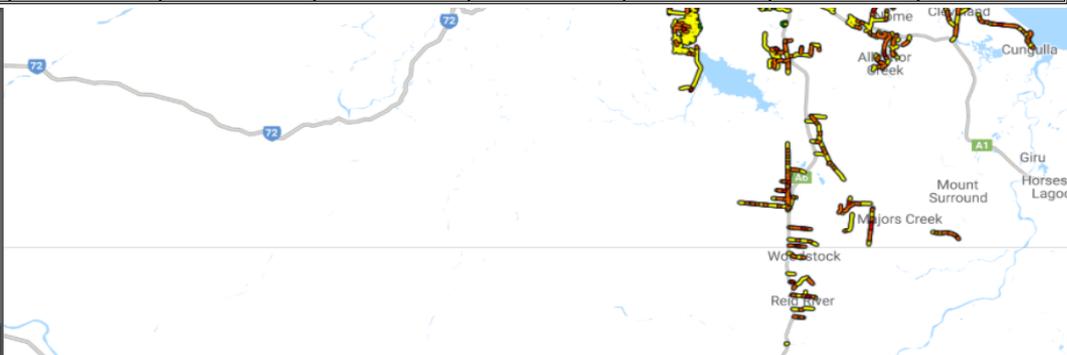
# Distribution of Rut Depth (mm) Across the Network

Rutting (mm) Bins	Network	Seal				Asphalt			
		Class 1&2	Class 3&4	Class 5	Class 6, 7&8	Class 1&2	Class 3&4	Class 5	Class 6, 7&8
0 – 3	37.32%	7.92%	5.25%	11.54%	-	31.95%	44.29%	58.86%	-
3 – 8	53.10%	75.86%	65.37%	68.67%	-	62.37%	52.58%	39.18%	100%
8 – 15	8.73%	15.03%	26.67%	18.84%	50.00%	5.29%	2.98%	1.75%	-
> 15	0.85%	1.19%	2.72%	1.75%	50.00%	0.40%	0.15%	0.21%	-

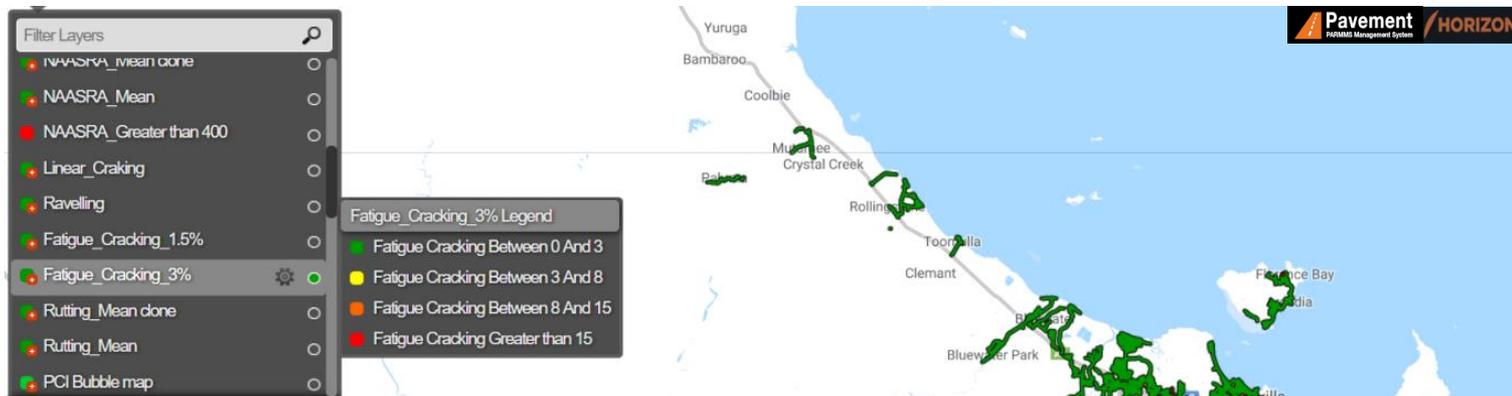
# Distribution of Cracking (% Area) Across the Network

Fatigue Cracking (%) Bins	Network	Seal				Asphalt			
		Class 1&2	Class 3&4	Class 5	Class 6, 7&8	Class 1&2	Class 3&4	Class 5	Class 6, 7&8
0 – 3	95.88%	96.35%	99.33%	98.59%	100%	95.48%	96.12%	93.79%	71.43
3 – 8	1.45%	1.30%	0.22%	0.50%	-	1.77%	1.38%	2.16%	-
8 – 15	1.38%	1.22%	0.25%	0.45%	-	1.45%	1.49%	2.04%	14.29%
> 15	1.30%	1.13%	0.19%	0.46%	-	1.30%	1.01%	2.01%	14.29%

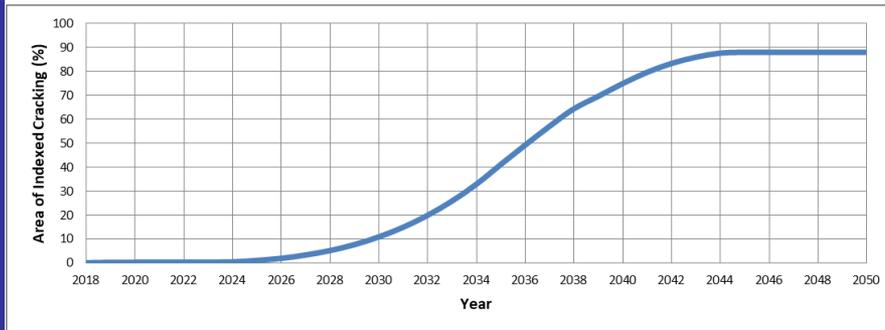
## Cracking

# Deterioration Models Based on Historical Data / PMS Experience

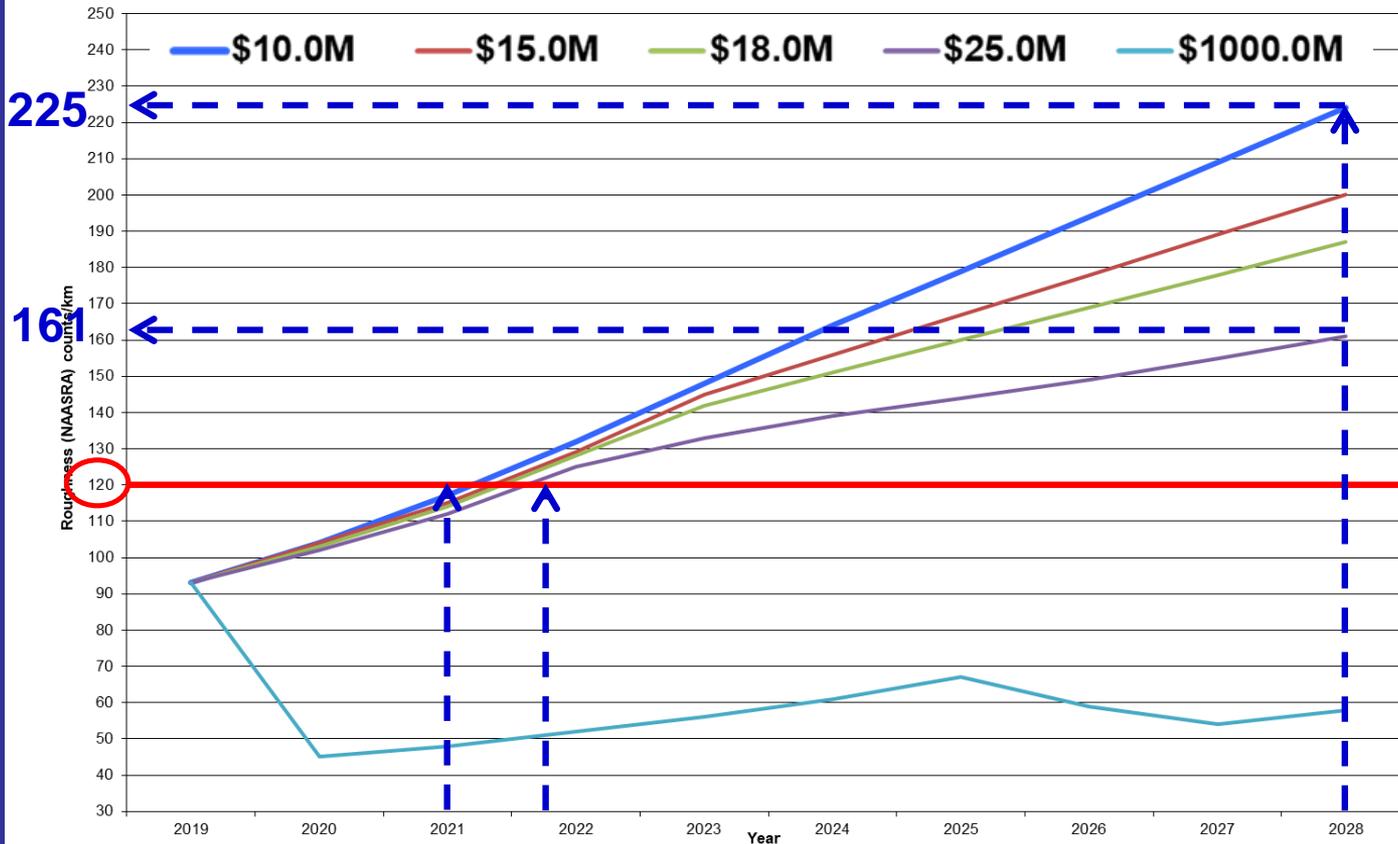
# Budget Comparison and Analysis (per Year)

KPI for Reconstruction

Roughness Progression vs. Budget Strategy

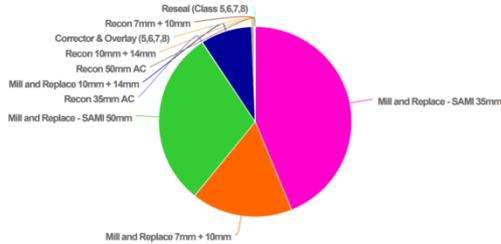
Total Spend Required \$636,888,380.60

This report contains details regarding the complete list of treatments triggered over the network in the current condition. The total cost of treatments given below is indicative and is based on the treatment costs provided within treatment definitions. A detailed list of treatments can be found in the Treatment Set Configuration report.

Mill and Replace - SAMI 35mm	\$279,210,373.92
Mill and Replace 7mm + 10mm	\$108,076,212.70
Mill and Replace - SAMI 50mm	\$190,509,022.83
Recon 35mm AC	\$397,680.00
Mill and Replace 10mm + 14mm	\$54,883,473.60
Recon 50mm AC	\$2,117,901.85
Recon 10mm + 14mm	\$1,029,789.17
Corrector & Overlay (5,6,7,8)	\$393,832.33
Recon 7mm + 10mm	\$266,944.20
Reseal (Class 5,6,7,8)	\$3,150.00

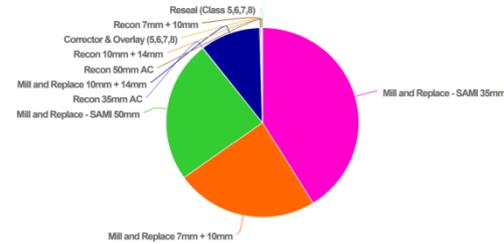
Total Quantity Required 9,035,407 m<sup>2</sup>

This report contains details regarding the complete list of treatments triggered over the network in the current condition. The total quantity of treatments given below is indicative and is based on the treatment type provided within treatment definitions. A detailed list of treatments can be found in the Treatment Set Configuration report.

Mill and Replace - SAMI 35mm	3,722,806 m <sup>2</sup>
Mill and Replace 7mm + 10mm	2,161,524 m <sup>2</sup>
Mill and Replace - SAMI 50mm	2,189,759 m <sup>2</sup>
Recon 35mm AC	3,977 m <sup>2</sup>
Mill and Replace 10mm + 14mm	914,725 m <sup>2</sup>
Recon 50mm AC	18,910 m <sup>2</sup>
Recon 10mm + 14mm	10,840 m <sup>2</sup>
Corrector & Overlay (5,6,7,8)	9,377 m <sup>2</sup>
Recon 7mm + 10mm	3,141 m <sup>2</sup>
Reseal (Class 5,6,7,8)	350 m <sup>2</sup>

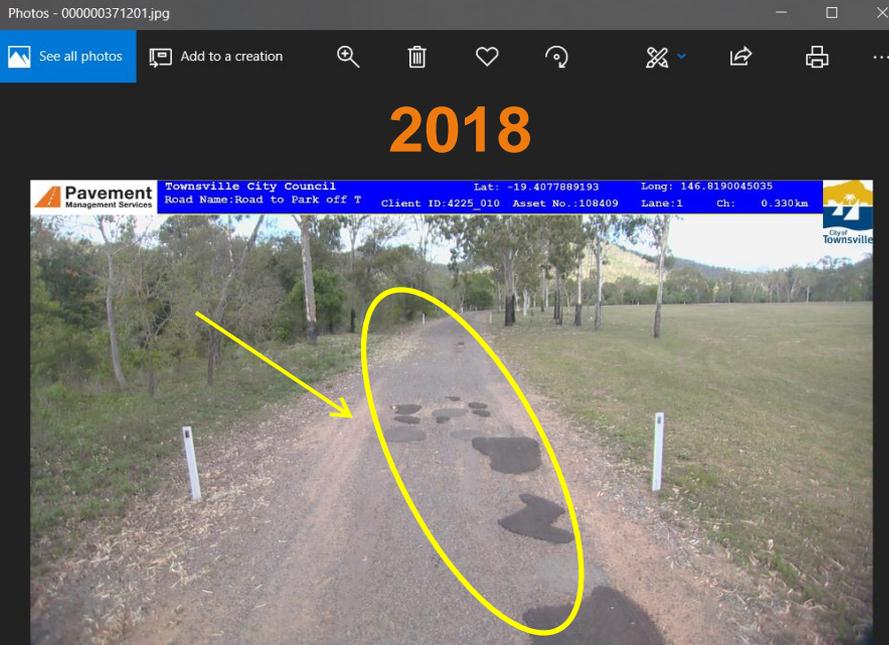
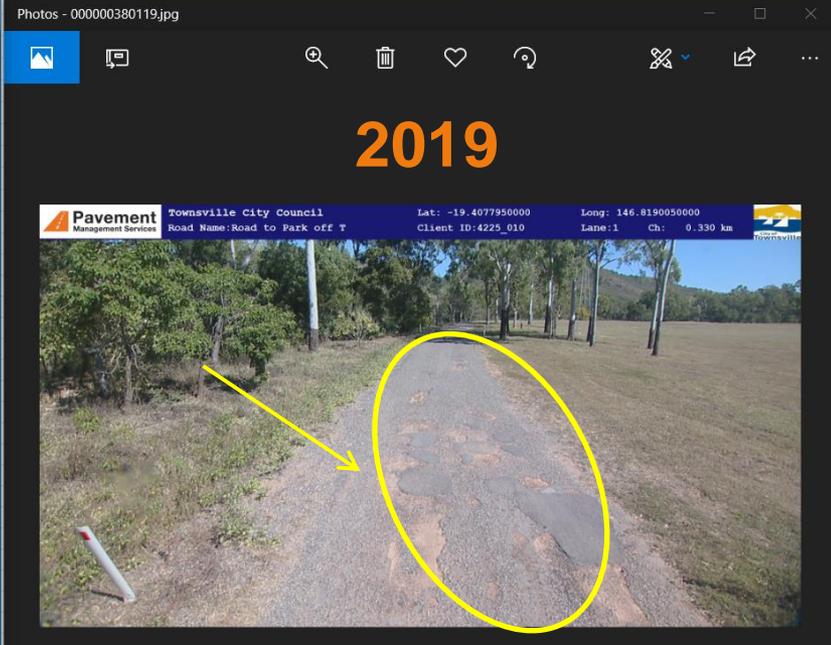
pms_id	Route_Name	client_id	Ru_18	Ru_19	Pothole_18	Pothole_19	Irregular_Patching_18	Irregular_Patching_19	ROW_18	ROW_19
T4225LA1L11S0010	Road to Park off T	4225_010	10.5	16.4	2.97	10.13	8.9	18.74	V:/Townsville/2018/PartB/ROW/000000371201.jpg	V:/Townsville/2019/PartB/ROW/000000380119.jpg
