## Simpson Street Tunnel Rehabilitation and Lining Stage 1

Rohan D McKinnon <sup>1\*</sup> and Luke Coughlan<sup>2</sup>

<sup>1</sup> Senior Projects Engineer, Warrnambool City Council

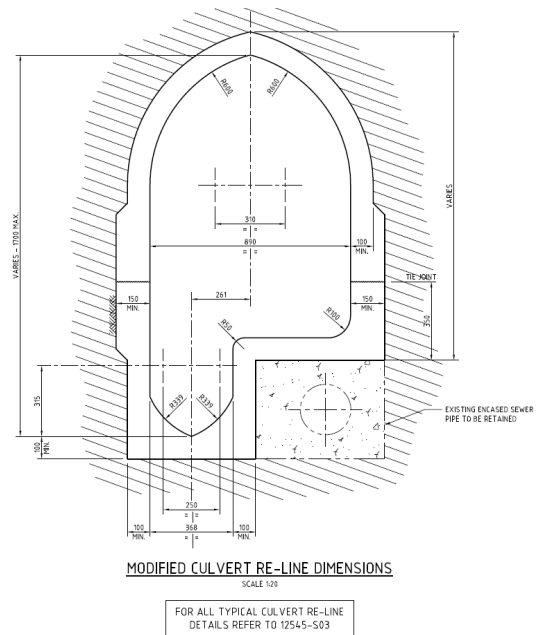
To accommodate the sewer in this section of tunnel a modified ovoid profile was used. (See Figure 10). The modified profile maintained the invert of the tunnel near the original level and maximized the water way area.

Figure 10: Tunneline profile

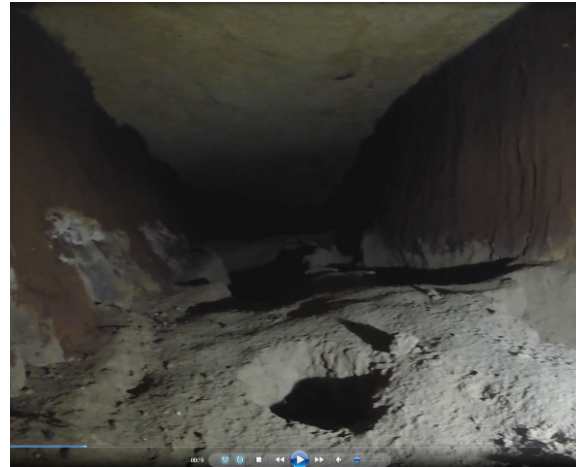
During the Tunneline works a large void over the first 30 metres of multi-plate culvert was discovered downstream of MH 4. (See Figures 16-17). The demolition of the culvert and replacement with liner was included in the works.

Figure 16: Entrance to void over multi-plate culvert

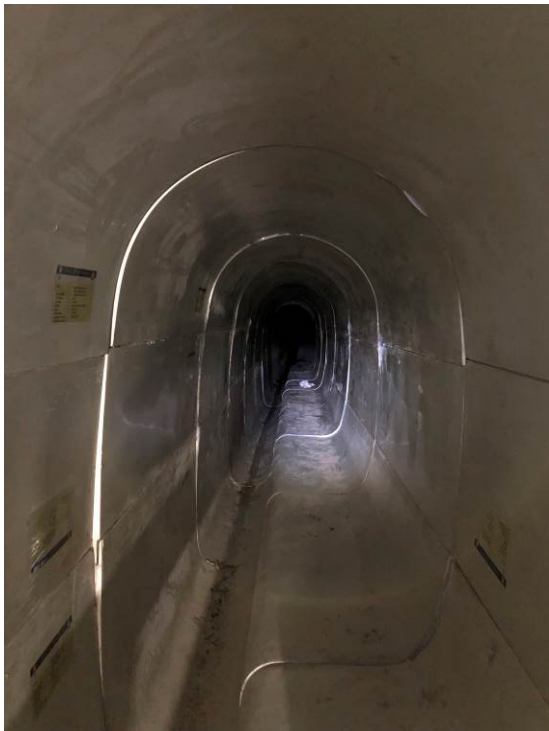
Figure 25 shows the inside of the tunnel before grouting, the inside surface of the GFRP pipes is smooth, there is some roughness at the joints, but a much improved product over the unlined tunnel.

Figure 24: GFRP liner ready for grouting
