## Stormwater pipe condition assessments - if only animals could talk

**C Campbell<sup>1</sup>**

<sup>1</sup> Moreton Bay Regional Council, Strathpine, QLD

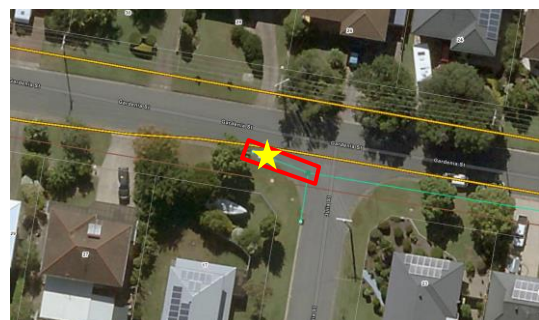
**Figure 1:** Map showing the stormwater and sewer networks (pipe of interest shown in red and intruding service shown in yellow)

**Background:** In 2010 Council completed a routine inspection of the 300mm stormwater pipe and identified a break at one of the pipe joints. Sometime between late-2011 and mid-2012, Unitywater constructed a vent pole to the south of the pipe to connect to their existing sewer manhole to the north of the pipe. In 2017 Council reinspected the 300mm pipe in preparation for relining and discovered a service had been built through it.

**Issue:** As the service was constructed through the pipe; slightly obstructing the pipe and pushing concrete and reinforcement into the pipe, relining was no longer a viable solution.

**Outcome:** Council are still working with Unitywater to get the service relocated and the stormwater pipe replaced.

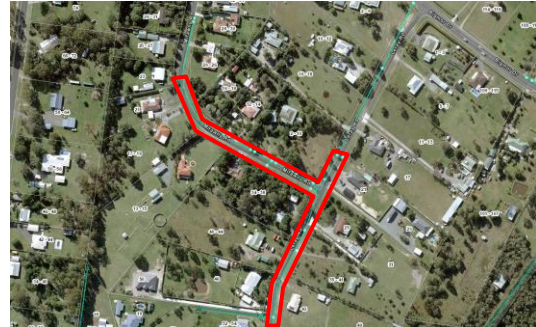
**Figure 4:** Map showing the stormwater pipe network (damaged network shown in red)

**Background:** The stormwater network was constructed in 1997. In 2012 Operations inspected and replaced a collapsed pipe in Leray Road. In early 2017 Operations patched a large pothole (located over the stormwater network) at the corner of Mifawny Road and Leray Road. In late 2017 Operations were called out to address a sinkhole (located behind a catchpit) in Mifawny Road. Operations requested CCTV of the affected

pipe and pit. When the CCTV came back showing the invert of the pipe had disappeared and the top of the catchpit had collapsed, Drainage requested CCTV of the entire network in the area.

**Issue:** The 500 metres of FRC pipe ranging in size from 300mm to 750mm in diameter was in very poor condition due to invert corrosion, circumferential and longitudinal cracking and fracturing, and complex cracking and fracturing. The rural residential area had no evidence of anything that would cause failures of this nature, and Council did not want to risk replacing the network and having it fail within 20 years. Council engaged GHD to conduct a number of tests to determine the failure mechanism and recommend a replacement pipe material. GHD's investigation determined that acid attack from the inside of the pipe was the most likely cause of the deterioration, however were not able to determine the cause of the acid attack.

**Outcome:** In 2019 Council replaced all the affected FRC pipes with HDPE pipes and brought in imported backfill material.

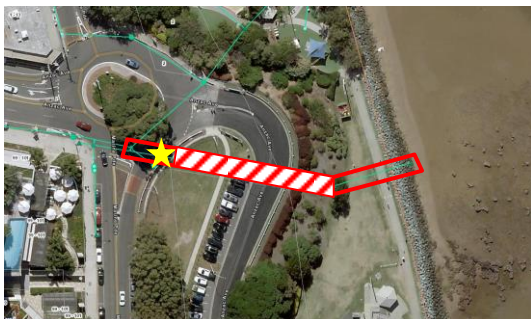
**Figure 7:** Map showing the stormwater pipe network (investigation area shown in red, unknown network shown in hatching, and collapsed pipe shown in yellow)

**Background:** In 2017 Council completed a routine inspection of a stormwater pipe in Marine Parade and Anzac Avenue and found it had collapsed. This pipe was not on Council's asset register and had no as-constructed plans. Council wanted to determine the location and condition of the rest of the pipe and network before replacing the section of damaged pipe, however encountered some barriers.

**Issue:** After all the investigation Council could reasonably do, the condition of the remaining 90% of the 450mm pipe was unknown. Another element that complicated any renewal was that the Department of Transport and

**Outcome:** Council decided to abandon the 450mm pipe at the upstream manhole. This leaves the unknown network in place for any pipes connecting into it, however does not address the major defect. If the area above this defect does eventually collapse, Council will repair the defect and inspect the rest of the network.

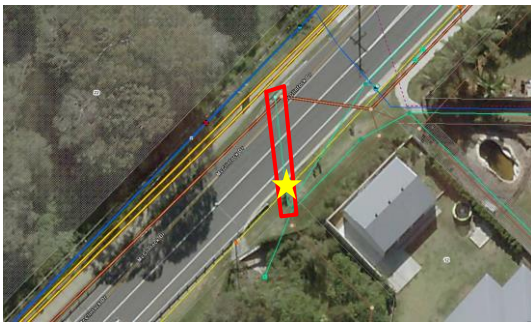
**Figure 10:** Map showing stormwater network and other services (pipe of interest shown in red and large break shown in yellow)

**Background:** In early 2016, Council completed a routine inspection of the upstream 2m of the pipe. This CCTV only covered a short length of pipe but suggested the rest of the pipe was in reasonable condition with no obstructions. In early 2017, a road rehabilitation of McClintock Road was finished. This included construction of kerb and channel near the pipe of interest. In mid-2017, Council completed a post-construction inspection of the downstream 5m of pipe. This CCTV showed a large break and void located roughly where the kerb and channel crossed the pipe.

**Issue:** The original CCTV did not inspect the damaged section of pipe, however it did show that the pipe appeared to be intact. The new CCTV, when reviewed very closely, showed a subsoil pipe above the broken and displaced concrete and void. A review of the as-constructed plans showed no assets were constructed near the major defect, except for the kerb and channel. Council would normally replace a section of pipe with this type of defect, however did not want to damage brand new pavement or kerb and channel.

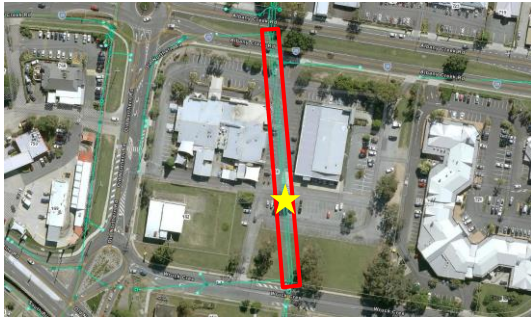
**Figure 13:** Map showing the stormwater network (pipes of interest shown in red and root blockage shown in yellow)

**Background:** In 2017 Council completed a routine inspection of the 1800x900mm twin box culverts running through an easement on private property on Albany Creek Road. These large box culverts were severely blocked with tree roots. A site inspection identified a large

fig tree in an island in the carpark as the likely culprit.

**Issue:** The access points for the culverts were 45m upstream and 100m downstream from the blockage. This posed an issue when it came to confined space, particularly as the culverts, at 900mm high, were not a comfortable height to walk through. Council decided it would be safer, cheaper, and better in the long run to install a manhole where the blockages were. This would allow the blockages to be removed more quickly, safely, and cheaply, and would provide an access point in future. The property owner was supportive of Council removing the tree to install the manholes and unblock the culverts, with the understanding that the tree would not be reinstated in the easement.
