The Importance of Adequate Development Compliance from an Asset Managers Perspective

Case Study

Property damage believed to be caused by
insufficient drainage infrastructure

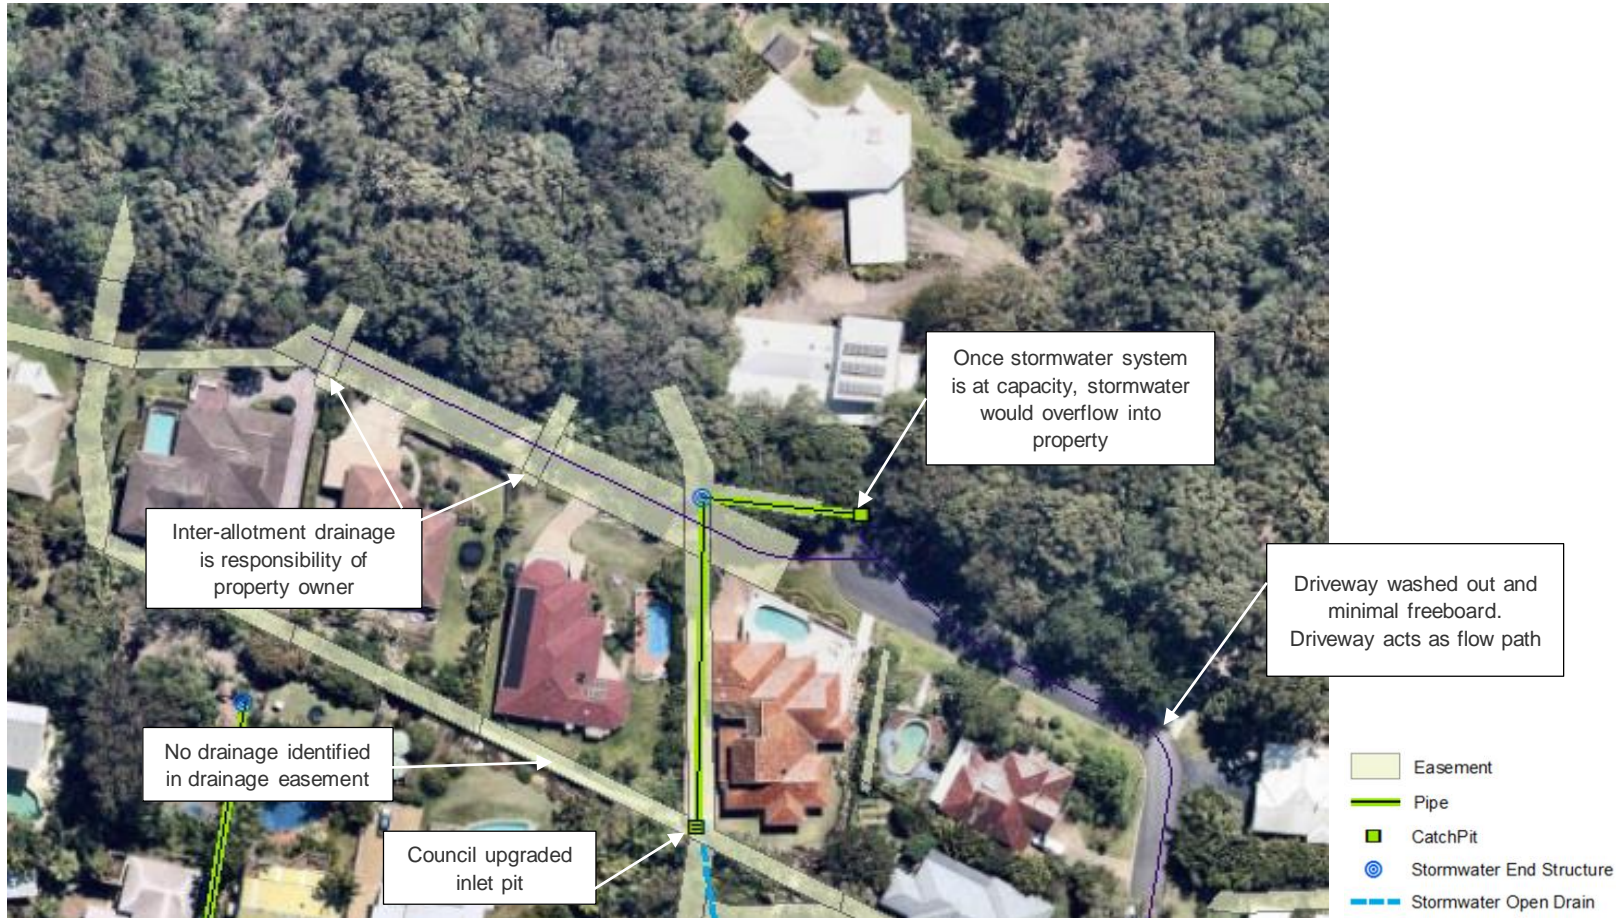
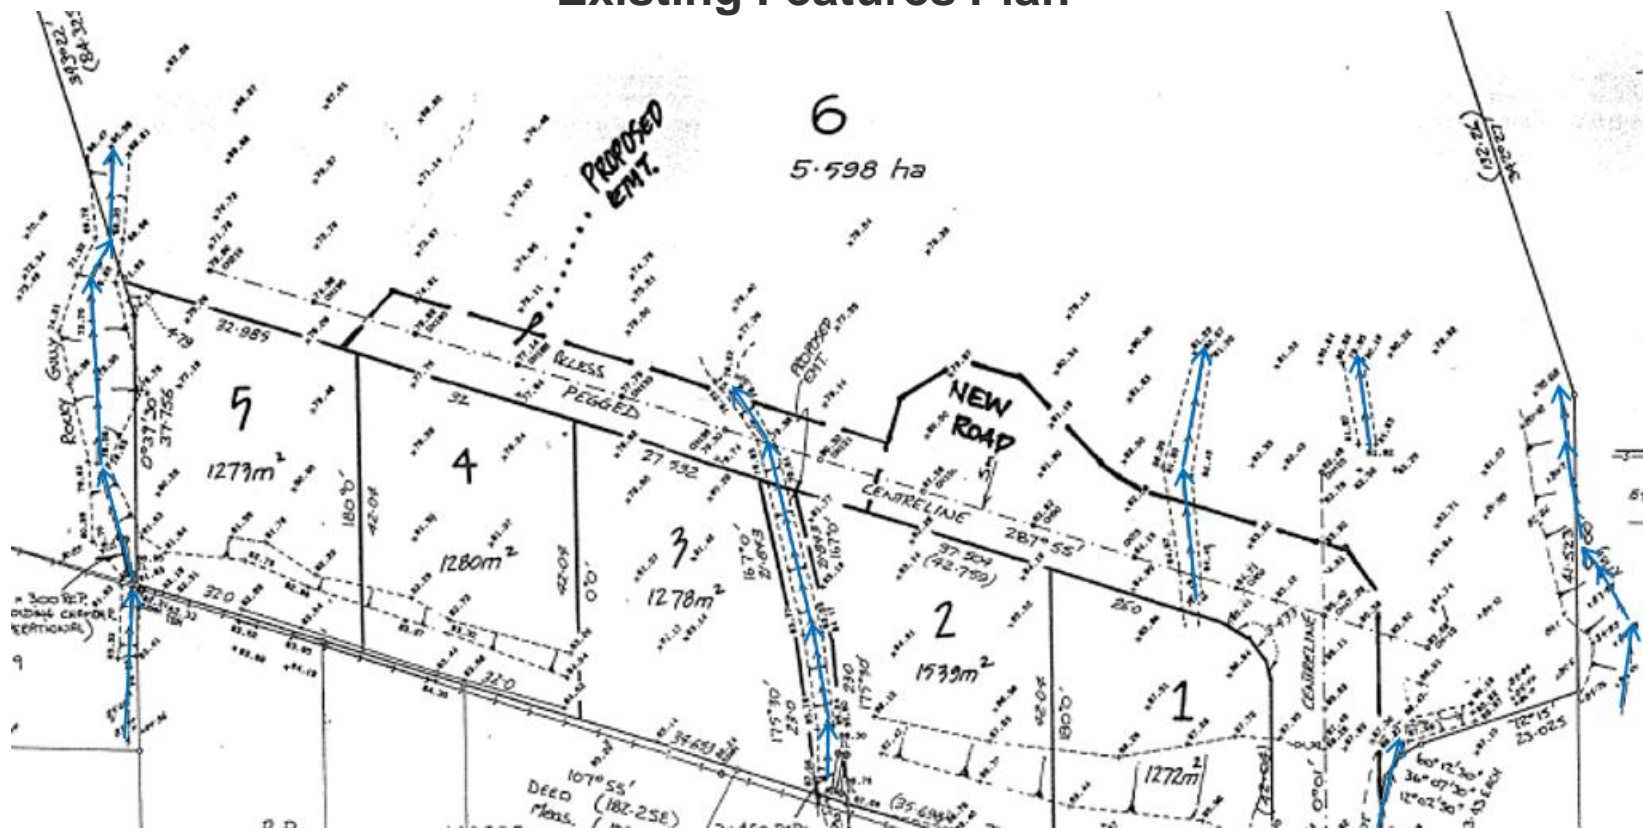
Outcome of Site Investigation

With reference to your letter dated I wish to advise that Condition has now been deleted from Permit to Subdivide

However, if problems arise with discharge of stormwater in future Council may require the applicant to provide the relevant stormwater easement without the costs of compensation being incurred by Council.
