City of Hobart presents

Rejuvenating kunanyi / Mt Wellington's Great Short Walk

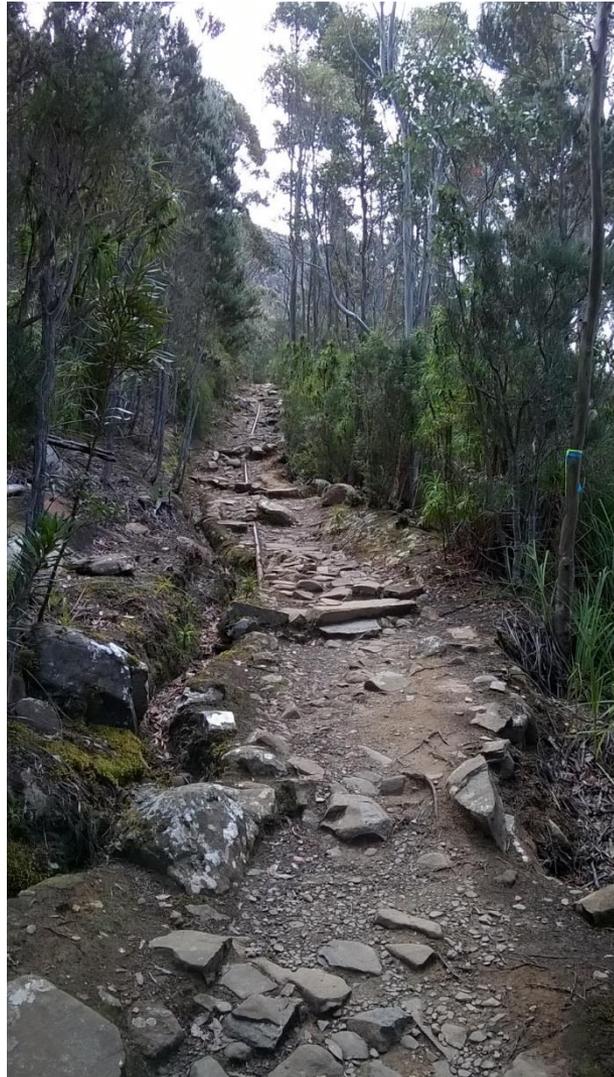
Challenges

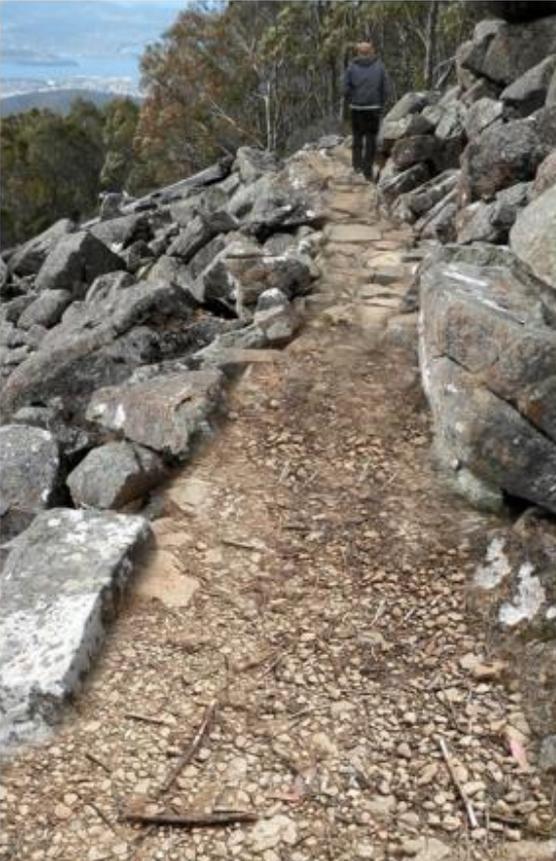
A photograph showing the same boulder field as the 'Existing' image, but with a more defined and stable path. The path is filled with coarse gravel and smaller rocks, and the edges are reinforced with larger boulders. A person is walking away from the camera on the path, providing a sense of scale. The background view is the same as in the 'Existing' image.
<p>Existing Existing boulder field crossing in poor condition. Aggregate has washed away leaving unstable base rocks and hazardous voids. Visitors report inability to appreciate surrounds and views as attention is consumed by navigating track.</p>	<p>Proposed Fill voids with rock and coarse gravel. Restore edge retaining boulders where these have collapsed. Re-gravel with matching material from the approved source. Stable and safe rocky sections may be left uncovered.</p>

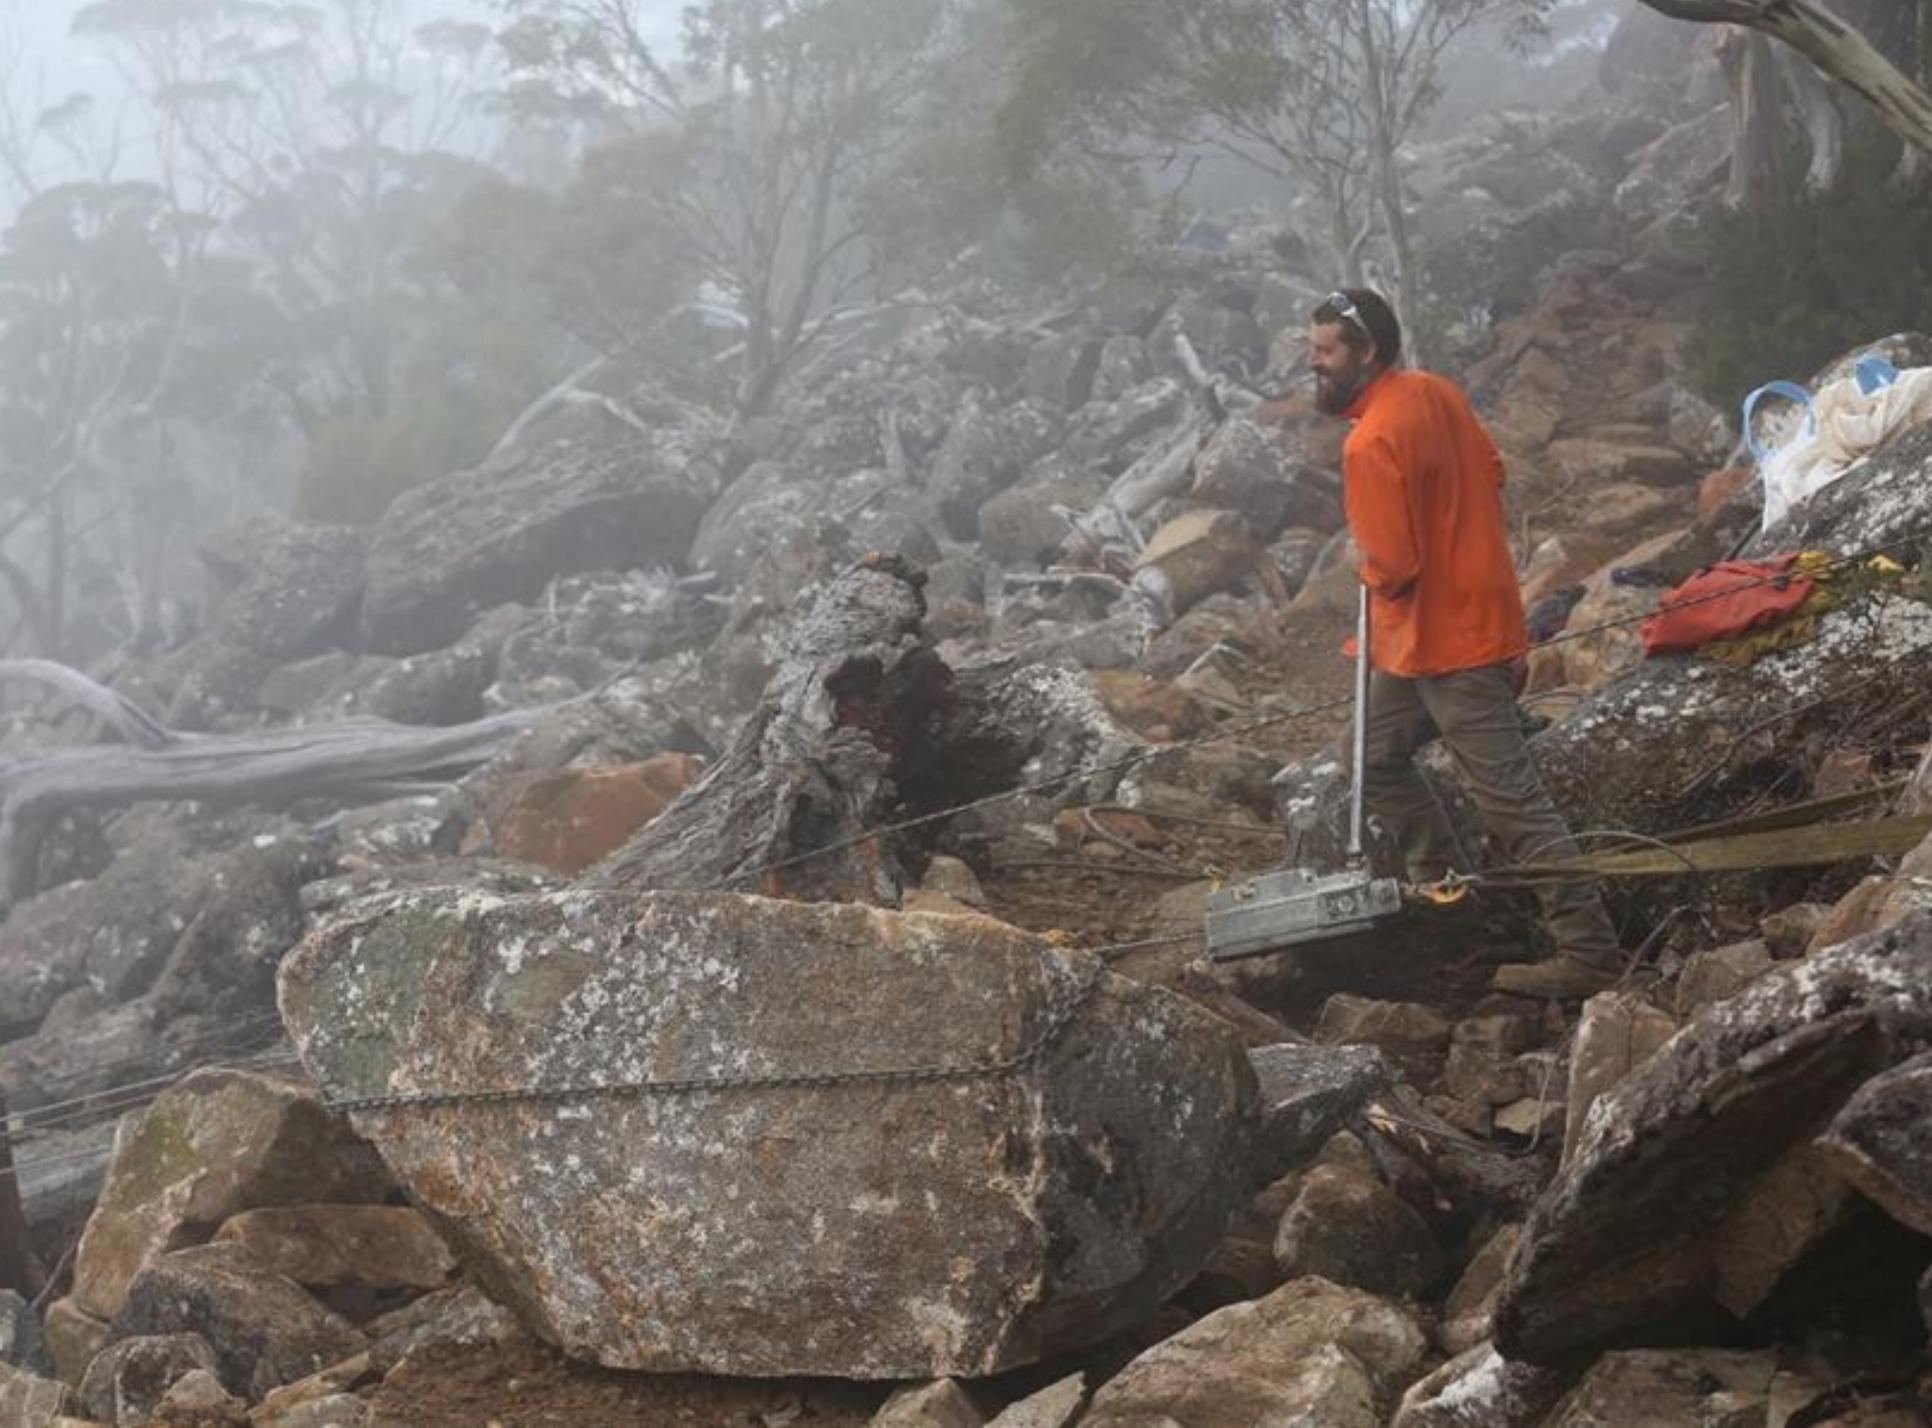
Hazardous Boulders

- Assessment of site
- Stabilization

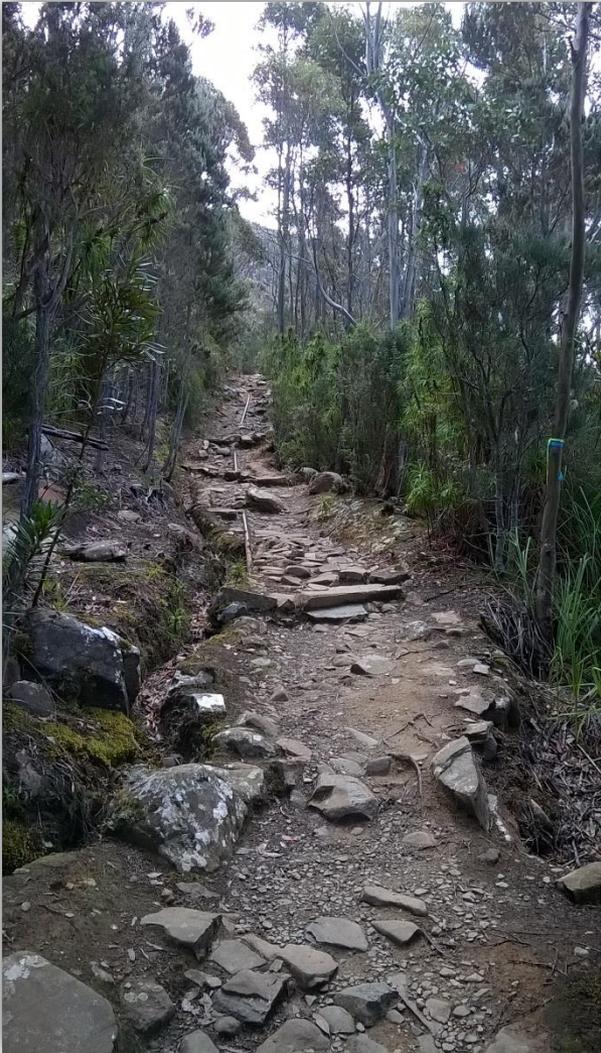
Before

Rock / Gravel

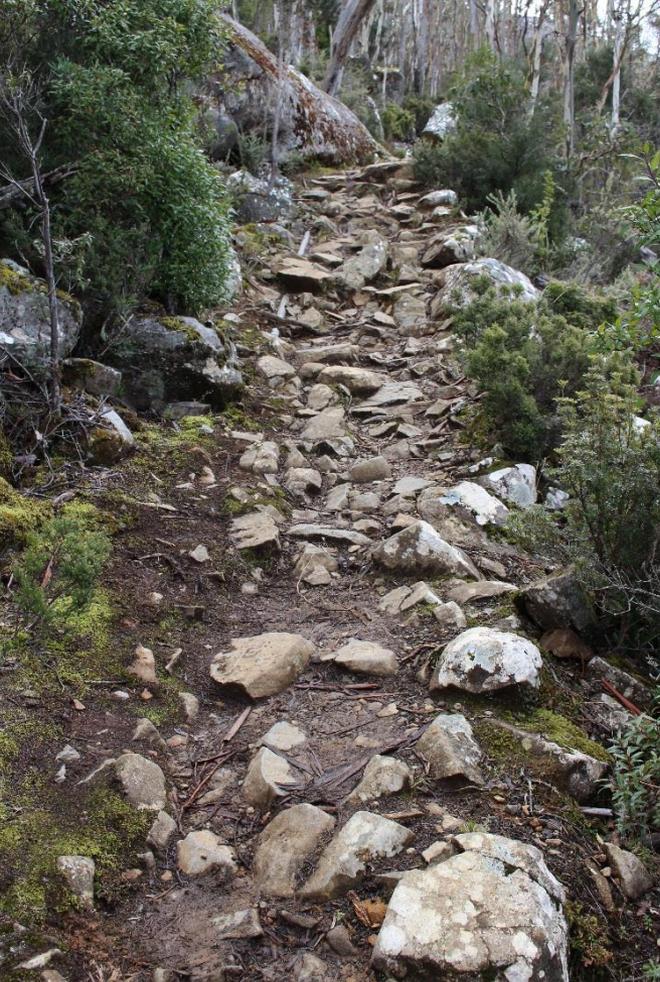
Before

Pitching
